**Australian Transport Safety Bureau**

# Foreign object damage involving Airbus A320, VH-VGY

Auckland International Airport, New Zealand, 27 October 2017

**ATSB Transport Safety Report**  
Aviation Occurrence Investigation  
AO-2017-108  
Final – 27 February 2018

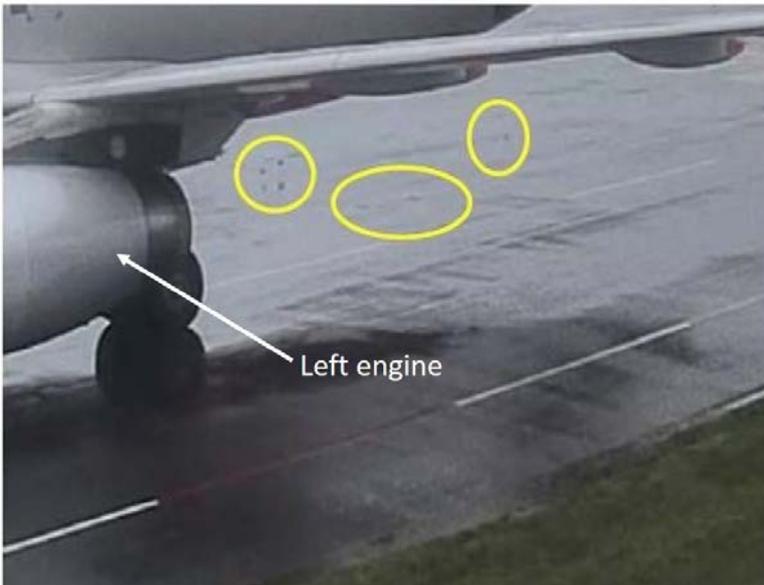
At about 1925, when the aircraft was taxiing, the leading hand realised his clipboard with the paperwork was missing and thought the dispatcher had the paperwork. The leading hand asked the dispatcher about the clipboard and she mentioned she saw it in the right engine during the walk-around. The ground crew returned to where they were preparing the aircraft and noticed paper debris on the ground. The ground crew organised for their operations area to contact the flight crew.

**Figure 1: Foreign object debris on the ground behind the aircraft (circled)**
