Level crossing collision between freight train 8426N and road-train truck

Cobb Highway, Ivanhoe, New South Wales, 11 July 2017

ATSB Transport Safety Report

RO-2017-005

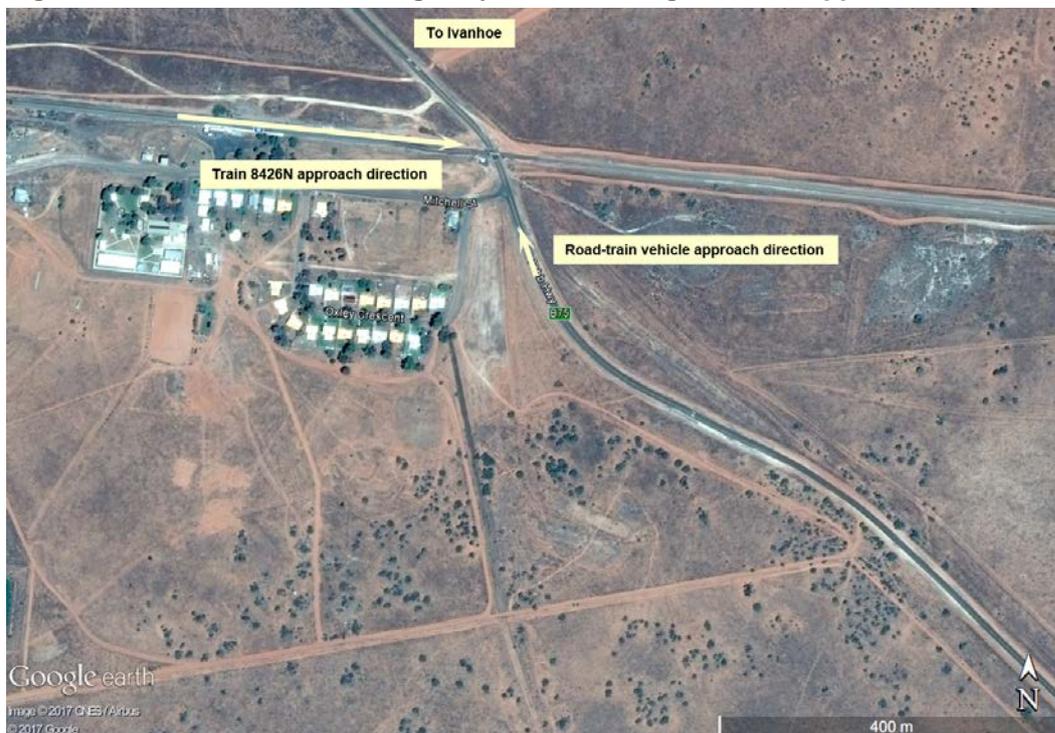
Figure 1: Aerial view of Cobb Highway level crossing and road approaches

The road-train driver was negotiating a sweeping right-hand bend before the road alignment straightened toward the crossing (Figure 1). The road-train driver reported travelling at about 70 km/h approaching the crossing (the posted speed limit was 80 km/h).

The driver stated that the alignment of the sweeping 'S' bend road approach and roadside vegetation meant that sighting of the flashing lights was also restricted until the vehicle had travelled through the bend and was within 180 m from the crossing. On sighting the level crossing operating, the driver assessed that there was now insufficient distance to stop the road-train prior to it entering the crossing.

Road and rail authorities should consider measures to enhance the awareness of motorists approaching railway crossings, especially at locations with restricted sighting due to curved approach roads.

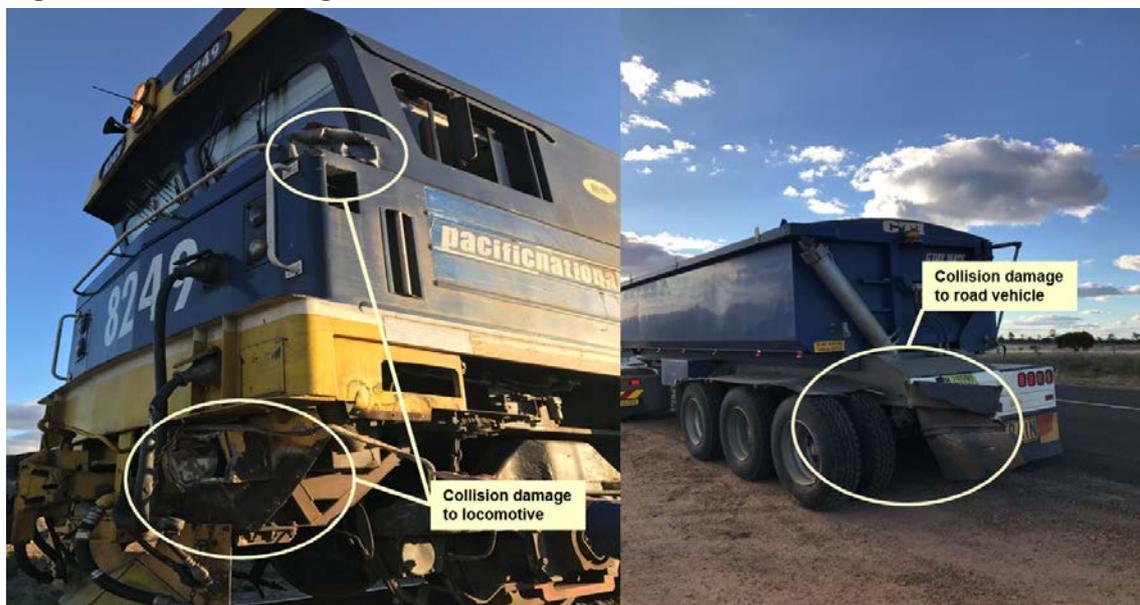
Figure 2: Collision damage to the locomotive and the last trailer of the road-train

Train 8426N subsequently collided with the near side rear corner of the last trailer of the road-train (Figure 2), travelling a further 319 m before stopping. Shortly after, the train driver reported the collision to the Australian Rail Track Corporation Junee Network Control Centre. The train crew and the driver of the road-train were shaken but otherwise unhurt.

Train operator:	Pacific National	
Registration:	8426N	
Type of operation:	Freight	
Persons on board:	Crew – 2	Passengers – 0
Injuries:	Crew – nil	Passengers – nil
Damage:	Minor damage to the front of locomotive 8249

Registration:	Private
Vehicle details:	Mack Superliner road-train
Persons on board:	1
Injuries:	nil
Damage:	Minor damage near side rear corner of the last trailer
