# De-icing boot failure involving SAAB 340, VH-ZLH

Esperance Airport, Western Australia, 26 May 2018

**ATSB Transport Safety Report**  
Aviation Occurrence Investigation  
AO-2018-045  
Final – 26 October 2018

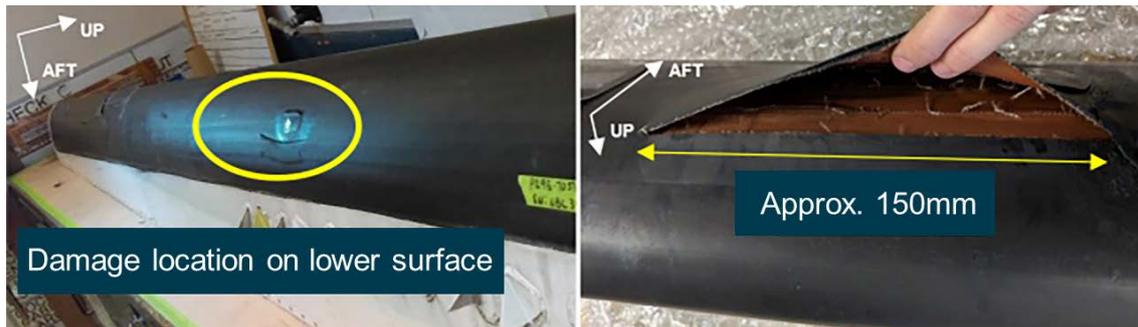
During the post-flight walk-around, the FO observed that the right-hand stabiliser boot had a tear approximately six inches (150 mm) in length (Figure 1). The de-icing boot was replaced in accordance with the aircraft maintenance manual before the aircraft was returned to service. There were no other faults found with the de-icing system.

**Figure 1: Photo of the damaged de-icing boot**

The horizontal stabiliser is located approximately 4 m from the ground with the top surface of the de-icing boot sweeping back over the horizontal stabiliser to be parallel to the ground. The flight crew indicated that a visual inspection of all surfaces of the boot is possible from the ground, however, it can be more difficult to see the uppermost surface. The tear in this occurrence was located on the lower surface of the stabiliser boot (Figure 1), which is an easily inspected location from the ground.

On examination by the engineering team, the only fault found within the de-icing system was a torn de-icing boot. It was therefore likely that the cockpit warning lights were indicative of that defect, despite the fact that the unlit TIMER light was not consistent with a torn boot as described in the QRH. The TIMER light not illuminating during testing was likely to have been a system anomaly and there was, in fact, a defect present in the de-icing boot that either went undetected during visual inspections or ruptured during the pre-flight test.

The FO did not observe any defects in the surface of the de-icing boots during the walk-around inspections, either the evening before or on the morning of the incident. During the post-flight walk-around however, the FO identified the tear without difficulty. It was therefore likely that if there was a pre-flight tear, it was small in nature, allowing it to go undetected. That being the case,

aerodynamic loading on the horizontal stabiliser during the flight would have resulted in the defect increasing to the size that was readily identified post-flight.

- It was likely that the crew conducted a flight with a small defect in the aircraft's horizontal stabiliser de-icing boot, which increased to a readily detectable size during the flight.
- The timer light for the de-icing system did not illuminate, giving the flight crew indications that were inconsistent with a torn de-icing boot. The reason for the unlit timer light could not be determined.
- The flight crew managed the risk of airframe icing prior to continuing with the flight.

- provided additional training on the de-icing systems and associated MELs to the flight crew
- discussed the potential occurrence of a torn de-icing boot with no associated TIMER light with the manufacturer
- all five de-icing boot MELs have been amended to include PIC maintenance visual inspections.
