# Water ingress into steering gear compartment onboard *Goliath*

Bass Strait, on 7 March 2018

**ATSB Transport Safety Report**  
Marine Occurrence Investigation  
340-MO-2018-003  
Final – 25 January 2019

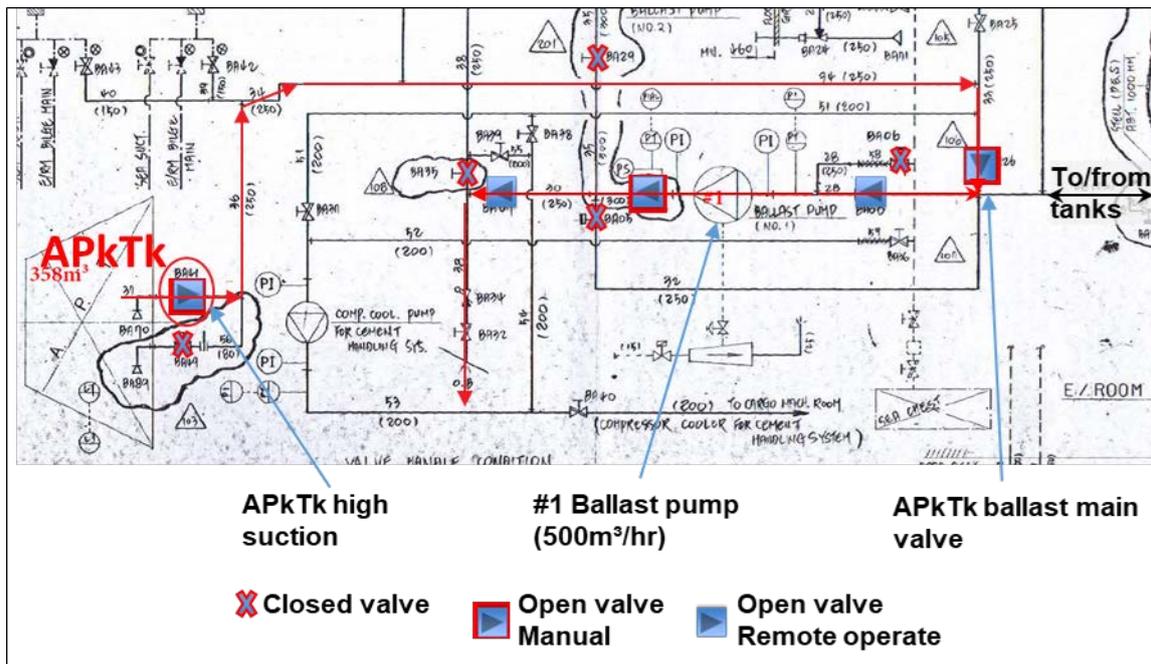
At 1500, the third mate contacted the duty IR and asked that the two after peak manually operated valves be closed (Figure 2). For reasons that could not be determined, the requested valve closures were not actioned. The third mate did not confirm with the IR that the message had been received and actioned so he was unaware that the valves connecting the after peak tank to the starboard ballast main had not been closed.

**Figure 2: Part of the ballast system piping diagram showing valve configuration for pumping out the after peak tank (APkTk)**

At 1745 the ballasting operations were stopped and tanks sounded. The after peak tank sounded at 11.54 m, 3 m higher than at the completion of after peak tank ballasting at 1500. At 1752, after checking stability conditions, the chief mate started pumping down the after peak. The chief mate also directed the duty IR to check the after peak tank ballast line valves. Both valves were found to be open.

A condition of class was placed on the ship until suitable repairs had been completed. In the meantime, any ballasting was to be completed with additional monitoring of this area of the ship and tank levels. Procedures were amended to require the duty officer to keep a log of all manual valve operations and ballasting of the after peak tank was to be conducted only during daylight hours. In addition, a status tracking board was made for the manual valves with moveable pegs to be used to show the status of each valve.

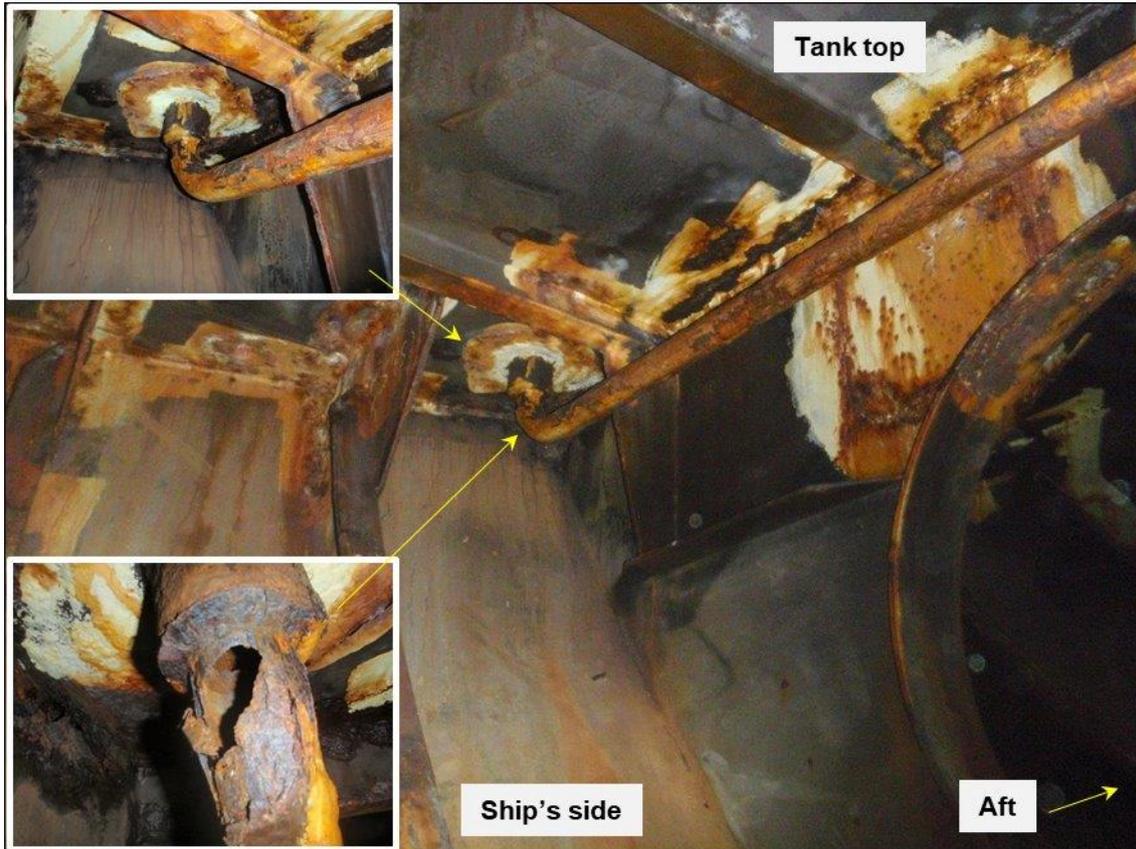
A tank entry and inspection of the after peak tank found the scupper line from the CO<sub>2</sub> room holed, on the outboard (back) side of the pipe, adjacent to the ship's side, just below the tank top (Figure 3). This line ran through the after peak tank before passing through the steering gear room bulkhead to drain into the steering gear room bilge well. The rear of the elbow piece directly below the tank top was heavily corroded and wasted with most of the pipe wall missing.

The tank was rarely filled to a depth which covered the holed section of pipe. However, when the starboard ballast tank was pressed up to overflowing, the open valves to the after peak tank allowed it to also fill. As the tank neared full, water covered the hole in the pipe, drained into the steering gear room bilge well and overflowed.

**Figure 3: Scupper pipe in after peak tank showing corroded and holed elbow**

Initial repairs involving renewal of the CO<sub>2</sub> room drain line (about 7.5 m), deck and bulkhead penetrations were completed on 10 March. Final repairs, survey and testing were completed on 18 March and the condition of class was lifted.

- Ballast tank inspection procedures have been reviewed and updated with added emphasis on internal tank fixtures
- During scheduled drydocking of *Goliath* in 2018 it:
  - fitted a ballast water treatment system in compliance with the Ballast Water Management convention which will remove the need for ballast water exchange
  - had the ballast tank remote sounding and alarm system replaced
  - had steelwork in the ballast tanks, including piping in the after peak tank, replaced.
