# Runway excursion involving Cessna 207, VH-MIA

East Wallabi Island, WA, on 16 September 2018

**ATSB Transport Safety Report**  
Aviation Occurrence Investigation  
AO-2018-062  
Final – 29 January 2019

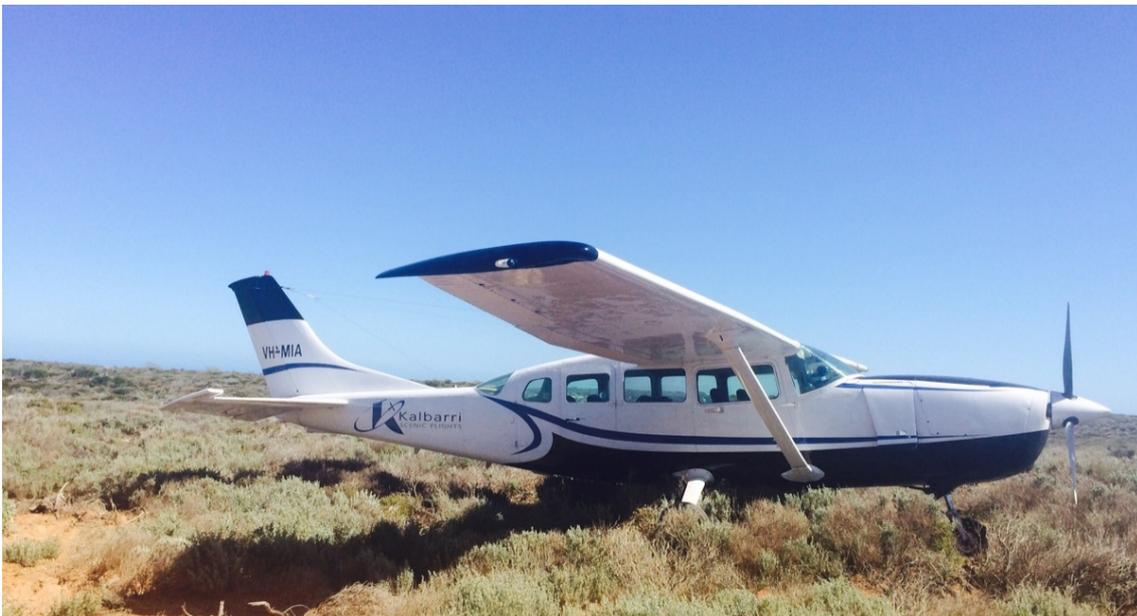
**Figure 1: VH-MIA after runway excursion**

The aircraft overflew the island and the pilot reported that she observed the windsock was indicating an easterly wind, which was a crosswind for both runways. She decided to join runway 36 on the mid-crosswind leg of the circuit. The pilot reported that she touched down on the runway abeam the taxiway (see Figure 2), which normally gives her enough runway length to stop the aircraft. However, on this occasion, she could not stop the aircraft and overran the runway end by approximately 1 metre (Figure 1). The aircraft was not damaged and there were no injuries to the pilot or passengers.

While the pilot advised she had checked the wind as they overflew the runway to join the circuit for runway 36, weather information received from the Bureau of Meteorology indicated that there was a southerly wind at the time the aircraft landed. The ATSB could not clarify if the pilot misread the windsock or the wind direction had momentarily changed when they joined the circuit and returned back to the southerly direction before the aircraft landed. The aircraft most likely landed with a tail wind component resulting in a faster ground speed at touchdown and the aircraft overrunning the end of the runway.

The pilot's decision to land the aircraft adjacent to the taxiway reduced the available stopping distance available. Using the full runway strip, would probably have allowed the pilot to stop the aircraft on the runway.

- It is likely that the aircraft landed with a tailwind component resulting in the aircraft overrunning the runway.
- The pilot's chosen landing position did not use the full runway strip length, reducing the stopping distance available.

The operator has discussed the incident with the pilot. They have stressed the importance of checking the windsock on the final leg of the circuit to ensure there is no downwind component,

especially on a short runway. The operator and the pilot have also discussed the importance of using all available weather data, in particular the observations page on the Bureau of Meteorology website before going flying.

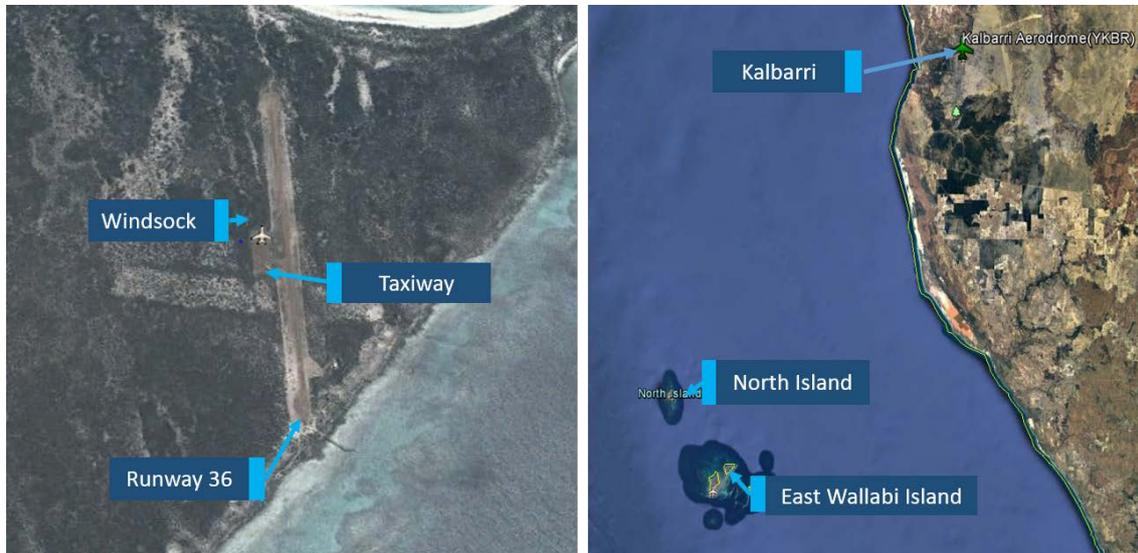
**Figure 2: East Wallabi Island runway and Kalbarri, North Island and East Wallabi Island**

The runway strip on East Wallabi Island is a privately owned unsealed strip. It is 637 m long and 30 m wide. The pilot reported that it slopes down slightly in the middle and has soft sand at one end. The windsock is on the western side of the runway on a slight hill.
