# Runaway loaded ore train M02712

211 km mark south of Port Hedland, WA on 5 November 2018

**ATSB Transport Safety Report**  
Rail Occurrence Investigation  
RO-2018-018  
Preliminary – 12 March 2019

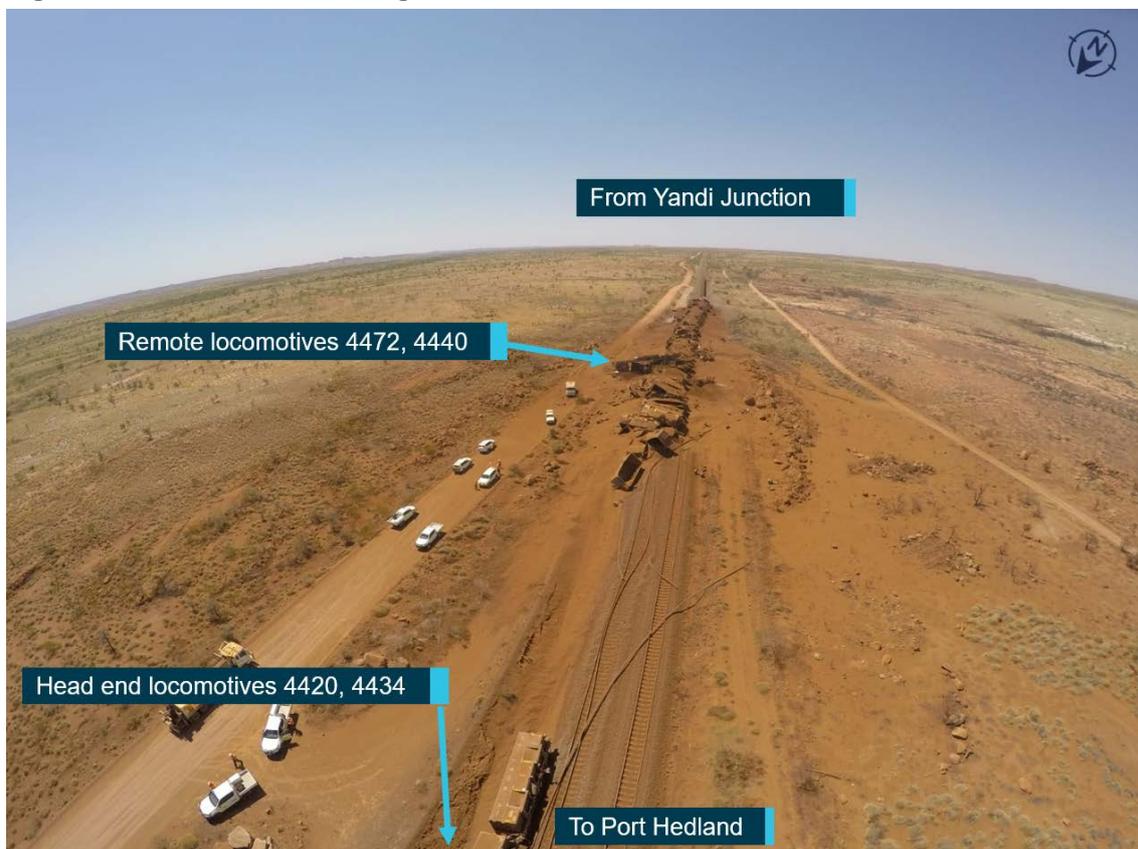
**Figure 1: Train M02712 wreckage at Turner South**

At about 0526, the head end locomotives traversed the crossover. Shortly after, 245-ore cars and the two remote locomotives, located mid consist, derailed. There was significant damage to rolling stock and track infrastructure at Turner South (Figure 1). There was no injury to any person from the derailment.

Aerial image viewed in a southerly direction of train wreckage and track damage at Turner South. The lead locomotives 4420 and 4434 and one ore car (out of frame in the foreground) remained on track Source: BHP, annotated ATSB

The derailment destroyed two locomotives, 245-ore cars and 2 km of track infrastructure at Turner South.
