Taxiing proximity event involving Airbus A321, VH-VWQ, and Boeing 737, VH-VZB

Melbourne Airport, Victoria, on 30 April 2018

ATSB Transport Safety Report
Aviation Occurrence Investigation
AO-2018-040
Final – 6 June 2019

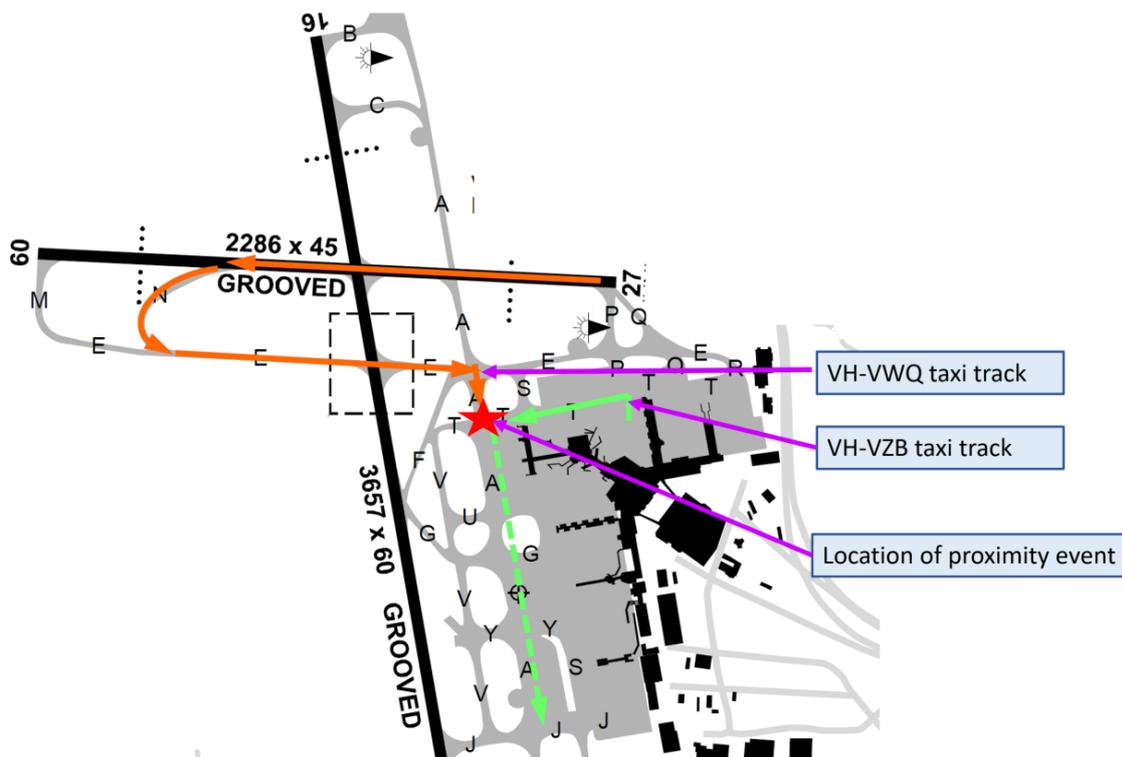
Figure 2: Airport diagram showing aircraft tracks

take-off. The SMC cleared VZB to ‘taxi via TANGO [T] and hold short of [taxiway] ALPHA [A]’ (Figure 2).

At 0927:43, the SMC cleared VWQ to ‘cross runway 34, taxi via ALPHA [A], hold short of JULIET [J],’ which was four intersections beyond taxiway T. As VZB was required to hold short of taxiway A, at that time, VWQ had right of way through the intersection of taxiways A and T.

As VWQ taxied along taxiway A and approached the intersection with taxiway T, the captain, seated in the left seat, sighted VZB approaching the intersection from the left (on taxiway T). The captain of VWQ assessed that the flight crew of VZB had not seen VWQ and that if both aircraft continued at their current speed, they might collide at the intersection. In response, he took control of the aircraft from the first officer (the operating pilot) and braked heavily.

After commencing the handover, the controller forgot that he had issued VWQ clearance to taxi through intersection A/T, thinking that he had instructed the crew to hold short of T. Situations of high workload are likely to reduce memory performance.⁵

When the controller then cleared VZB through the same intersection, a potential conflict resulted. His workload and distraction associated with the handover probably contributed to the delay in detecting the conflict. When the conflict was detected, other radio transmissions delayed the controller instructing the flight crew of VWQ to give way to VZB until after avoiding action had already been taken.

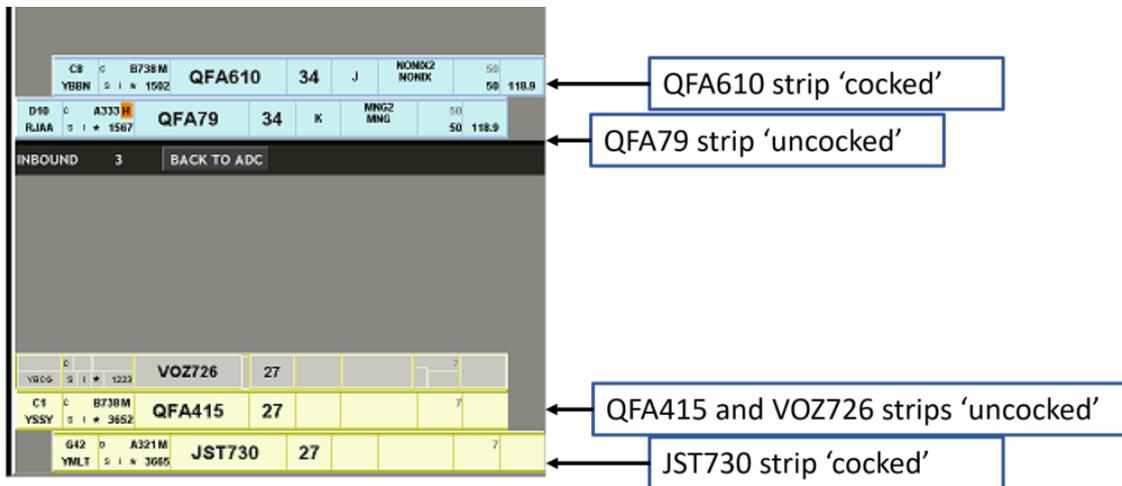
Figure 3: Examples of flight strips cocked and uncocked

A technique that controllers do use to remind themselves that a clearance limit has been issued and further instructions are required is to ‘cock’ the flight strip (Figure 3). This involves leaving the strip offset to the right side of the bay. The controller moves it to the left (‘uncocked’) when a clearance has been issued where no further instructions are required. The SMC advised that he used that technique.

This technique provides a visual trigger to remind controllers that there is an outstanding action. However, an uncocked strip when no clearance limit has been issued would not provide that cue, or alert to the potential for a proximity event.
