# Undetected engine thrust reverser deactivation involving Fokker F100, VH-NHA

Karratha Airport, Western Australia, on 27 December 2017

**ATSB Transport Safety Report**  
Aviation Occurrence Investigation  
AO-2018-001  
Final – 18 December 2019

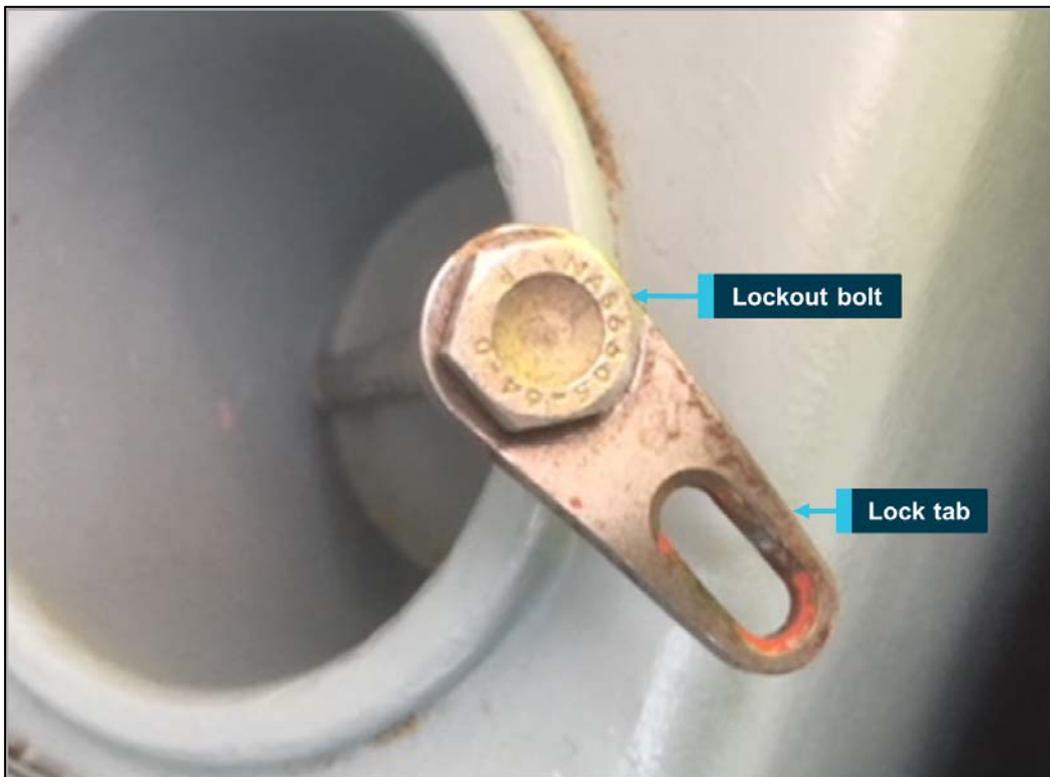
The flight crew reported the thrust reverser issue to engineering personnel for investigation. The subsequent engineering inspection found that the right engine thrust reverser had the 'minimum equipment list' (in-service) lockout bolt installed, effectively deactivating the reverser. The lockout bolt (Figure 1) was removed, normal operation of the thrust reverser was confirmed, and the aircraft returned to service.

**Figure 1: In-service thrust reverser lockout bolt and lock tab**

The right engine thrust reverser did not activate after VH-NHA landed at the Karratha Airport, because its in-service lockout bolt was installed. The engineer who installed the bolt during the maintenance in Perth before the flight had mistakenly not removed the bolt after the maintenance was completed. The presence of the bolt was missed for a number of reasons.

The aircraft maintenance organisation, Network Aviation, advised the ATSB that it has taken safety actions that include highlighting to maintenance staff the importance of following the safety instructions and warnings contained in the aircraft maintenance manual. Further, the procedures for maintenance activities including task assessments, tooling and task procedures have been reinforced.

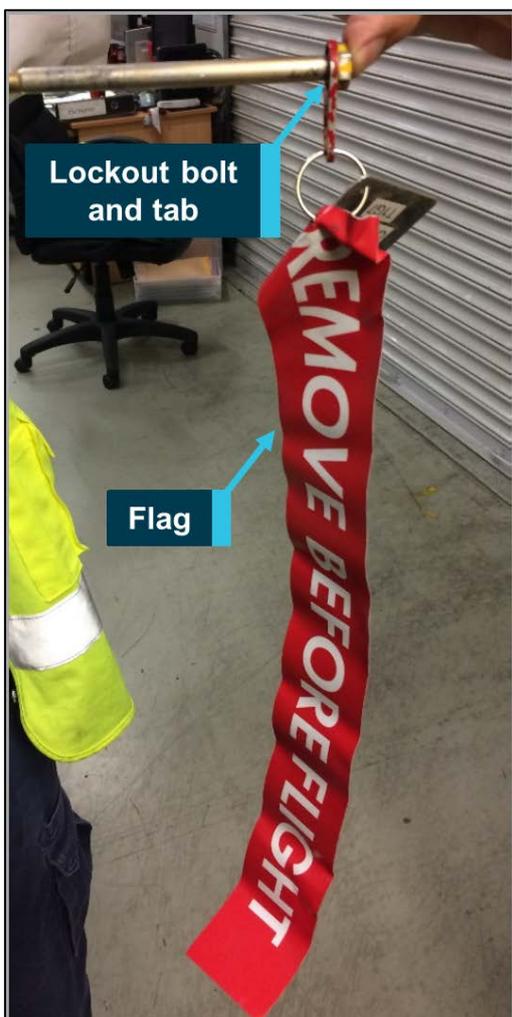
The Fokker F100 job instruction card specified using a rigging pin to de-activate the thrust reversers. Instead of using the rigging pin, the engineer decided to use the in-service lockout bolt from the aircraft's cockpit. The aircraft maintenance manual specified the use of a maintenance bolt. This bolt was available from the tool store and had a red warning flag about 0.5 m long (Figure 2). The in-service bolt did not have an attached warning flag, nor was it required to.

**Figure 2: Maintenance lockout bolt**

The engineer used the lockout bolt during the maintenance task to safely isolate the thrust reverser mechanism. However, he used the bolt from the cockpit because it was conveniently located. Therefore, the risk controls associated with using the specified maintenance lockout bolt were rendered ineffective.

Specifically, there was no warning flag to alert the engineer, dispatch engineer and flight crew that the lockout bolt was still installed. Further, the tooling check that would have identified that the bolt had not been removed was circumvented. Additionally, there were no warning labels in the cockpit to warn the flight crew that the bolt may be installed. Consequently, the aircraft was returned to service with the thrust reverser deactivated, but that was not identified prior to flight.

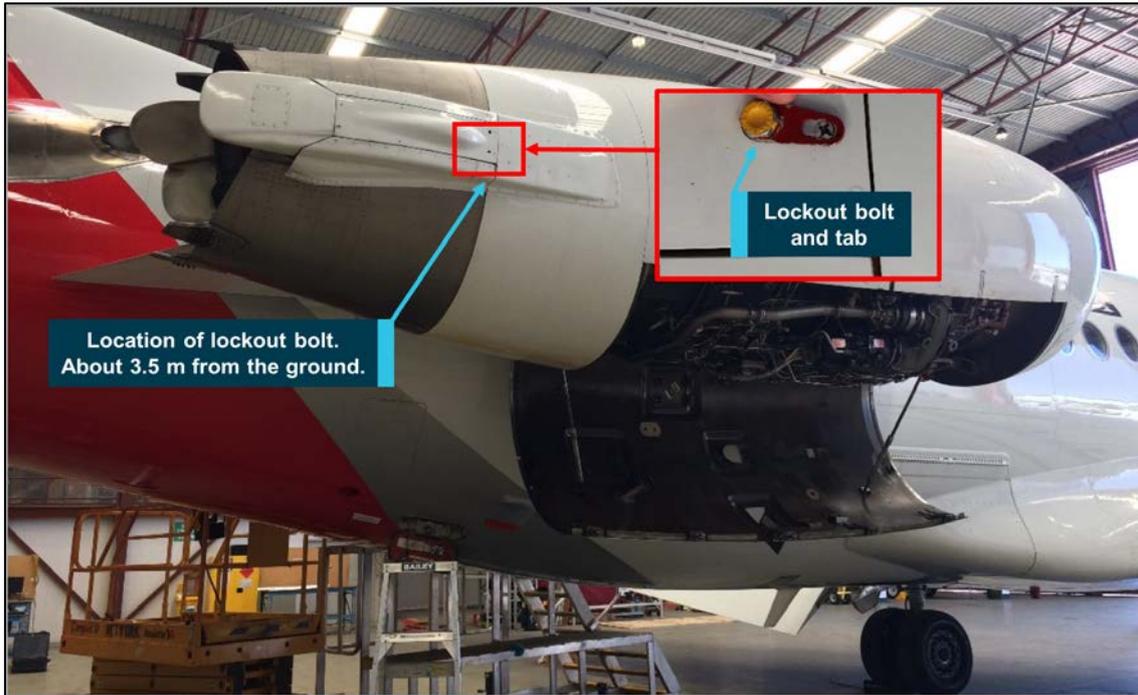
The engineer completed the inspections on the first aircraft and returned the in-service bolt to the aircraft cockpit. He then began inspections on NHA, again using the lockout bolt from the cockpit. After completing the inspection on the left engine, he installed the bolt into the right engine. The installation position was about 3.5 m from the ground and required the engineer to use a stand to insert the bolt (Figure 3).

**Figure 3: Photograph of right engine with an exemplar in-service thrust reverser lockout bolt**

The engineer completed the inspection but, due to a reported oversight, did not remove the bolt. He then completed the maintenance paperwork for both aircraft inspections.
