Suspected engine room fire and passenger evacuation on board *Fitzroy Flyer*

7 NM east-north-east of Cairns, Queensland, on 29 March 2019

ATSB Transport Safety Report
Marine Occurrence Investigation
348-MO-2019-004
Final – 24 June 2020

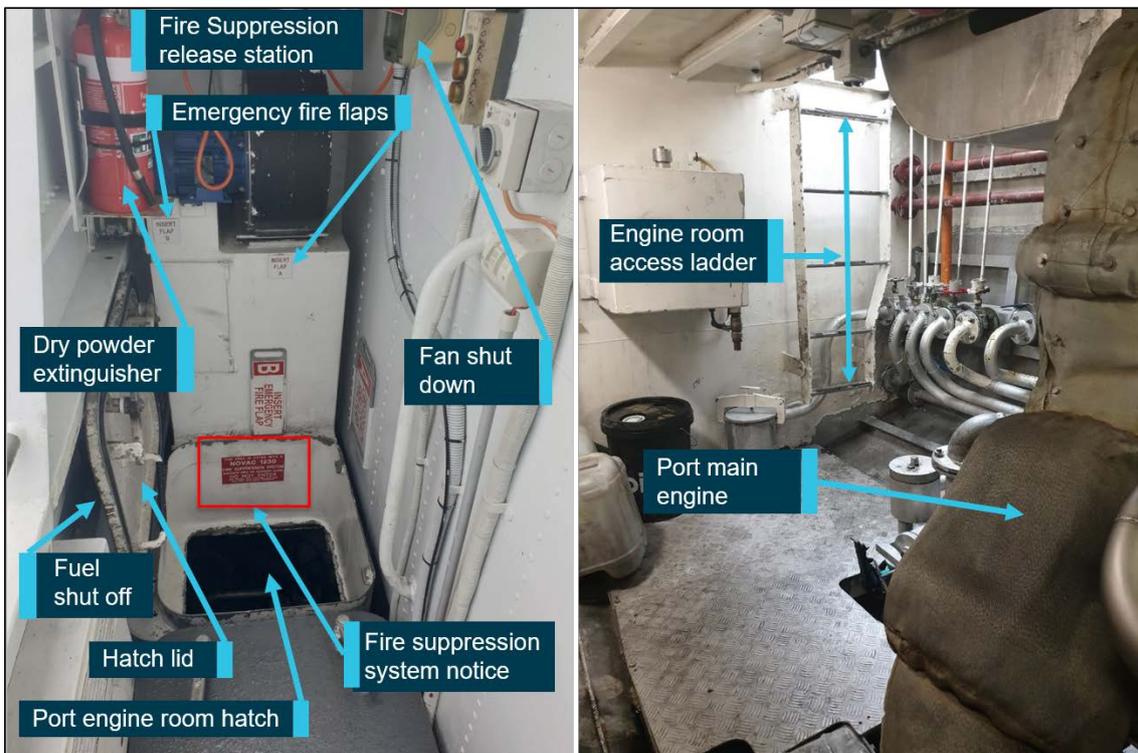
Figure 3: Port engine room and entrance

As DH1 and the passenger approached the engine room hatch lid, they could feel heat coming from it (Figure 3). As a precaution before opening the hatch lid, the passenger had collected a portable carbon dioxide (CO₂) fire extinguisher. When the hatch lid was opened, they sighted light-coloured smoke. They then climbed down the ladder, which was ‘hot to touch’, into the engine room to investigate further. They saw smoke, tinged blue, near the fuel filters,² and the passenger released the CO₂ extinguisher. They both then left the engine room and closed the lid.
