# Collision with a tree involving the airboat *Gale Force*

Sweets Lagoon, Northern Territory, on 22 June 2019

**ATSB Transport Safety Report**  
Marine Occurrence Investigation  
349-MO-2019-007  
Final – 26 June 2020

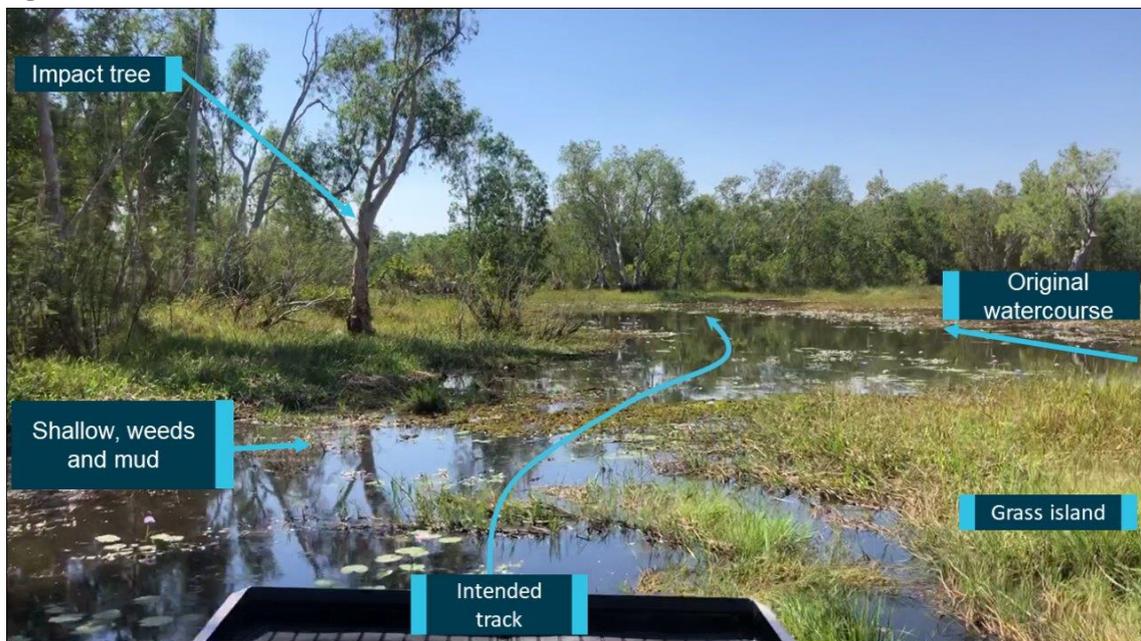
**Figure 2: Location of the collision**

A few minutes into the ride, the airboat was at speed when the track into a turn to starboard was slightly misjudged and control was lost. The airboat’s stern swung to port and left the channel. The starboard aft corner of the airboat swung round and made contact with a tree a few metres from the water’s edge (Figure 2).

As the airboat was being driven through a confined swampland watercourse on the second wetlands tour, it was at or near full throttle when going into a turn to starboard. In contrast to the earlier tour, the approach into the turn was misjudged and the airboat was slightly off track to port. In this area, the channel narrowed and the surface of the water was broken by grass, water plant and mud patches (Figure 2).

As the airboat crossed this surface, it rode up onto the material and control was lost. The airboat engine was at full throttle and there was insufficient reserve power available to drive the boat forward and through the turn. Consequently, the stern swung to port, through about 120°, and left the channel. The stern swung round until the starboard quarter impacted a tree a few metres from the water's edge.

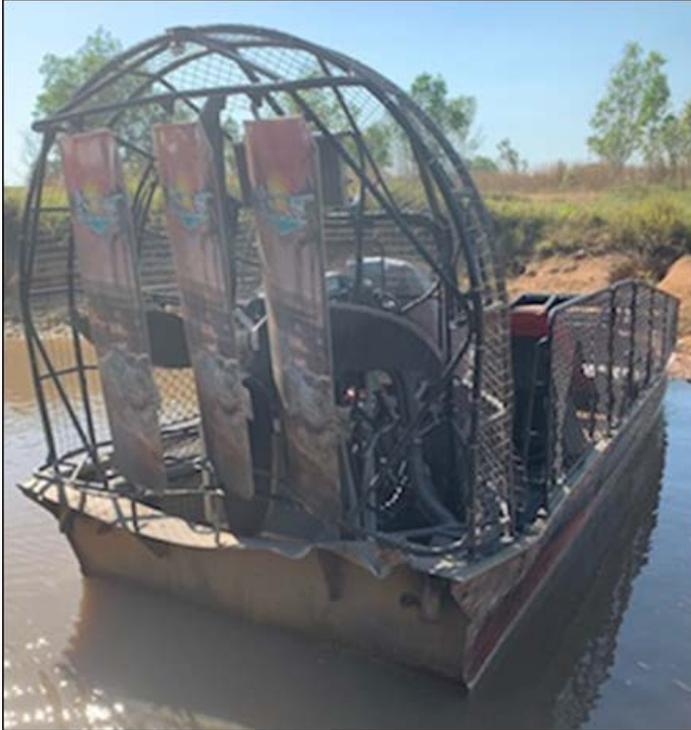
**Figure 3: *Gale Force* stern damage**

*Gale Force* was retrieved from the site and taken ashore for inspection and repair. The airboat had damage to the fan, the protective cage and the hull and the transom had been pushed to port by the impact (Figure 3).

Name:	<i>Gale Force</i>	
Unique Identifier:	429374	
Flag:	Australia	
Type of operation:	Tourism – smooth waters, 12 passengers or less	
Departure:	Sweets Lagoon, Northern Territory	
Destination:	Scenic wetlands tour	
Injuries:	Crew – 1 serious	Passengers – 2 serious, 2 minor
Damage:	Hull panel damage and transom pushed to port. Propeller, rudders and guard damaged.

The airboat was stripped and the hull repaired. New components were obtained and fitted and the airboat was inspected, surveyed and approved prior to returning to service.
