# Engine failure during take-off involving Bombardier Dash 8, VH-ZZE

Darwin Airport, Northern Territory, on 11 November 2019

## **ATSB Transport Safety Report**

AO-2019-060

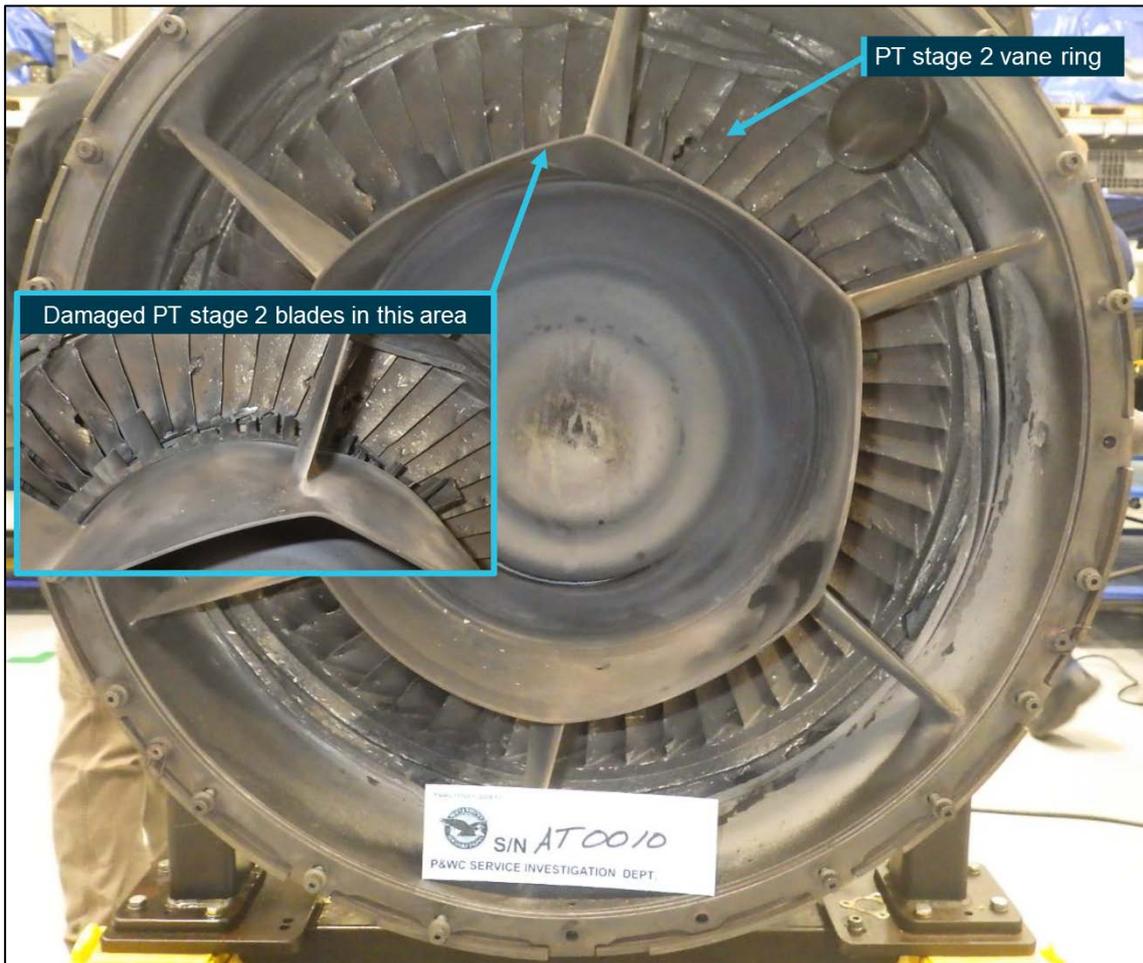
The right engine was subsequently removed from the aircraft with an external inspection revealing that all of the second-stage power turbine (PT) blades had separated from the disk (Figure 1). The PT assembly could not be rotated but the propeller shaft turned freely.

Figure 1: Rear-view of engine showing second-stage PT damage

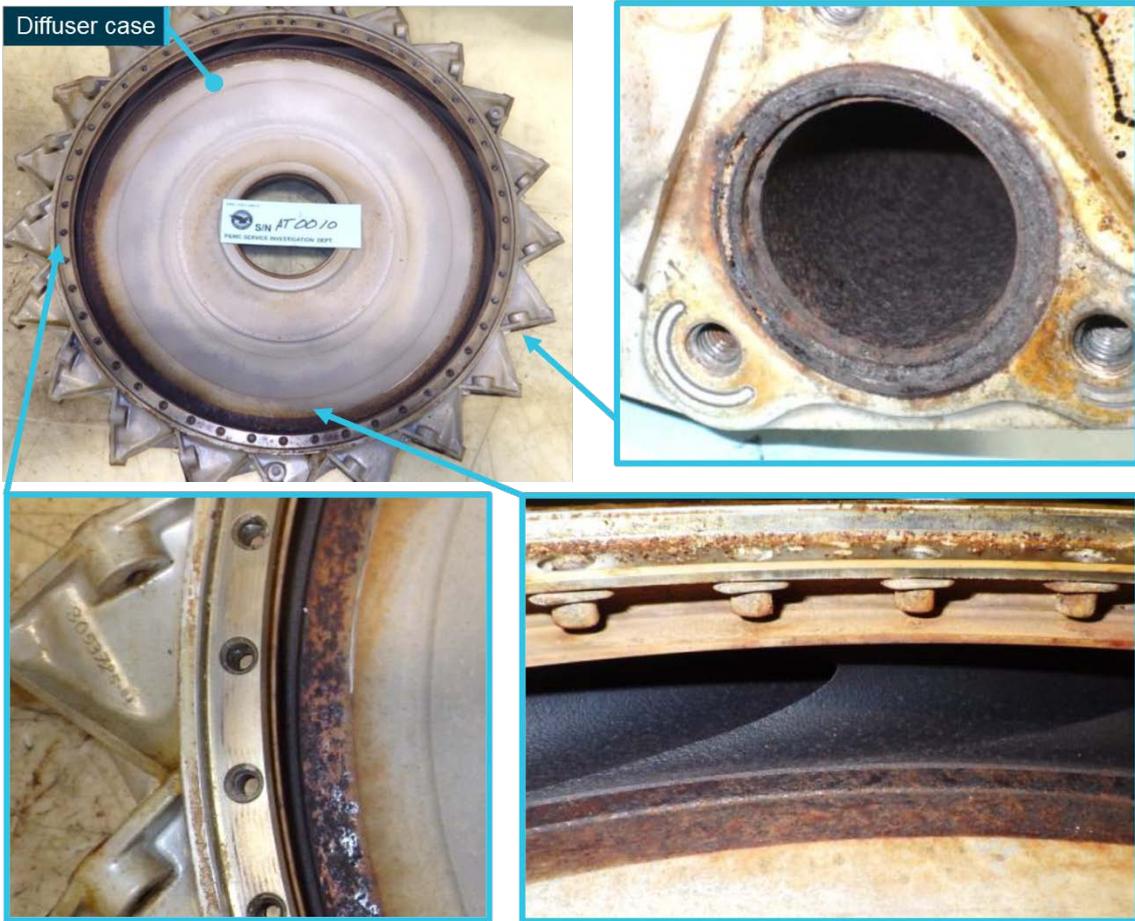
- Visual examination of the diffuser case, which contained the LP centrifugal impeller, showed corrosion at several locations (Figure 2). The LP impeller blades showed leading edge erosion.
- All PT stage 1 and stage 2 blades had fractured through tensile overload (Figure 3).
- The PT shaft (serial number A0030D9A) had fractured in two locations, referred to as surface 'A' and 'B' (Figure 4). Visual examination of the inner diameter next to surface A indicated corrosion pitting (Figure 5).
- No. 6 and No. 7 bearing oil transfer tubes had evidence of impact damage, and the vent transfer tube was fractured.
- The turbine interstage baffle was found buckled.
- The LP turbine disk assembly showed rubbing and cracks at the blade tips.
- The PT stator and vane ring exhibited impact damage.
- The exhaust case was deformed.

**Figure 2: Diffuser case showing areas of corrosion**

PT shaft fracture. According to P&WC, the LP impeller leading edge erosion, diffuser corrosion and PT shaft corrosion was due the engine’s operational environment.

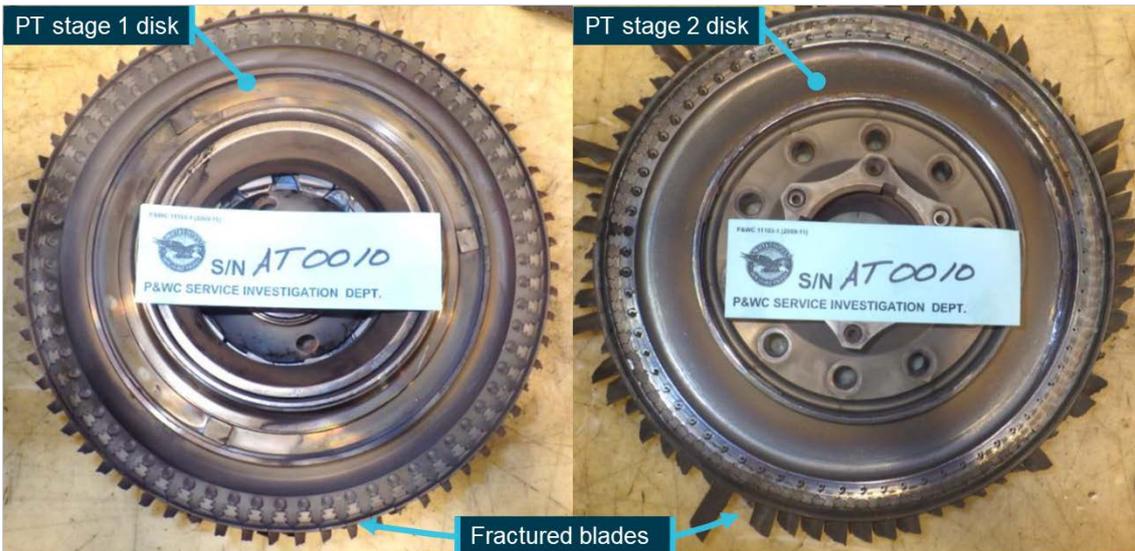
**Figure 3: Power turbine disk assemblies with all blades fractured**

The analysis concluded that the PT shaft had fractured from fatigue cracking, which initiated at the internal corrosion pitting at surface A. The fracture of the shaft at surface B was considered secondary. After the shaft fractured, the PT stage 1 and stage 2 disks moved backwards. The stage 1 disk subsequently went into an overspeed condition, which caused the blades to fracture by tensile overload near each blade platform as designed.<sup>4</sup> The stage 2 disk contacted the exhaust duct, resulting in the blades fracturing through tensile overload, at various heights above the blade platforms, from impact and overspeed.

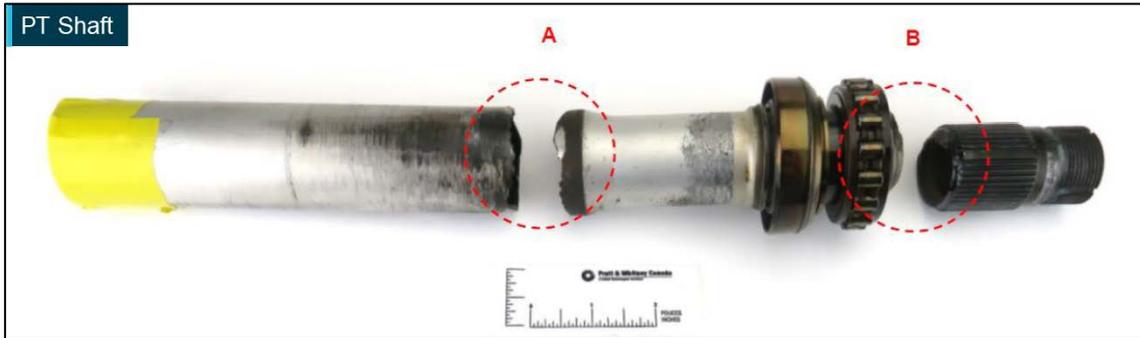
**Figure 4: Fractured PT shaft**

Circled locations A and B refer to the two different fracture surfaces  
Source: P&WC

- Fatigue cracks had initiated from corrosion pits on fracture surface A. Due to the corrosion, the material thickness was 25 per cent below the minimum thickness requirement.
- The base material (steel alloy) and its hardness were consistent with the design specification.
- The corroded layer near the fracture origin showed the presence of sodium, phosphorus, sulphur, and chlorine.
- Fracture surface B showed evidence of bending (as opposed to torsional) overload fracture.

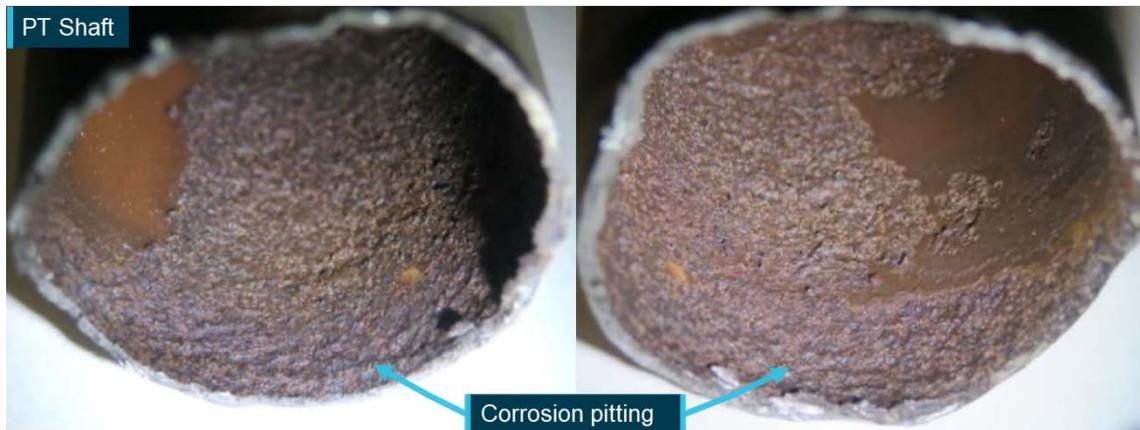
**Figure 5: Corrosion pitting of PT shaft internal diameter next to fracture surface A**

The corrosion products identified at the PT shaft fracture origin indicated that the corrosion was probably caused by salt-laden air. Since air from the compressor entered the PT shaft during normal engine operation, corrosion causing contaminants (for example, salt) and moisture within the ambient air probably built up on the inside of the shaft, allowing corrosion to occur.

The Australian Transport Safety Bureau recommends that Pratt & Whitney Canada takes safety action to address the risk of corrosion-related fracture of the power turbine shaft in its PW100 series engines.
