ATSB TRANSPORT SAFETY REPORT
Aviation Occurrence Investigation A0-2009-027
Preliminary

In-flight fire – 427 km south-west of Guam, 10 June 2009 Airbus Industrie A330-202, VH-EBF

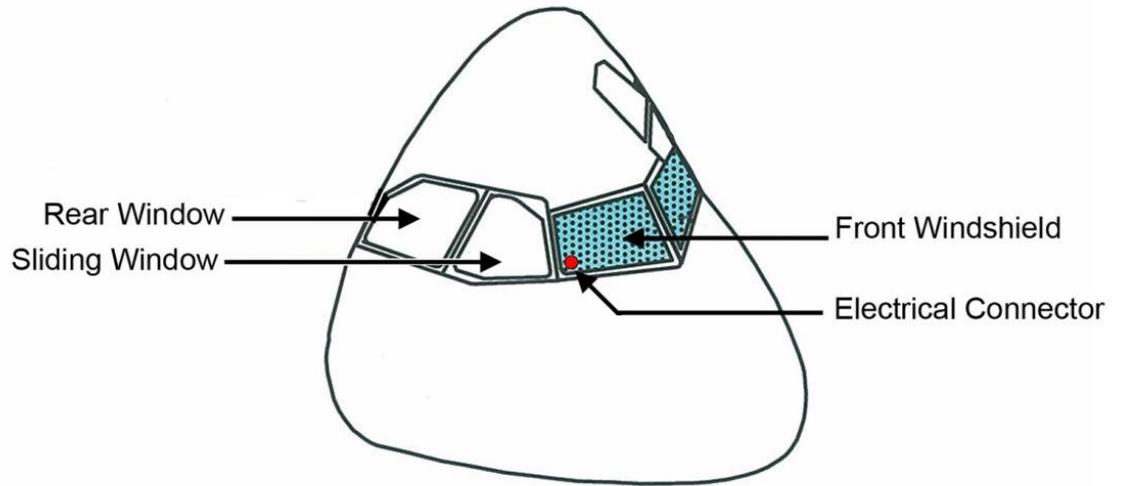
Figure 1: Cockpit windows

The aircraft's cockpit had two windshields, two fixed windows, and two sliding windows (Figure 1). Each window incorporated a thin layer of electrically conductive material, which received electrical power from one of two WHCs to prevent ice accumulation and fogging.

Electrical power was transferred to each windshield's conductive layer via an electrical connector (Figure 1) and terminal block (Figure 2) positioned on the lower outboard section of each windshield.

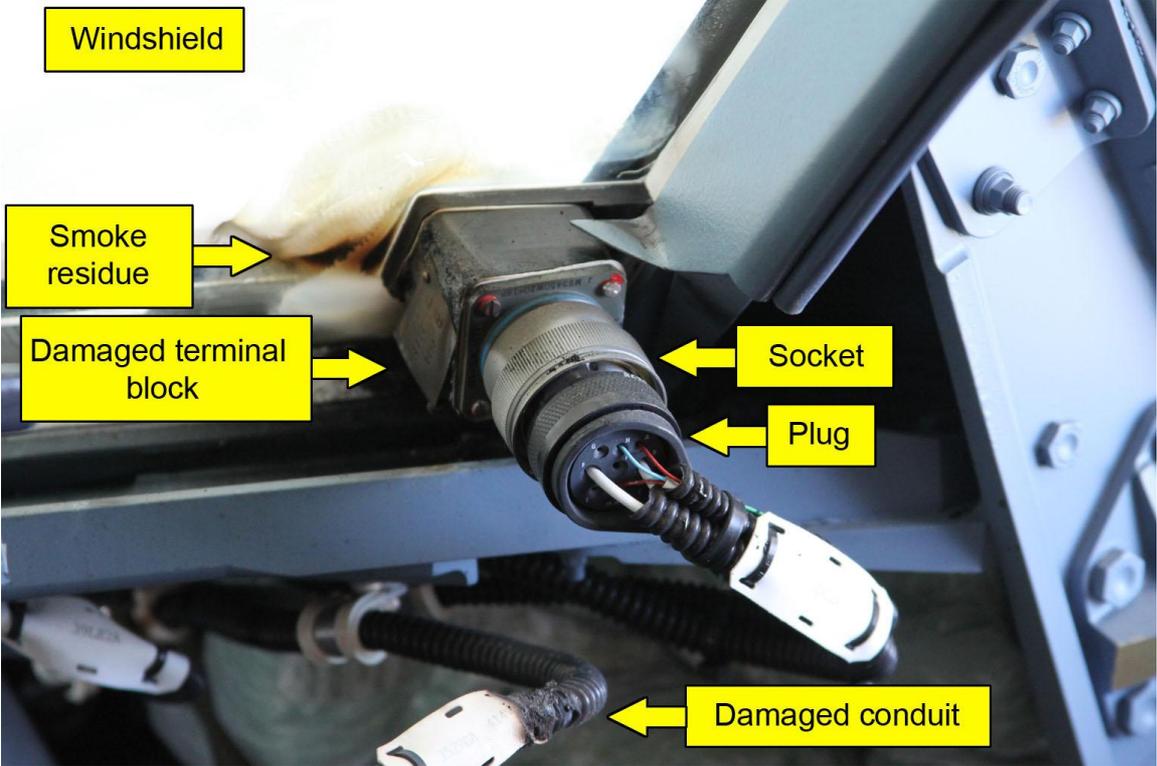
Figure 2: Windshield heat connector and terminal block (in situ)

Post-flight inspections of the aircraft in Guam showed severe burning and melting of the right side windshield terminal block (Figure 2), and minor heat damage to the glare shield and wire conduit around nearby loudspeaker wiring. The electrical plug from the WHC was firmly secured to the terminal block socket and was undamaged. There was no evidence of a loose fitting between the socket and the terminal block.

A small amount of smoke residue was present on the inner surface of the right windshield adjacent to the terminal block. No further damage was observed on any nearby equipment or wiring.

The aircraft maintenance provider immediately initiated an inspection of all windshield electrical connections within their A330 fleet.

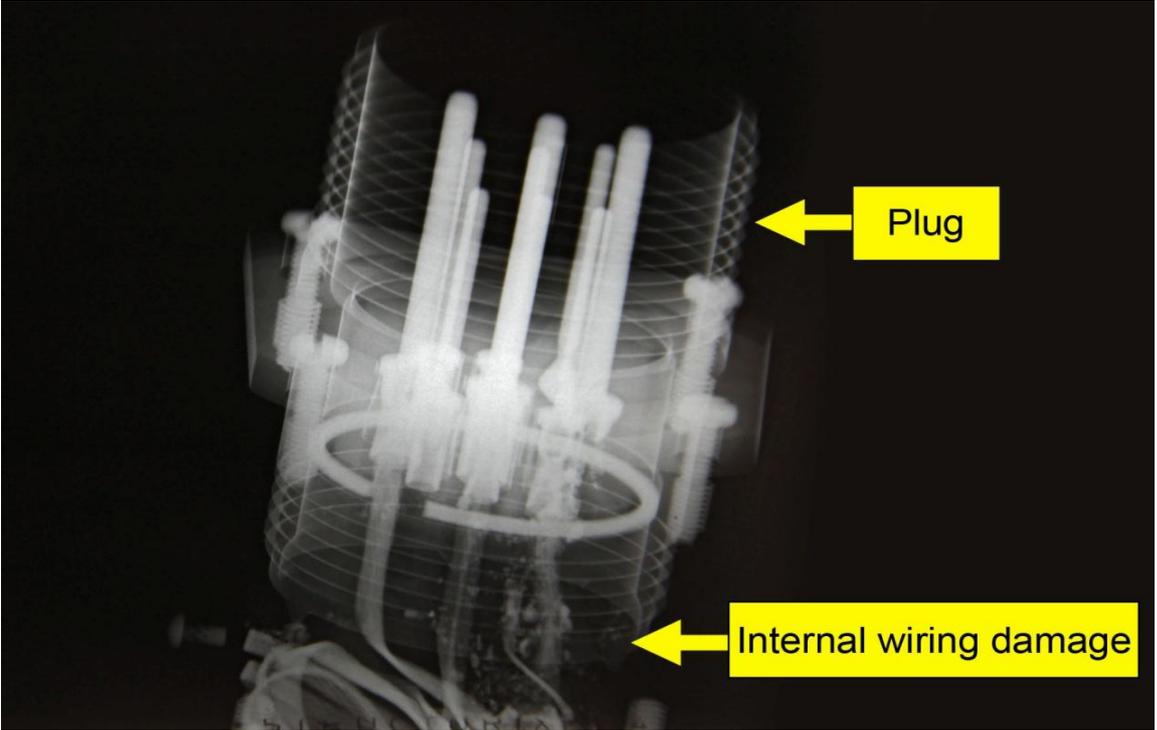
Figure 3: Windshield terminal block x-ray

The windshield terminal block (P/N: SPS A340-1-4-1A, S/N: 3594) was subsequently non-destructively examined using x-ray radiography. The examination revealed severe, localised, damage to the internal wiring within the terminal block (Figure 3).
