**ATSB TRANSPORT SAFETY INVESTIGATION REPORT**

Aviation Occurrence Report – 200600738

**Loss of Control – St Kilda, Vic - 12 February 2006**

**Robinson Helicopter Company R44**

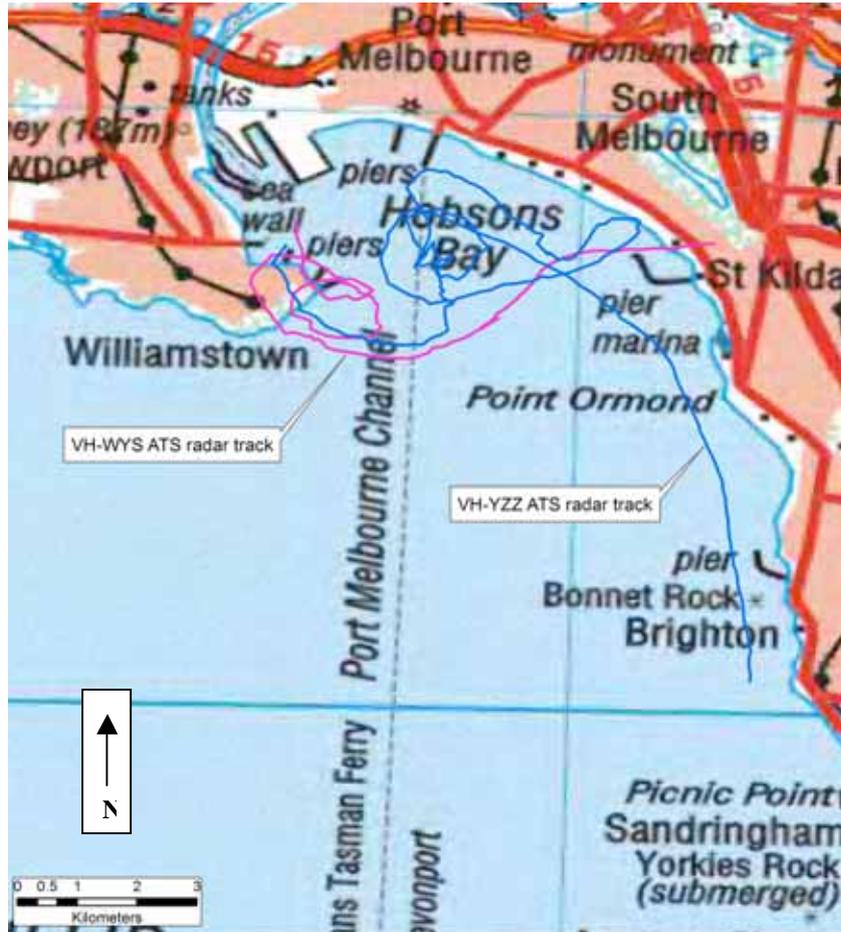
**Figure 1. Relative tracks of VH-WYS and VH-YZZ.**

The purpose of the flight was to photograph and film a promotional banner being towed by a Bell Helicopter Company 407 (B407) helicopter, registered VH-YZZ. The Australian Advanced Air Traffic System (TAAATS) replay of the flight showed that at 1229, the pilot of the R44 was flying slow anticlockwise orbits at 2,000 ft above ground level over Williamstown, while the pilot of the B407 was tracking north at approximately 30 kts and 1,600 ft over Hobsons Bay (figure 1).

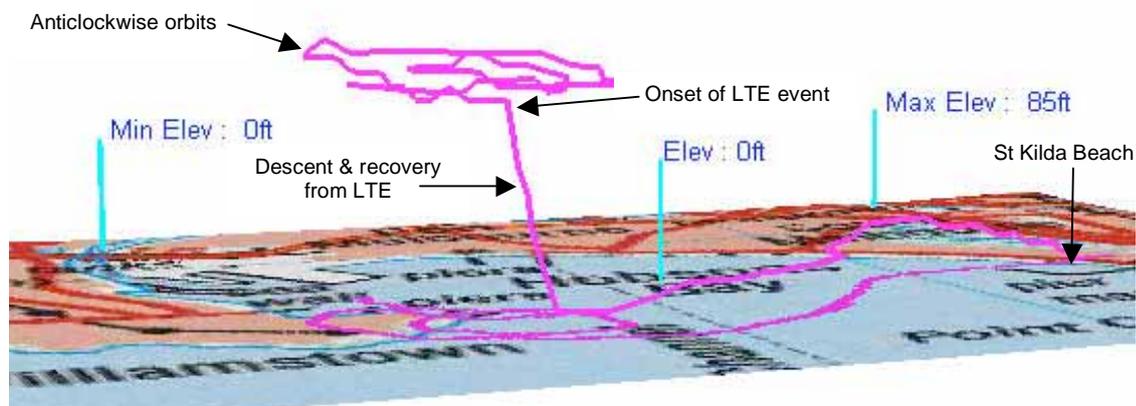
**Figure 2. Radar derived vertical profile of VH-WYS.**

MAYDAY<sup>6</sup> call to Essendon Tower and the photographer transmitted a MAYDAY call on frequency 123.45 MHz to alert the pilot of the B407. The recorded radar data indicated that the pilot regained control of the helicopter about 20 seconds later, at approximately 200 ft above the surface of the water. The radar-derived vertical profile of the helicopter is presented in figure 2.
