# Engine room flooding on board *Great Majesty*

Port Kembla, New South Wales  
 27 October 2008

ATSB-23

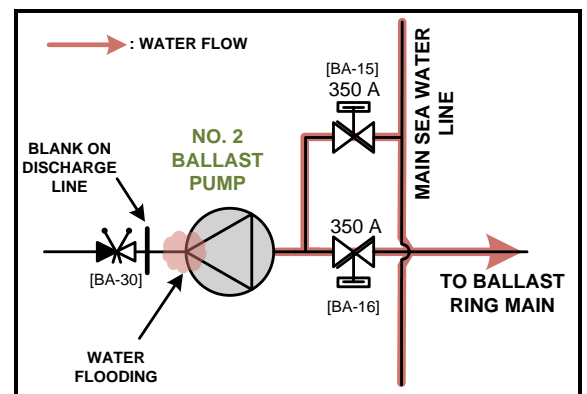
Figure 3: Flooding line

At 1745, the chief mate started to gravitate water ballast into No. 1 WBTK. He opened valves BA-15 and BA-16 (Figure 3) to connect the main sea water line to the ballast main piping.

About 10 minutes later, the motorman who was on duty in the engine room heard the bilge alarm sound. On investigation, he saw seawater flooding into the engine room through the open casing of No. 2 WB P/P. The motorman immediately informed the third engineer who, in turn, called the chief engineer.

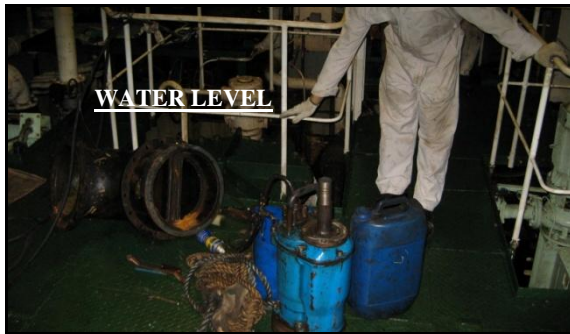
**Figure 4: Flooded water level indicated by hand**

On inspection, it was found that the water level in the engine room was about 1 m above the bottom plates (Figure 4).

The crew started to clean the engine room and check the operation of all motors and pumps. A total of 22 electric motors located around the lower levels of the engine room had been damaged by the water ingress. At about this time, the master contacted the ship's local agent and requested technical assistance with the damaged electric motors.

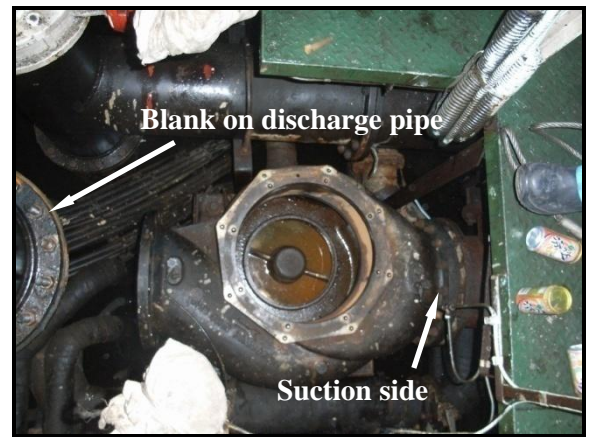
**Figure 5: Disassembled pump casing**

At about 1800 on 27 October 2008, seawater flooded *Great Majesty's* engine room bottom plates when the chief mate remotely opened valves adjacent to No. 2 WB P/P. The pump had been stripped for repairs and while the discharge line from the pump had been blanked, the pump casing was left open and the suction line to the pump and its casing had not been blanked off (Figure 5).

At about 1800 on 27 October 2008, about 390 m<sup>3</sup> of seawater flooded *Great Majesty's* engine room bottom plates when the suction valves to No. 2 WB P/P were remotely opened from the ballast control room. No. 2 WB P/P had been stripped for repairs with its casing left open at the time.

- When the ballast pump was disassembled for repair, the suction pipe was not blanked off and the suction valves were not isolated. Consequently, the chief mate was able to remotely open the pump's suction valves and connect the open pump casing to the main seawater line, which resulted in the flooding.
