ATSB TRANSPORT SAFETY REPORT
 Marine Occurrence Investigation No.268
 MO-2009-008
 Preliminary

Collision between *Silver Yang* and *Ella's Pink Lady* off Point Lookout, Queensland 9 September 2009

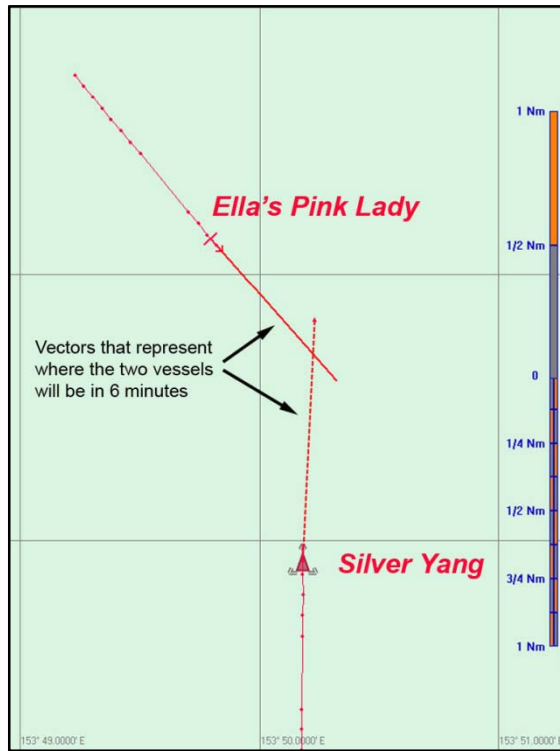
Figure 4: AIS recorded image showing the relative positions of both vessels at 0146

However, she had not detected *Silver Yang*, which was now about 1 mile to the south-southeast of her position (Figure 4).

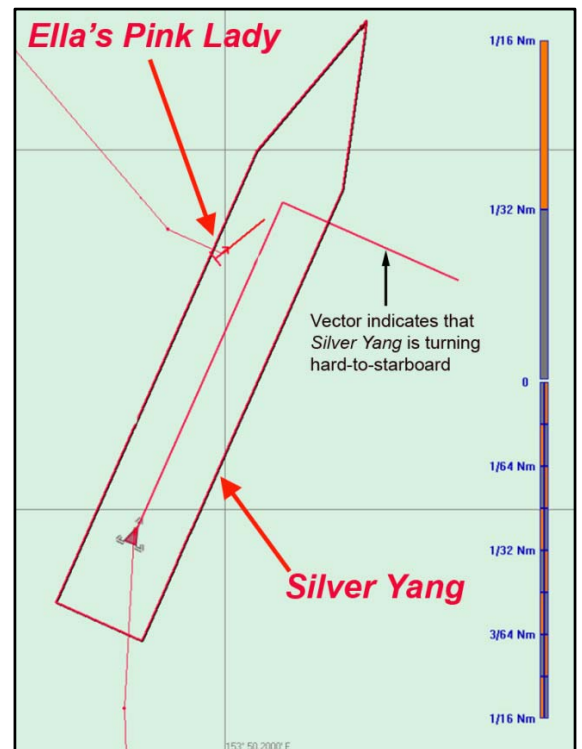
Figure 5: AIS recorded image at 0150½ showing the collision, with *Silver Yang* to scale

At 0150½, *Ella's Pink Lady's* bow collided with *Silver Yang's* port side mid section. The ship had come around to a heading of 024°(T), so the collision was almost square on (Figure 5). The impact pushed the yacht's bow to port and its starboard side scraped along part of the port side of the ship.

The collision woke *Ella's Pink Lady's* skipper. She climbed out of the cabin, grabbed the tiller and tried to steer the yacht. She looked upwards and thought that it was likely that the yacht's rigging would become entangled with the ship and dismast her vessel, so she returned to the cabin. A few seconds later, the mast came crashing down.

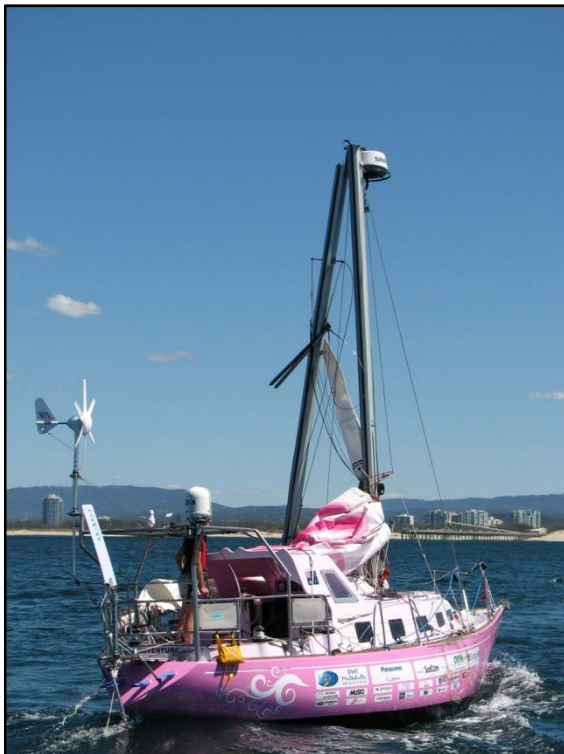
Figure 6: *Ella's Pink Lady* motoring towards Southport

At 0740, the Queensland water police vessel *D.A. Shean* departed Southport. At 0820, *D.A. Shean* rendezvoused with *Ella's Pink Lady* and began escorting the yacht towards Southport (Figure 6). By 1255, the two vessels berthed at the Queensland water police facilities in Southport.
