Depressurisation – 475 km north-west of Manila, Philippines – 25 July 2008

Overview of October 2009 report

FACTUAL INFORMATION UPDATE

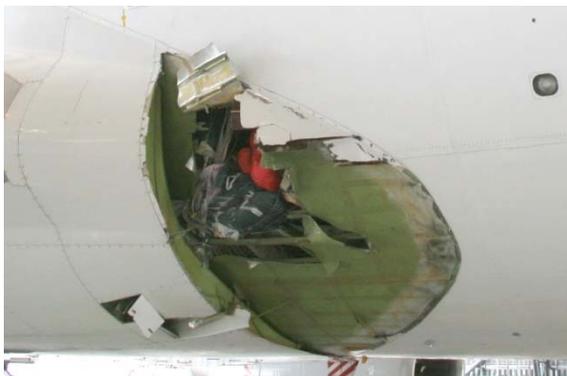
Figure 1: External damage sustained by the aircraft

An engineering inspection of the aircraft in Manila found that the fuselage rupture had occurred in a location coincident with the installed position of the number-4 passenger emergency oxygen cylinder; one of seven such cylinders installed as a bank along the right side of the aircraft's forward cargo hold. The number-4 cylinder was missing from the bank, with the associated oxygen service and feed lines fractured. Immediately above the normal location of the number-4 cylinder was a large, circular hole in the cabin floor, leading into the main cabin at a location just forward of the R2² door. Within the cabin, substantial damage had been sustained by the door frame and overhead panelling, and the door handle had been partly rotated toward the open position.

It was readily apparent to the investigation that the principal contributing event was the sudden and forceful rupture of the number-4 passenger emergency oxygen cylinder. That failure had compromised the aircraft's pressure hull, leading to the immediate and rapid depressurisation of the cabin. Part of the aircraft's fuselage and the number-4 cylinder were lost from the aircraft during the depressurisation.

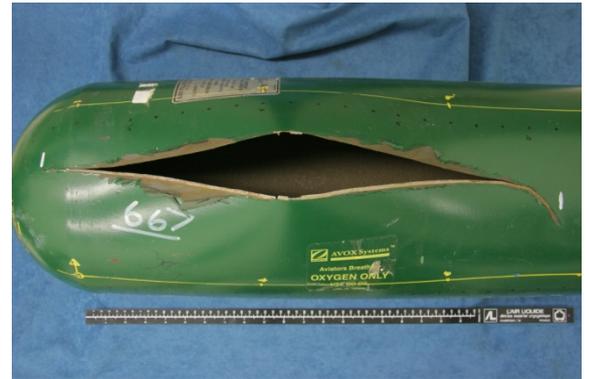
Cylinder	Failure pressure (psi / kPa)	Failure mode
535667	4,400 / 30,337	Burst
535643	5,005 / 34,508	Burst
535598 ^[1]	4,200 / 28,958	Leak

The minimum allowable rupture pressure prescribed by 49CFR178.44 was 4,111 psi (28,344 kPa), and all test cylinders exceeded that value. Figures 2 to 4 present the external appearance of the cylinders following rupture testing.

Figure 2: Rupture of cylinder 535667

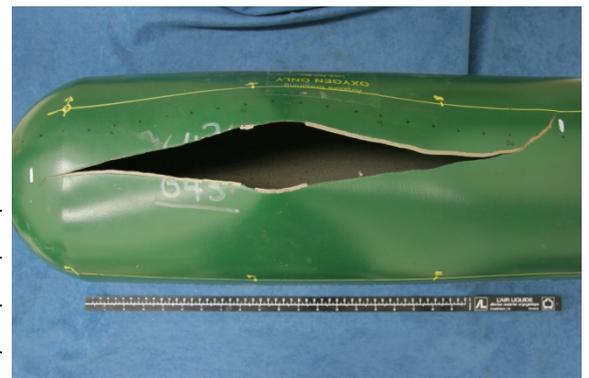
Figure 3: Rupture of cylinder 535643

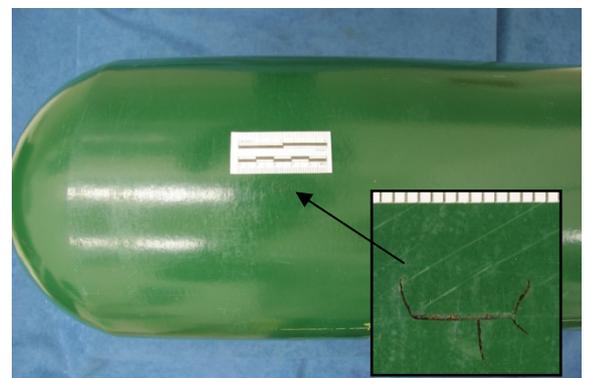
[1] - After cyclic testing program.

Figure 4: Rupture of cylinder 535598 (at arrow)

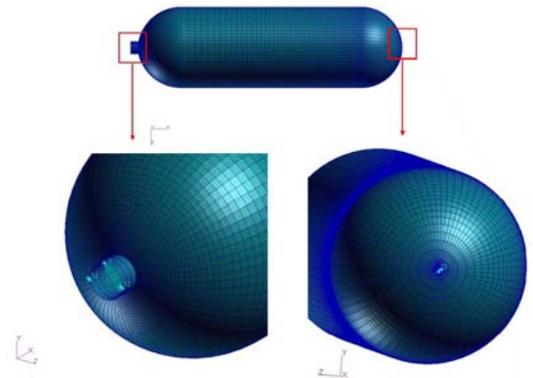
Figure 5: Finite element model of the oxygen cylinder

The finite element model (FEM, Figure 5) was prepared using data from engineering drawings sourced from the cylinder manufacturer. Values for the minimum cylindrical wall thickness (0.113 in / 2.87 mm), average internal cylinder diameter (8.75 in / 222.2 mm) and minimum lower hemisphere wall thickness (0.102 in / 2.60 mm) were obtained from the production test certificate for the cylinder lot.

The FEM analysis produced an average longitudinal cylindrical wall stress value of 36.3 ksi (250.3 MPa) and average hoop (circumferential) stress value of 72.6 ksi (499.9 MPa), for the 1,850 psi design service pressure of the cylinder. Both values compared favourably with the conventionally calculated values of 37.3 ksi (257.2 MPa) and 74.7 ksi (515.0 MPa) respectively.

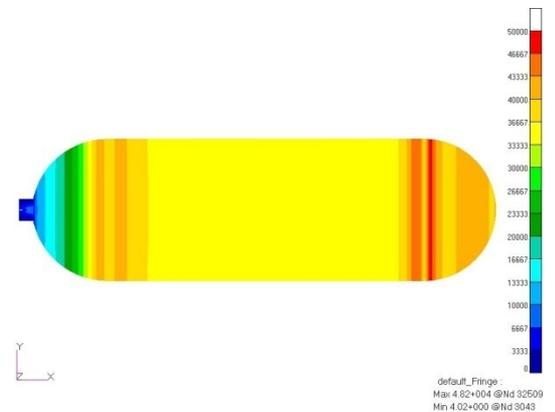
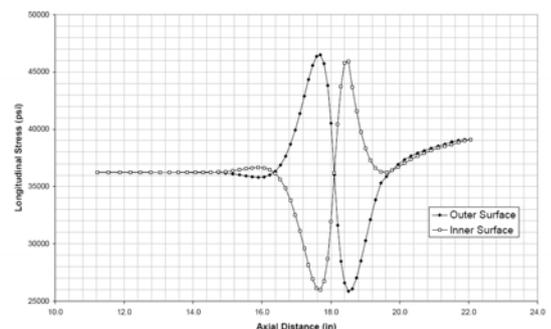
Taking into consideration the allowable reduction in wall thickness within the lower hemisphere (90% of the minimum cylindrical thickness), the FEM analysis revealed the presence of elevated peaks in the longitudinal stress field associated

with the transition region between the cylindrical and lower hemispherical sections (Figures 6 and 7). The peak longitudinal stress in this region was 45.9 ksi (316.5 MPa); a factor of 1.3 times the average longitudinal stress in the main body of the cylinder.

Figure 6: Stress distribution across the cylinder profile. Peak stresses are shown in red

Figure 7: Stress distribution across the cylinder - lower hemisphere transition

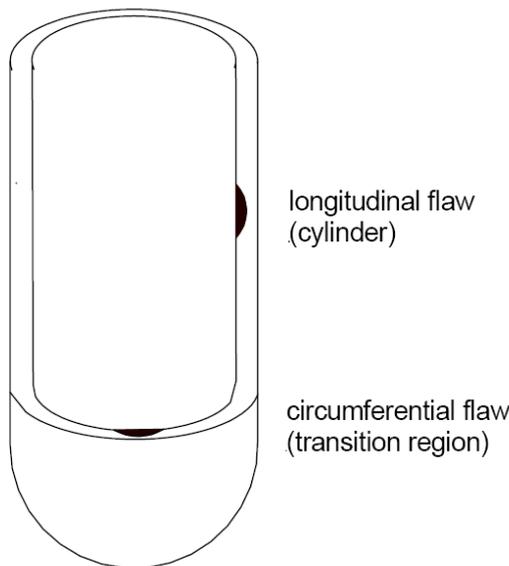
Figure 8: Cylinder flaw locations considered

Two potential locations were considered for the possible presence of critical semi-elliptical flaws within the failed cylinder (Figure 8):

- inner surface longitudinal flaw within the cylindrical (main body) of the cylinder
- inner surface circumferential flaw within the transition region between the main body and the lower hemispherical end of the cylinder.

The analysis results illustrated the key role played by aspect ratio in establishing the critical flaw size, with lower aspect ratio (longer, shallower) flaws proving more critical. From the results presented in Tables 3 and 4, it was shown that the most significant (i.e. smallest) flaw that could present as critical to the integrity of the cylinder type, was a longitudinal defect with a depth of 0.048 in (1.22 mm) and length of 0.478 in (12.1 mm), when evaluated at the cylinder service pressure (1,850 psi) and using a limiting material fracture toughness of 50 ksi√in. It was noted by the analysts however, that the flaw sizes determined by this process were likely to be conservative, and should be supplemented by additional analyses using elastic-plastic fracture mechanics techniques (EPFM) and/or a physical test program on cylinders with artificially-produced flaws. The ongoing ATSB investigation will encompass an evaluation of the cylinder performance in the presence of machined external flaws – further detail is provided in the ongoing investigation activities section of this report.
