DEPARTMENT OF TRANSPORT
ACCIDENT INVESTIGATION COMMISSION

**AIRCRAFT ACCIDENT INVESTIGATION INTERIM
REPORT**

**COLLISION WITH TERRAIN, P2-MCB, DE HAVILLAND
DHC 6-300, 6NM SSE KOKODA, 11 AUGUST 2009.**

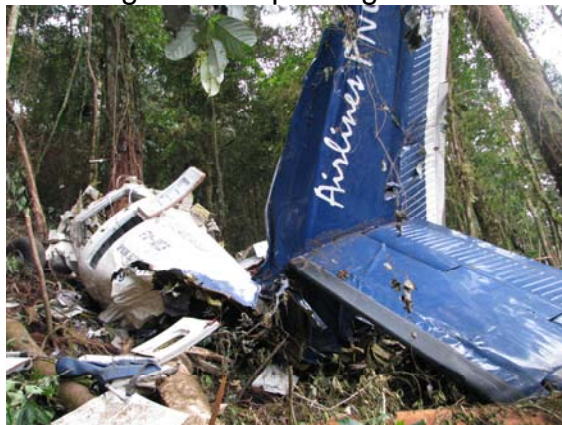
Figure 2: Aircraft main fuselage and empennage section

The aircraft wreckage was found at about 5,774 ft (1,760 m) AMSL, on a heading of about 110° M. The wreckage trail extended for about 100 meters on a slope of about 45° to the horizon in heavily-timbered terrain. The aircraft impacted the terrain in an upright attitude. The aircraft structure was significantly disrupted from impact forces (Figure 2). All primary and secondary flight controls were accounted for at the accident site.

Both wings had separated from the fuselage and both engines had separated from their respective wings. A number of items were recovered from the accident site for further examination, including: the propellers, engines, various aircraft instruments and a number of electronic and radio components.
