Aviation Occurrence Report – AO-2007-046

Collision with Terrain

Doongan Station, WA

Robinson Helicopter Company R22 Beta II, VH-HCN

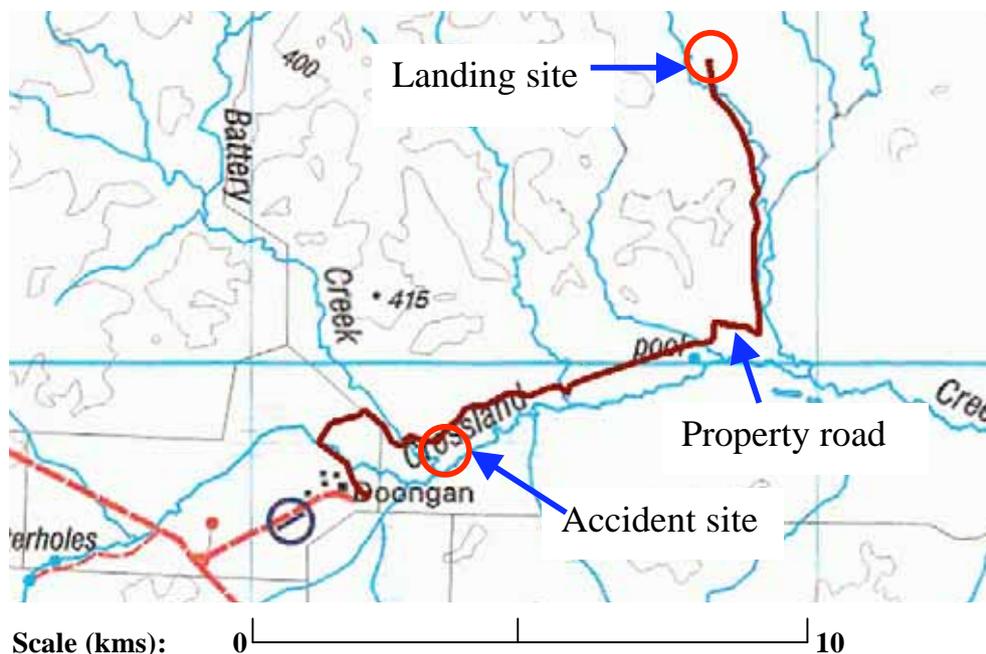
Figure 2: Accident site location

After about 5 to 10 minutes into the flight, the passenger notified the pilot that he detected a strong rubber-like burning smell. The pilot landed the helicopter in a clear area adjacent to a nearby road to conduct an inspection (Figure 2), and elected to keep the helicopter engine running. Both the pilot and passenger visually inspected the helicopter, focussing on the two rubber drive belts that transfer power from the engine to the helicopter rotor system.

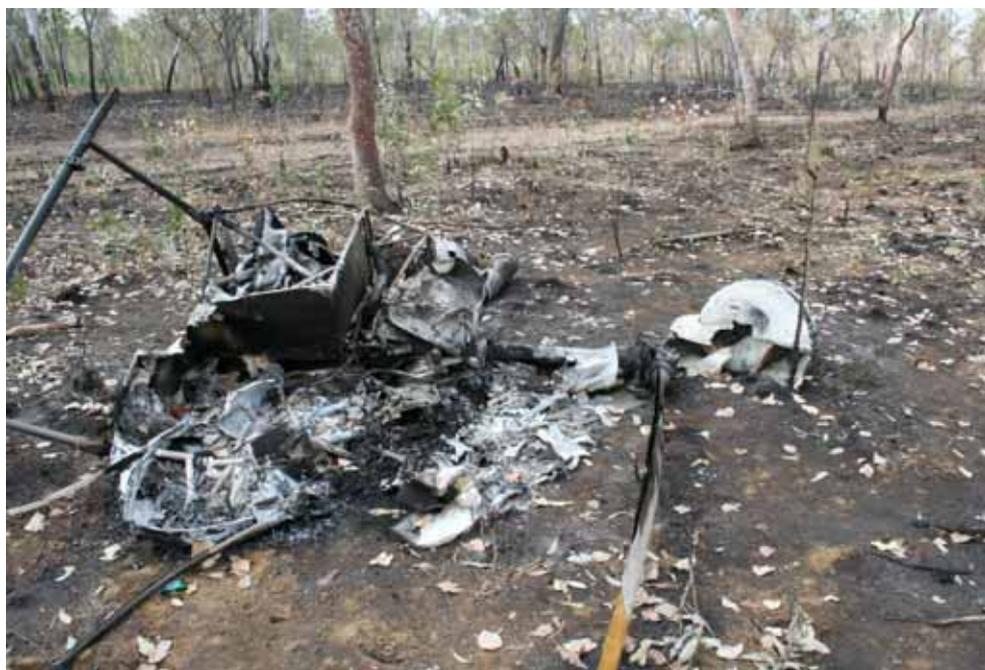
Figure 3: Accident site

The accident site was located in flat, lightly timbered, terrain about 4 km east of Doongan Station. The helicopter initially collided with trees before impacting the ground in a steep nose-down, left skid-low, attitude. The helicopter then came to rest a further 13 m on a bearing of about 240 degrees magnetic. One of the main rotor blades had fractured and separated from the helicopter and was located about 15 m from the wreckage. A severe post-impact fire consumed the majority of the helicopter and also ignited the surrounding vegetation (Figure 3). The resulting bushfire continued for several days and affected both the accident site and large areas of the surrounding environment.

Four trees, close to the line of flight, showed evidence of contact from the helicopter, with corresponding impact marks on the main and tail rotor blades, and the lower vertical stabiliser. On-site examination of the wreckage accounted for all major parts of the helicopter.

Due to the severity of the post-impact fire destroying sections of the aluminium control tubing, it was not possible to verify the integrity of the entire flight control system. However, all steel components associated with the collective and cyclic flight controls were found intact and secure. Evidence of the rubber drive belts was found in the main wreckage. However, due to the degree of fire damage, it was not possible to establish the serviceability of the belts at the time of the accident.
