Collision with terrain, VH-WXC, Cessna 210M

257 km SW Warburton, WA

17 October 2007

Abstract

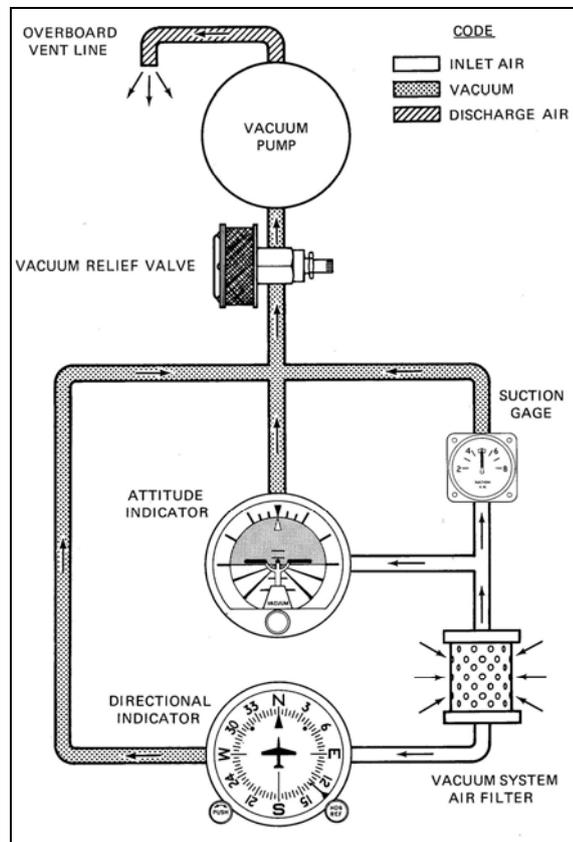
vacuum relief valve that regulated the suction provided to those instruments (Figure 1).

The aircraft manufacturer's Aircraft Flight Manual (AFM) indicated that a suction of 4.6 to 5.4 ins of mercury (in Hg) was required to operate the suction-powered gyroscopic flight instruments. The AFM indicated that a suction reading outside of that range may indicate a system malfunction or improper adjustment and that, in such case, the attitude and directional indicators should not be considered reliable.

Figure 1: Schematic of aircraft instrument vacuum system

The aircraft was not equipped with a secondary vacuum pump or a standby source of suction. There was no warning light in the C210M to indicate to the pilot that the suction was outside the range required for correct instrument operation.

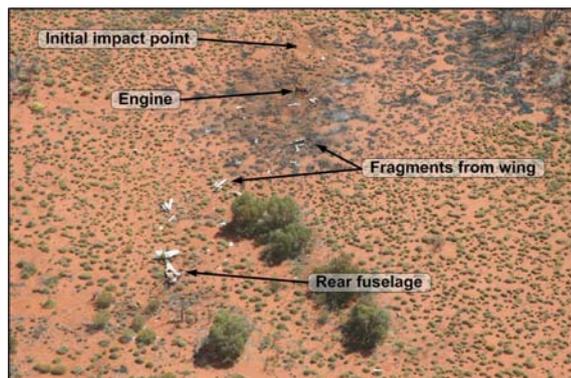
The aircraft impacted the sandy, desert-type terrain (Figure 2) at high speed and was seriously

damaged⁷ by impact forces. The fuel tanks ruptured on impact and there was a post impact fire.

The elevation of the terrain in the vicinity of the accident site was about 1,450 ft. The ground track of the aircraft immediately prior to impact was approximately 217 degrees magnetic and the rear fuselage came to rest in the direction of flight, approximately 50 m beyond the initial impact point.

Figure 2: Photograph overhead the accident site

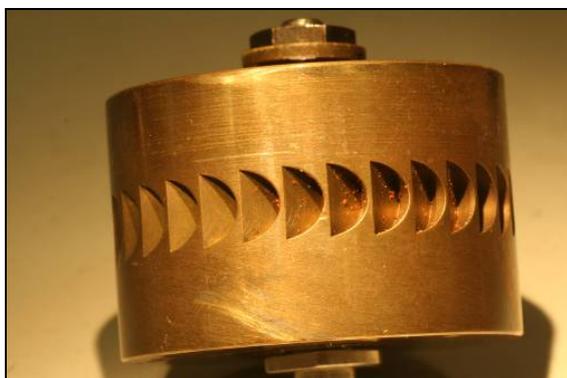
The attitude and directional indicators were recovered from the accident site. Although the cases of each instrument were disrupted, each instruments' brass gyroscope rotor remained within its respective case assembly. Further examination of the gyroscope rotors revealed damage that was consistent with each being in a low rotational energy state at the time of impact with terrain. That was characterised by minimal scuffing and rubbing of the rotor against its rotor case housing (Figure 3)

Figure 3: Gyroscope rotor from the disassembled directional indicator
