ATSB TRANSPORT SAFETY REPORT
Aviation Occurrence Investigation A0-2010-006
Preliminary

Total power loss, VH-NWO 11 Km NE of Derby, Western Australia 29 Jan 2010

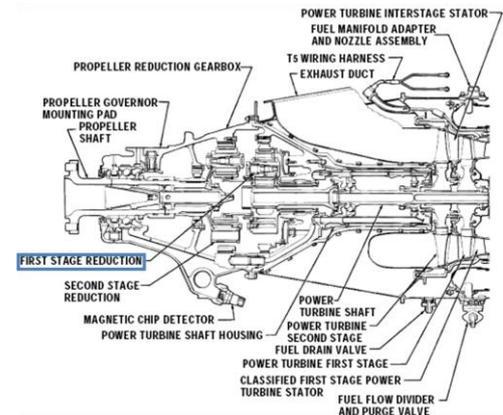
Figure 1: Location of failed bolts in the first-stage reduction of the propeller gearbox.

The engine was shipped to an approved Pratt and Whitney engine workshop for examination under the supervision of the Australian Transport Safety Bureau (ATSB). The examination of the propeller RGB revealed that four of the six first-stage reduction carrier bolts (part number MS 9490-34), had failed under the bolt heads due to fatigue cracking (Figures 1 and 2). As a result, failed bolt debris was released into the first-stage sun and planet gears, causing significant damage to those gears. Another carrier bolt had fractured through the threaded area, with the threaded portion remaining in the splined adapter.
