ATSB-XXXXX

## Collision with terrain

### 5 km north-east of Wickepin, WA

## 3 October 2009

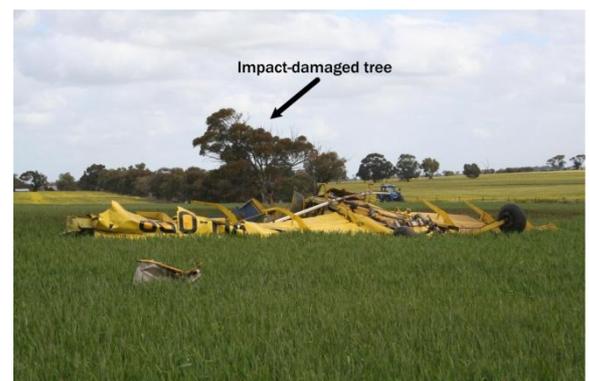
Figure 1: Main Wreckage

At about the time the pilot's loader driver was expecting the aircraft to return to the paddock for a second load of insecticide, the owner of the property discovered the wreckage of the aircraft in a field of knee-high wheat, which was adjacent to the canola crop that was to be sprayed (Figure 1).

The aircraft had impacted the ground in an inverted attitude, fatally injuring the pilot. There were no witnesses to the accident.

The aircraft impacted the ground about 150 m north of the tree, in an inverted, steep nose-down attitude and slid inverted for about 50 m, before coming to rest. Numerous items of aircraft wreckage were distributed along the wreckage trail. Damage to the aircraft was consistent with a high-energy impact and was not survivable.

The aircraft's hopper and fuel tanks were ruptured on impact with the ground. A considerable quantity of insecticide and fuel had spilled onto the site from the aircraft's hopper and wing fuel tanks respectively. There was no fire.
