KEY BISCAIYNE (JACK-UP DRILLING RIG)

PRELIMINARY INVESTIGATION INTO :

LOSS OF TOW AND SUBSEQUENT  
FOUNDING OFF THE COAST OF  
WESTERN AUSTRALIA ON  
1st SEPTEMBER 1983

PRELIMINARY INVESTIGATION INTO THE LOSS OF 'KEY BISCAIYNE' (MODU)

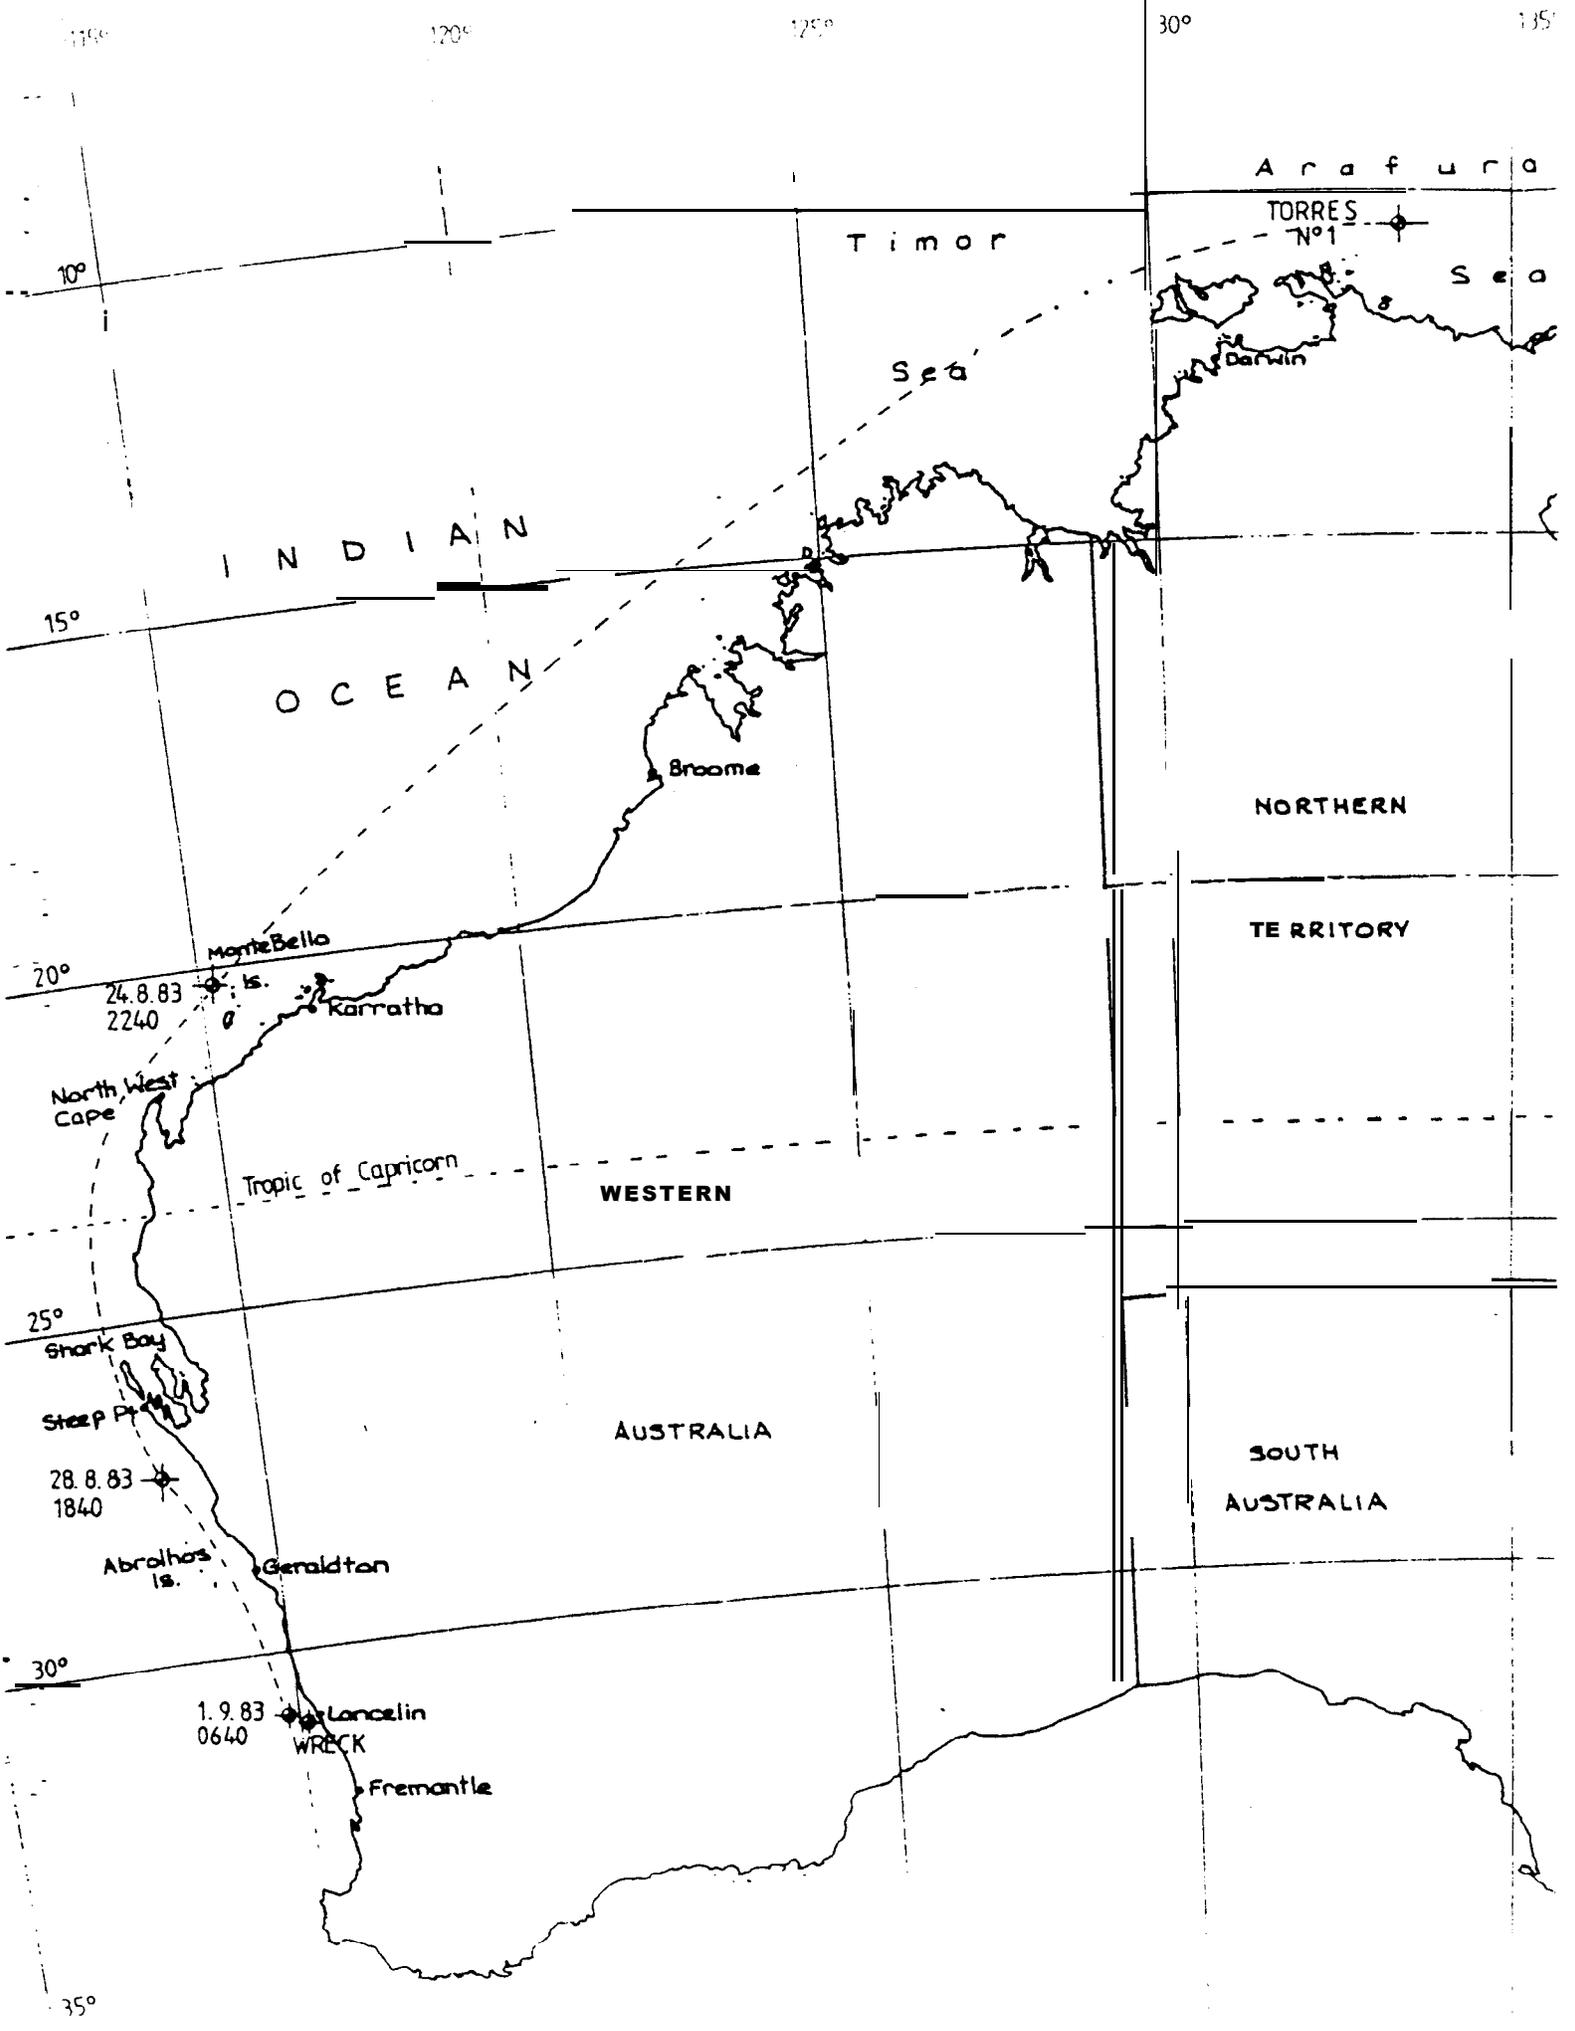
Subsequent underwater video film showed the rig to be inverted, lying on top of two of its legs with the third some distance away and all pointing in a north easterly direction. Part of the starboard quarter of the rig hull together with the jack housing, had broken adrift. The position of the hull and legs indicated that the rig had tipped over backward. In settling on the bottom the legs were either bent or broken as the barge inverted on top of them.

The rig is lying position 31° 10' S, 115° 11.7' E in 41 metres of water. The bottom of the inverted hull is roughly 26 metres below the surface and the deep well tower, protruding through the hull, has some 20 metres clear water above it. The rig does not present hazard to commercial shipping operating in the area. Fisherman and divers have been warned of the dangers of wires, metal obstructions and other hazards of working close by.
