Department of Transport
Bureau of Air Safety Investigation

INVESTIGATION REPORT
B/925/3042

British Aerospace BAe 146-200A VH-JJP
Near Meekatharra, Western Australia
22 March 1992

February 1994

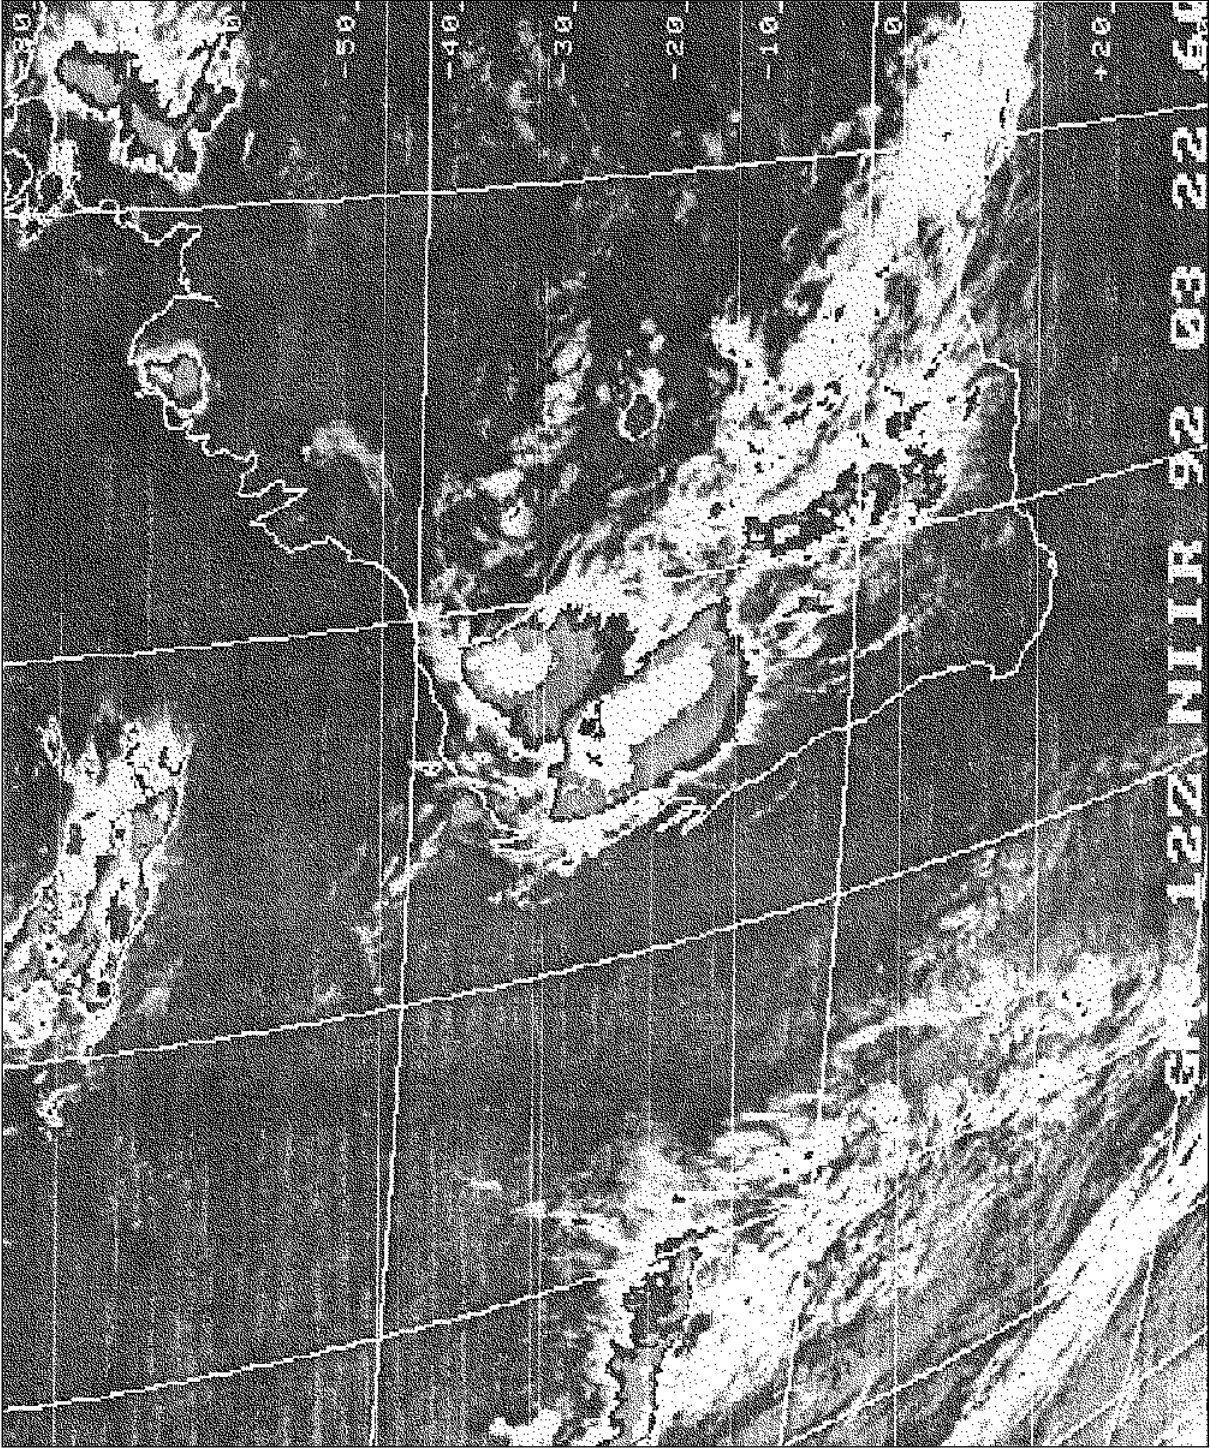
Figure 5: Enhanced Infrared Imagery (GMS4) for Western Australia for 1200Z 22 March 1992. Approximate location of incident denoted by (x).

The satellite imagery suggests that the cloud tops were being blown off towards the southeast, consistent with the observed northwesterly environmental flow. The cloud pattern is asymmetrical, with the black (coldest) area displaced to the east of the main cloud mass. This may have been the result of earlier convection to the west which was in the process of dissipating at the time of the imagery. The pilot (personal communication) mentioned that there appeared to be decaying cells in the area.

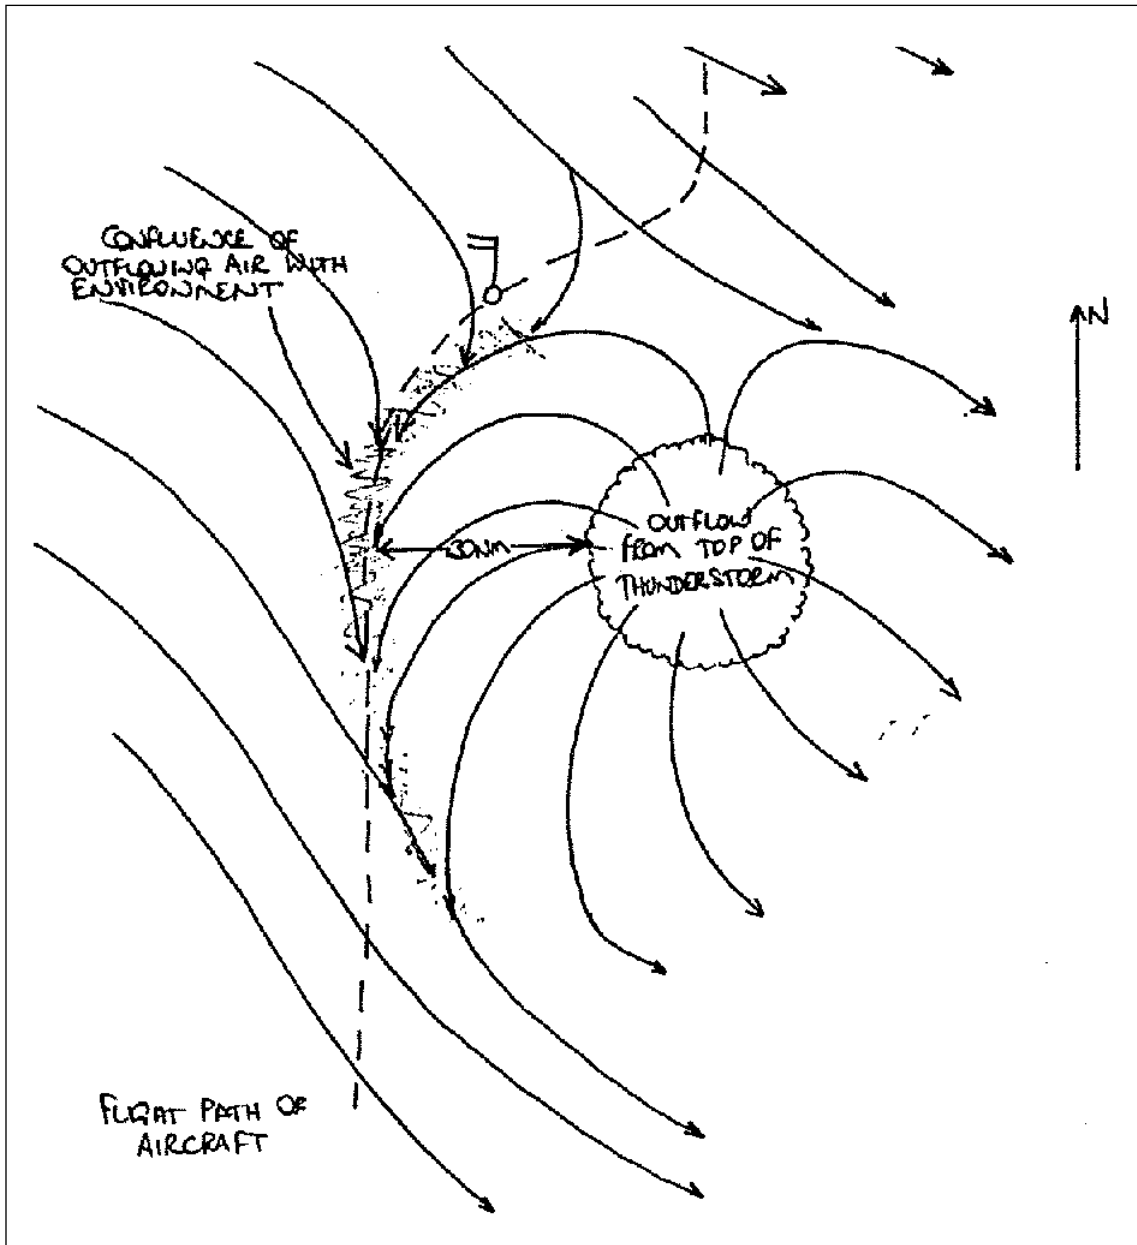
Figure 6: Schematic of interaction between environmental northwesterly winds and thunderstorm outflow. Airep from BAe146 is plotted relative to the storm.

It is most likely that air flowing out of the thunderhead encountered environmental northwesterly winds. This confluence of air of differing origins and physical characteristics would have caused the outflowing air on the western flank of the thunderhead to return from the stratosphere to the troposphere (Fig. 6) and, in descending, to rapidly warm. Adiabatic warming of a parcel from the top of the thunderhead (temperature of around minus 62°C determined from infrared satellite imagery) to the flight level of the aircraft (31000 feet) would produce a temperature near to minus 28°C which is in good agreement to the reported anomaly (Fig. 7).

The horizontal distribution of the anomaly is most likely to be concentrated in a zone of confluence between the environmental flow and the thunderstorm outflow, as that would be the area where maximum descent was occurring, associated with the largest perturbation of the tropopause. In this case the anomaly took place on the western flank of the main convective activity. It is unlikely that any anomalous warming would have occurred on the eastern side of the storm as there would have been no confluence and no tropopausal perturbation. The temperature anomaly was observed over a horizontal distance of approximately 60 nm. By comparison, the incident in 1979 took place within a distance of near 40 nm.

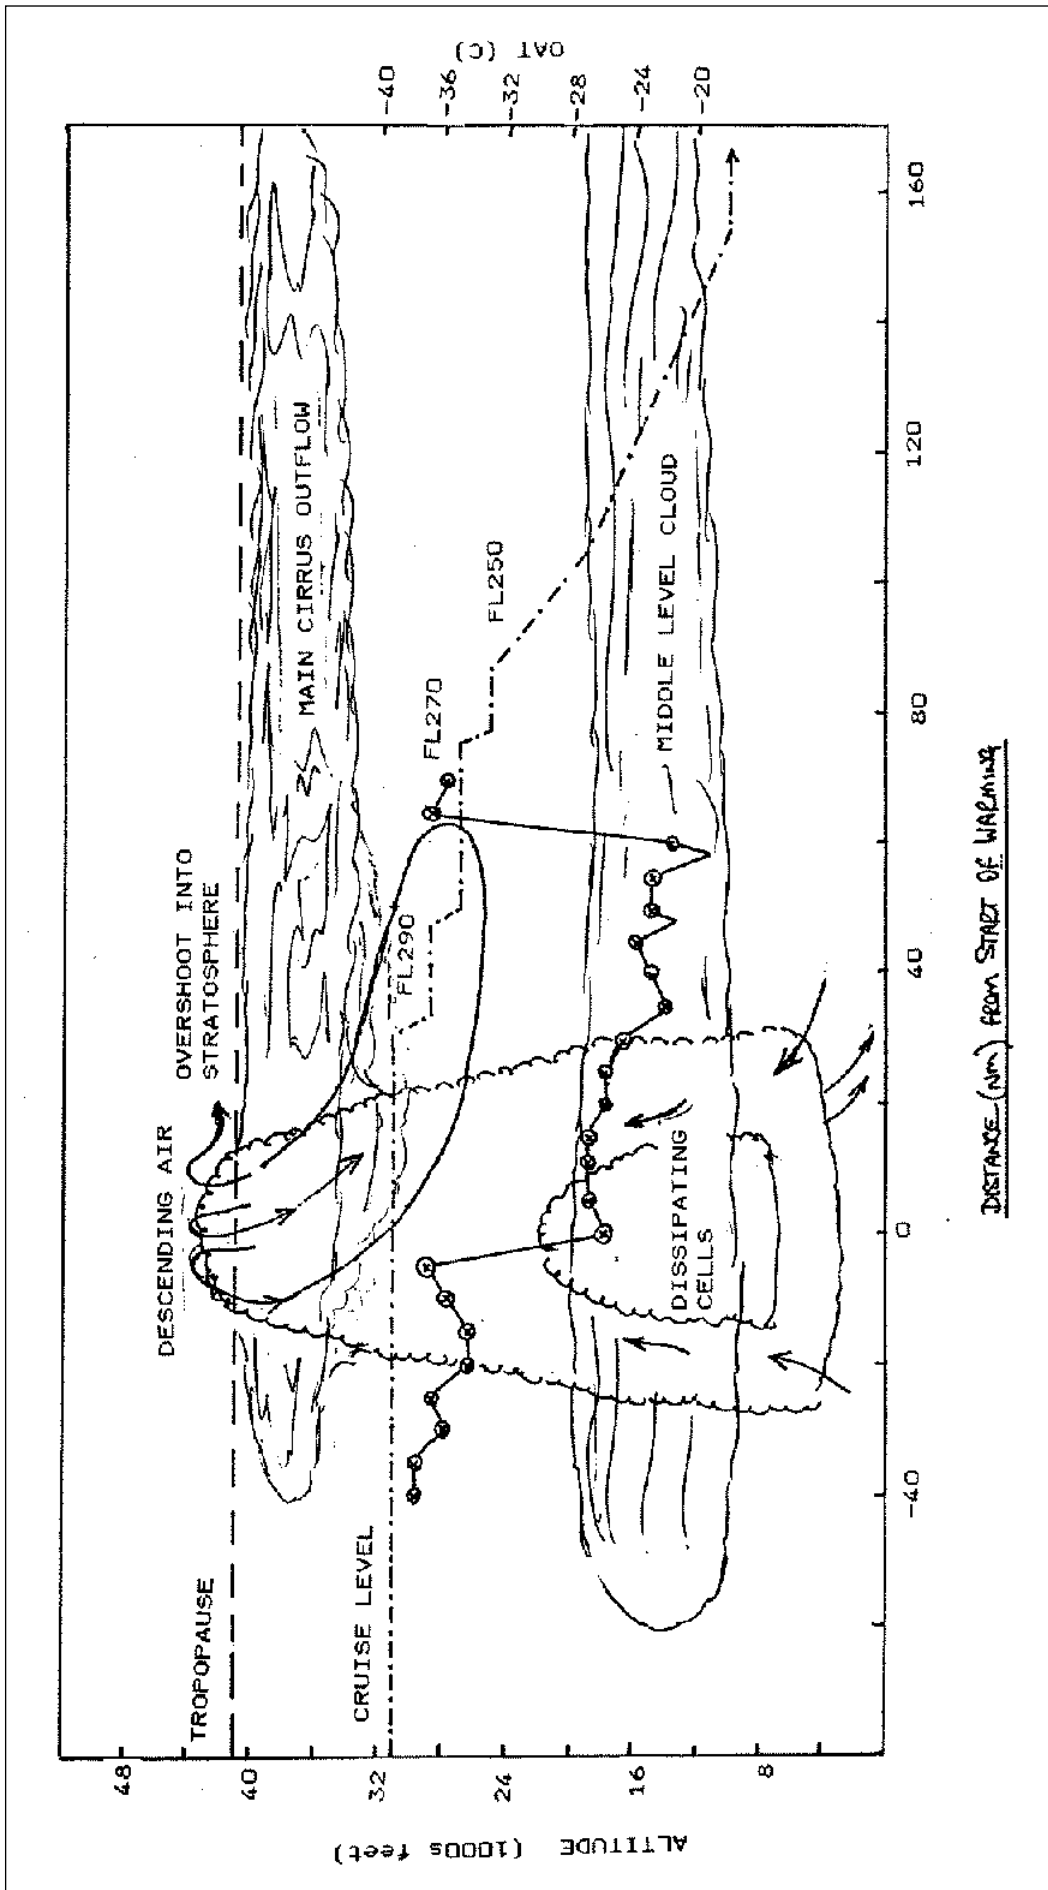
Figure 8: Schematic north/south cross-section of atmosphere at time of incident showing most likely cloud structure. Outside air temperature (OAT) from BAe146 showing warming relative to storm position is also plotted.

The probable cause of the warming was the descent of air from the stratosphere, associated with the interaction of air outflowing from the thunderhead and the surrounding environmental air. Estimation of the extent of warming by descent of an air parcel gave close agreement to OAT recorded by the aircraft.

The probable vertical extent of the temperature anomaly was from around 38000 feet (where the anomalous warming of descending air from the stratosphere became greater than 5°C) to around 28000 feet, where the anomaly was observed to abruptly stop.

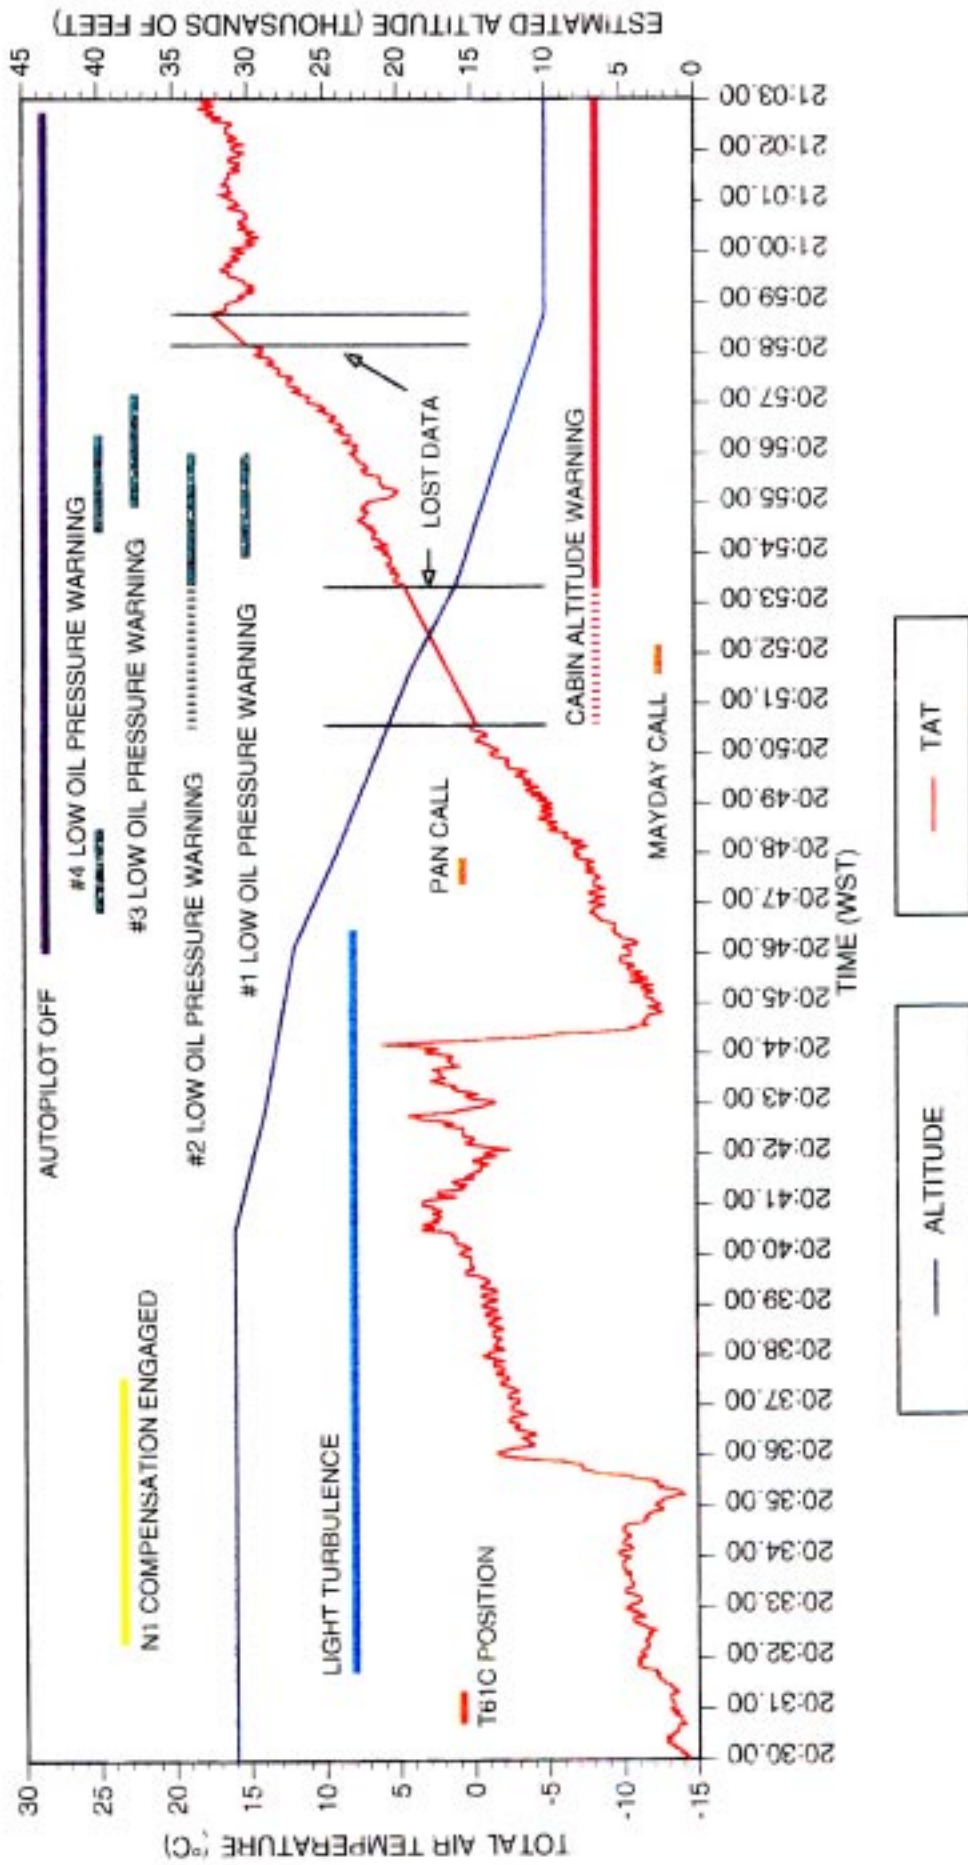
Bae146 VH-JJP FLIGHT RECORDER DATA PLOT

ELC data shows that the N2 RPM for all engines remained steady until the N1s had decreased to below about 60% when the N2s also began falling. While the N2s remained constant, the TGTs were maintained at the MCT value by the FCUs. After the N2s fell below about 88%, the TGTs also began to decrease, indicating a lower fuel-air ratio. These trends in TGT indicated correct operation of the FCUs. The engines continued to roll back until a sub-idle condition was reached.
