Bureau of Air Safety Investigation

ACCIDENT INVESTIGATION REPORT
B/921/1036

Aerospatiale AS355F1 VH-NJL
Kelmscott WA
8 May 1992

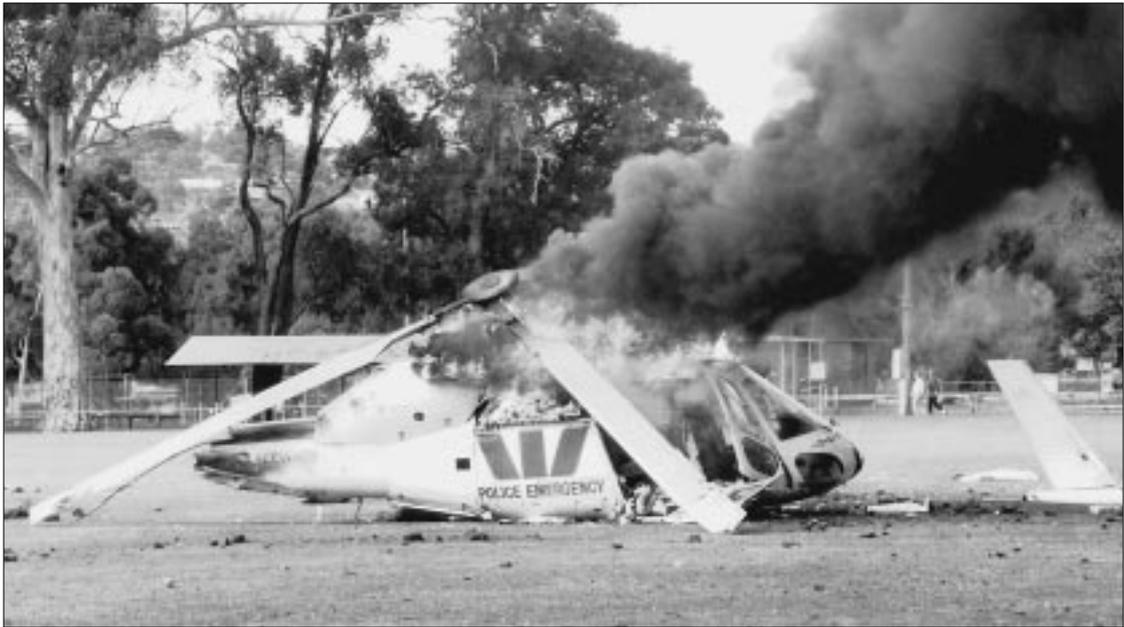
During the impact sequence, substantial damage occurred to the tail boom and to the main and tail rotor systems. A small fire, which began in the engine bay, could not be controlled by hand-held extinguishers and soon spread to destroy the helicopter.
