Department of Transport
Bureau of Air Safety Investigation

INVESTIGATION REPORT
9401043

DOUGLAS DC-3 VH-EDC
Botany Bay, New South Wales
24 April 1994

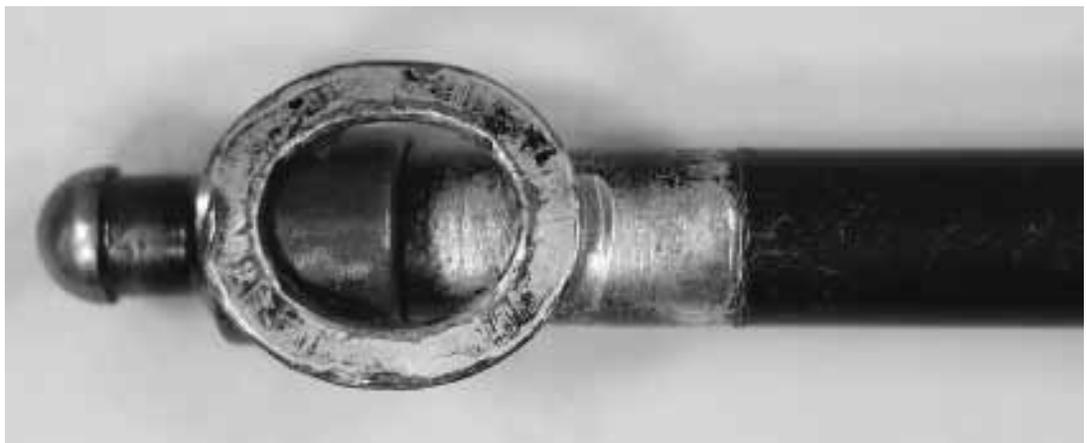
1. On removal of the no. 3 cylinder inlet valve pushrod cover, pushrod and tube, excessive wear of the pushrod and of the cylinder where the pushrod enters the valve rocker housing was apparent. Further inspection revealed that one of the thrust washers which are fitted either side of the rocker arm on the rocker shaft was not fitted to the shaft. The thrust washer subsequently fell out of the valve rocker housing. The loose washer was oval in shape, having sustained impact damage during engine operation. At the last time of fitting, the shaft was installed but failed to engage the washer which subsequently was left within the rocker housing. The housing, through which the cover tube is located and through which the pushrod operates, was damaged at the point coincident with the damage on the pushrod.

The cylinder, complete with inlet and exhaust valve assemblies, inlet valve pushrod and cover and the damaged washer, was examined. The aim was to determine when and how the washer was damaged, and the likelihood of this loose component jamming the inlet valve in the open position. The rocker arm end of the pushrod contained heavy rub marks which penetrated the pushrod to about 25% of the wall thickness. The curved edges of these wear marks matched the deformed washer. There was also a curved depression within the rocker housing, adjacent to the inlet pushrod tube, which matched the shape of the deformed washer. Plastic deformation of the cylinder head material into this depression indicated the nature of the compressive loads applied to the pushrod. The amount of material rolled inside the depression mark suggested that the washer had been in this position for a considerable period. With the washer located in the depression, it could become jammed between the cylinder head and the pushrod, thus preventing the inlet valve from closing. The amount of valve lift provided by the jammed pushrod was approximately 4 mm.

Figure 2. The deformed thrust washer and the deep rub marks on the push rod.

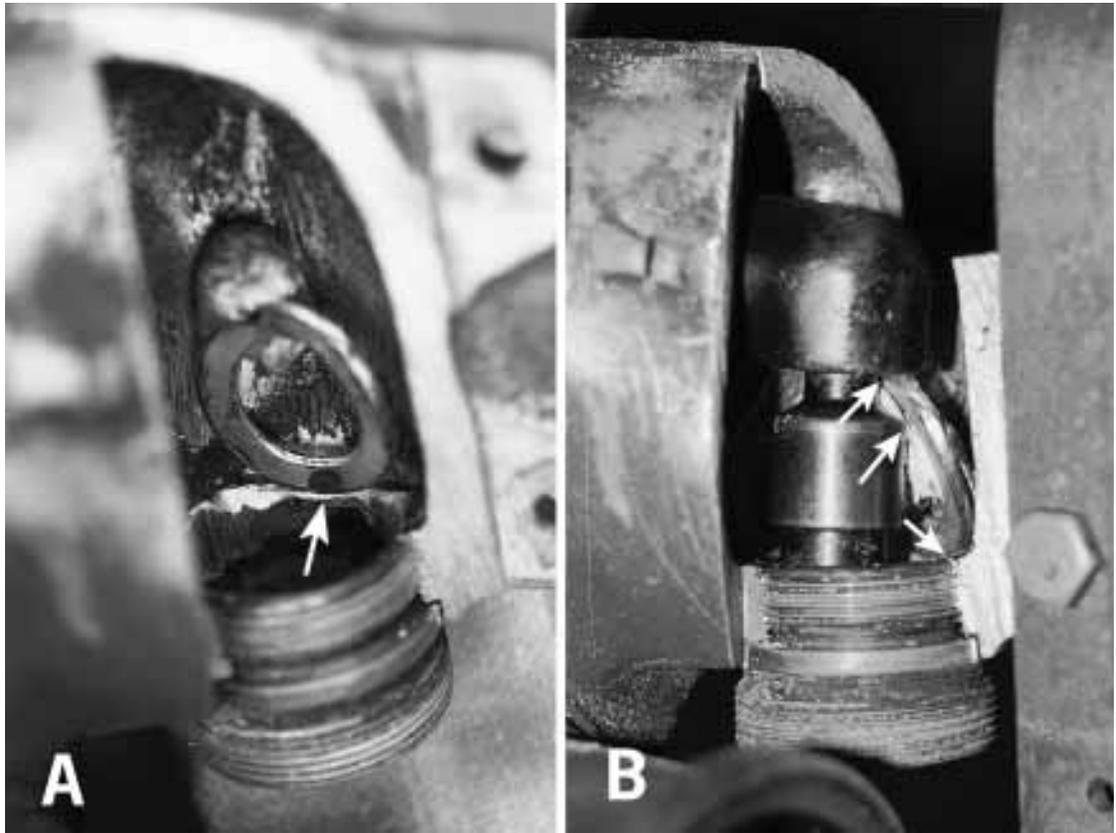
Figure 3.

- (A) The mark on the edge of the cylinder head rocker assembly housing is shown. Its shape matched the shape of the thrust washer.
- (B) The thrust washer with one side forced against the rocker assembly housing, while the opposite side is jammed between the rocker arm and the push rod upper end. To facilitate this demonstration, an adhesive was used to hold the washer in position.

The firing of the spark plugs on the cylinder while the inlet valve was jammed open would cause the fuel-air mixture in the common induction system to ignite. In addition to the loss of power from the no. 3 cylinder, the resultant disruption of the fuel-air mixture to the remaining cylinders would cause irregular engine operation and a reduction in power. The engine manufacturer has advised that a power loss of up to 50% could result, accompanied by backfiring through the intake manifold and carburettor. Fire residues and soot deposits were found in the no. 3 cylinder intake cavity and the adjacent intake manifold. Examination of the air intake assembly revealed deposits of black soot within the carburettor air intake and on the debris screen, indicative of backfiring, and possible intake fire.

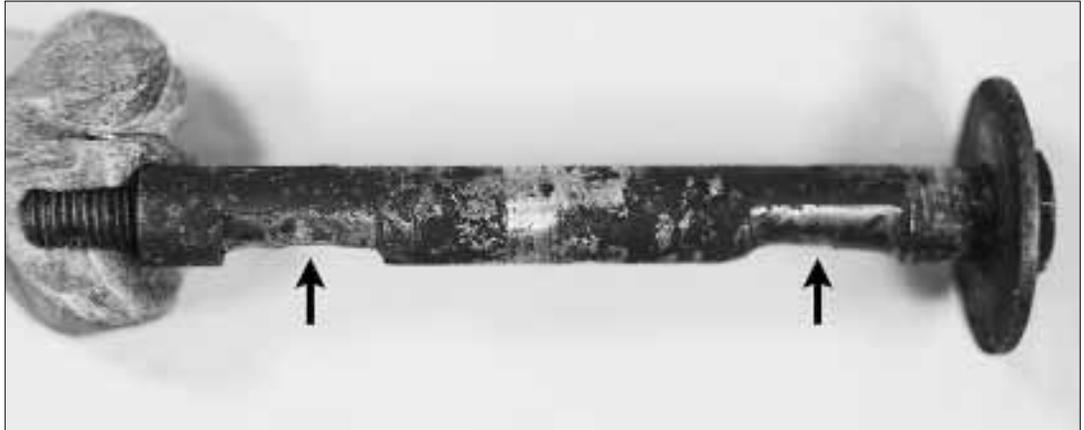
3. The propeller governor pitch control cable 90° pulley block securing bolt was excessively worn. There was a certification on the periodic inspection worksheets at the time of issue of the current maintenance release on 25 February 1994, some 6–8 operating hours prior to the accident, that the assembly had been renewed.

Figure 4. The worn pulley block securing bolt.

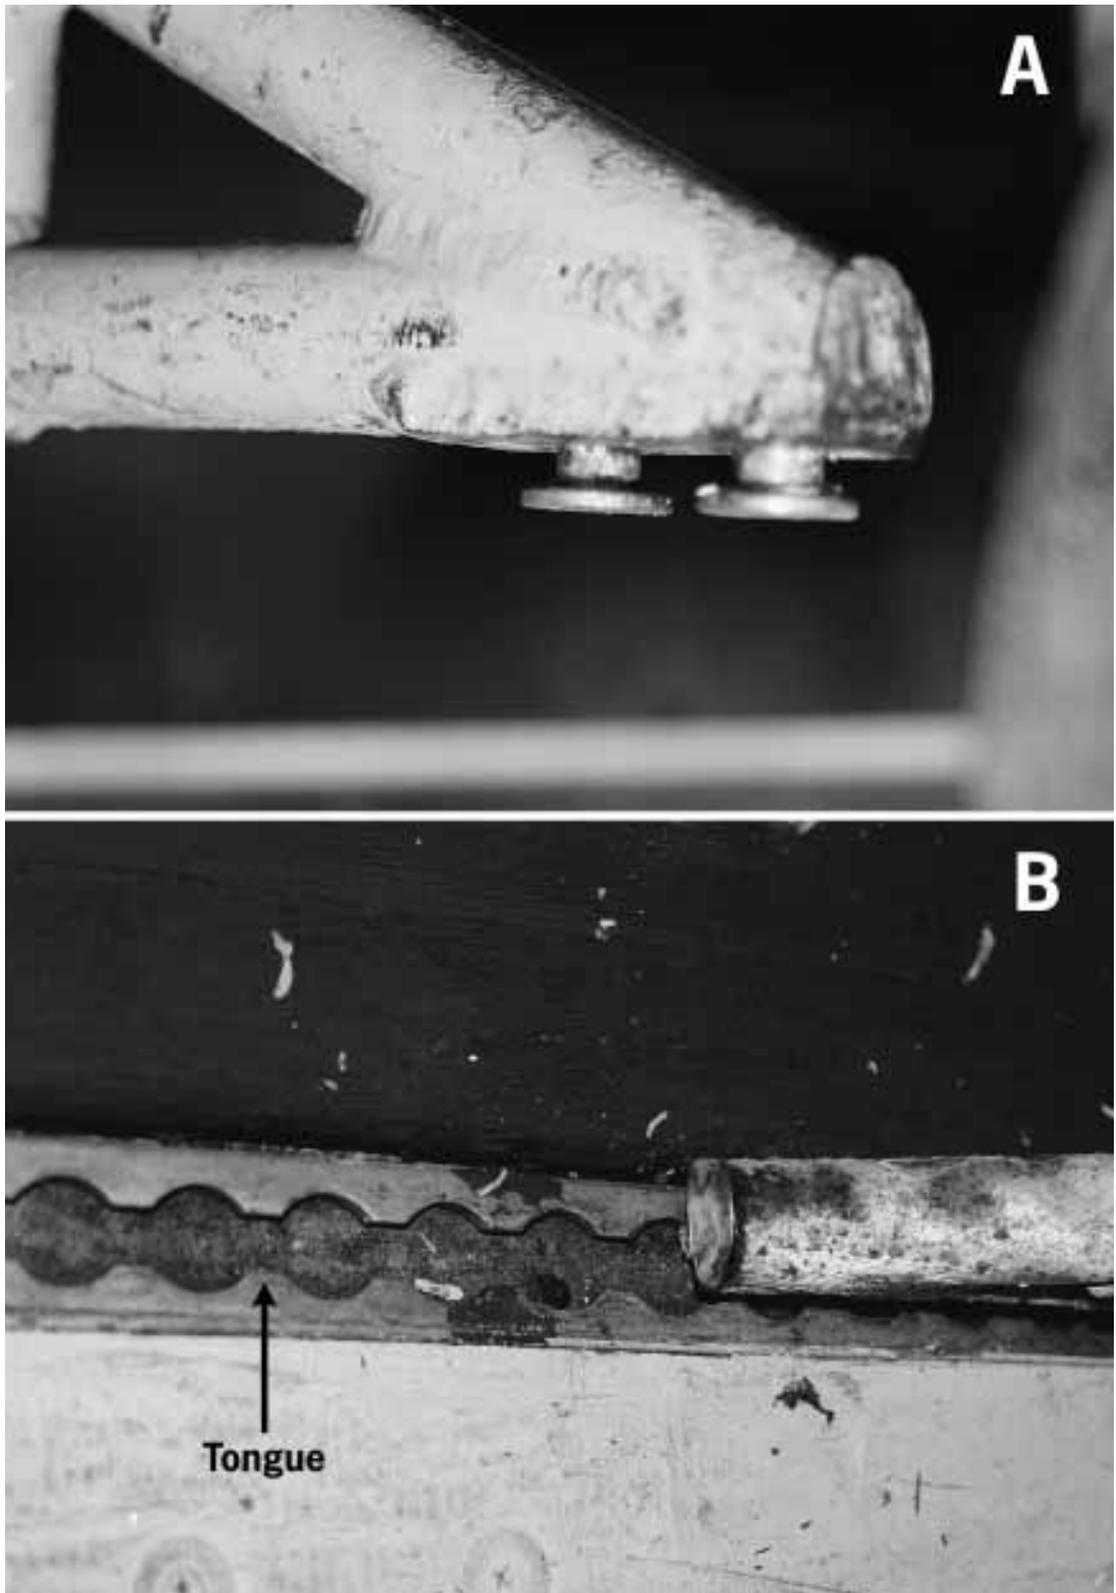
Figure 6.

At impact, one seat belt detached from seat 3D, and seat rows 1C/D, 5A/B and 6A/B separated from the seat rail on the outboard side. Examination of these seats indicated that the three outboard feet of seat rows 5 and 6 were not in the seat rail. The positioning pins were operational and there was no damage to either the seat rail or the feet of the seat. The rear two

outboard feet of row one were not in position. No damage had occurred to either the seat rail or feet and the positioning pin was stowed, with the adjusting mechanism absent.

(A) The lower arm of the seat structure showing the two rear locating feet.

(B) The Douglas track floor rail into which the feet of the passenger seat locate, under the rail tongue. The seat is retained in position by a spring-loaded locating pin which engages in the rail recess.

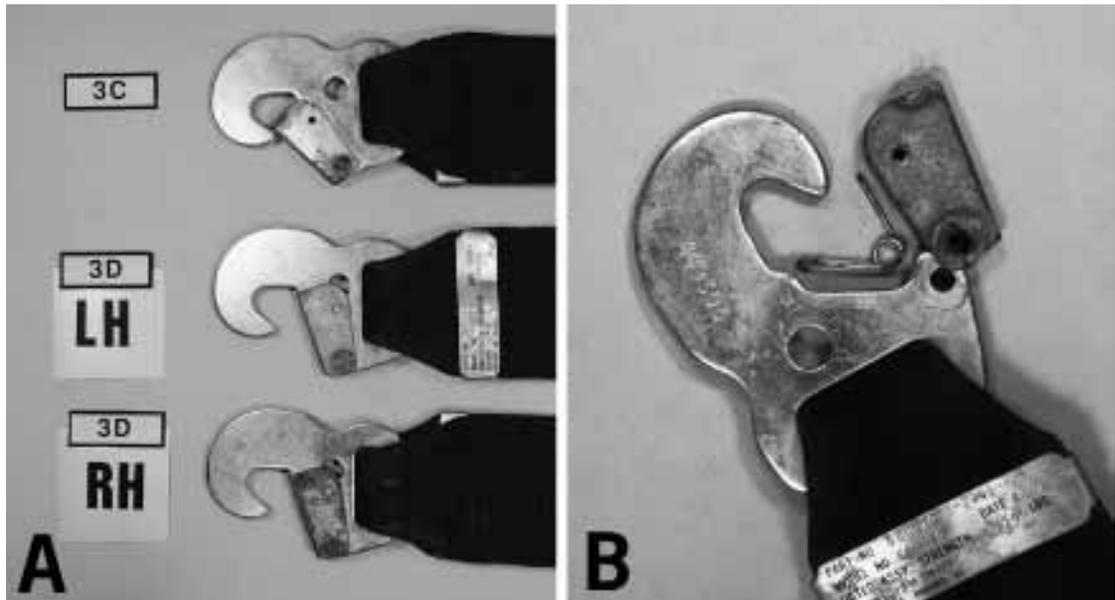
Figure 7.

In addition to the seat belt which detached from a seat, three further seat belt fixtures were found to be deficient. The outboard half of the 3D seat strap was dislodged, and the spring-loaded gate which secures the fitting to the seat structure was found to be jammed in the open position. The gate was also jammed open on the inboard side of 3D. Both springs were absent, as they also were on the outboard side of the belt for seat 2C. The gate itself was deformed and was partially open. The spring was present on the outboard seat attachment for seat 5C; however, the gate was deformed and partially open. Examination of the belts and their fittings did not indicate any pre-existing fault.

(A) The seat 3D belt straps as found, with the attachment gates jammed in the open position. The seat 3C strap is shown to demonstrate the position of a correctly functioning gate.
