Summary

At about 1100 on 9 August 1994, the Panama flag bulk carrier Kayax was alongside in the port of Portland, Victoria, to load a full cargo of grain.

The Kayax

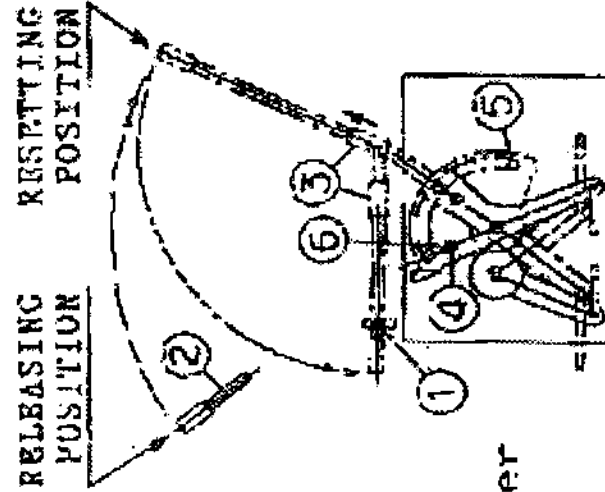
Instruction Plaque

In the Inspector's opinion, the drawing showing the operation of the release mechanism of the lifeboat was not clear, without some understanding of the Japanese or English text. The instructions, particularly the diagram, for retrieving the boat, were not possible to follow without a good knowledge of Japanese or English.

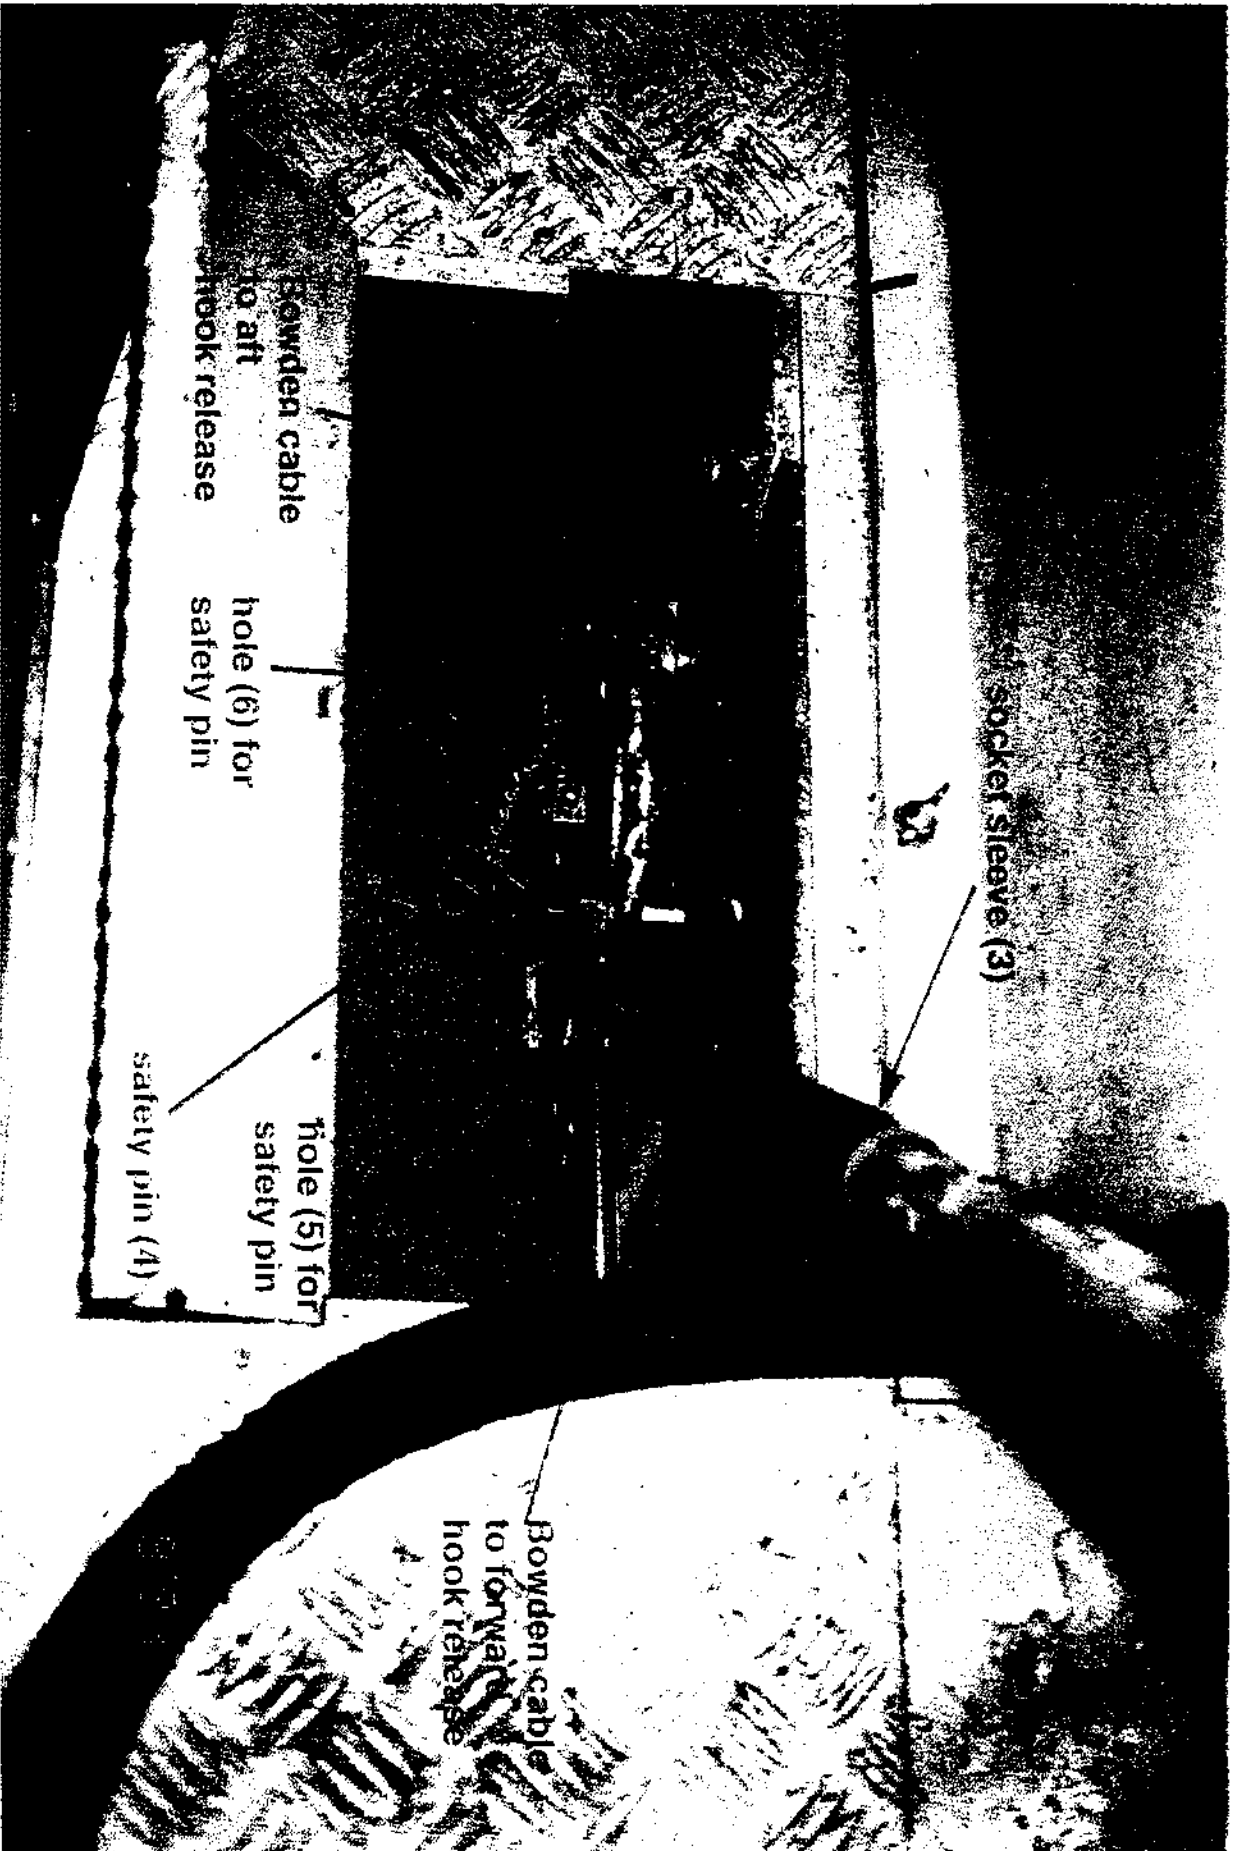
Lifeboat falls Release Lever in armed position with deck plate lifted
(safety pin not fitted in locking hole (5))

Critical to the accident is the lifeboat falls release mechanism. It was found that the mechanism was "armed" and in a condition for instant, on-load,

release. The two safety pins were hanging free on the end of their short chains, the lever for release of the falls was raised with the locking sleeve in position and the lever was in the "released" position. A "Danger" notice, written in English, immediately above the disengaging lever was missing from the port boat, although present in the starboard boat.

The evidence is that the safety pin was not replaced in "hole 5". In the effort to put the lifeboat into gear, it is probable that one of those in the lifeboat either pulled the already upright release handle, or raised the release handle, so that the sleeve dropped in place, and then pulled the handle. The investigating team, all experienced mariners, were struck by the similarity of this handle, when raised, to the ahead and astern gear

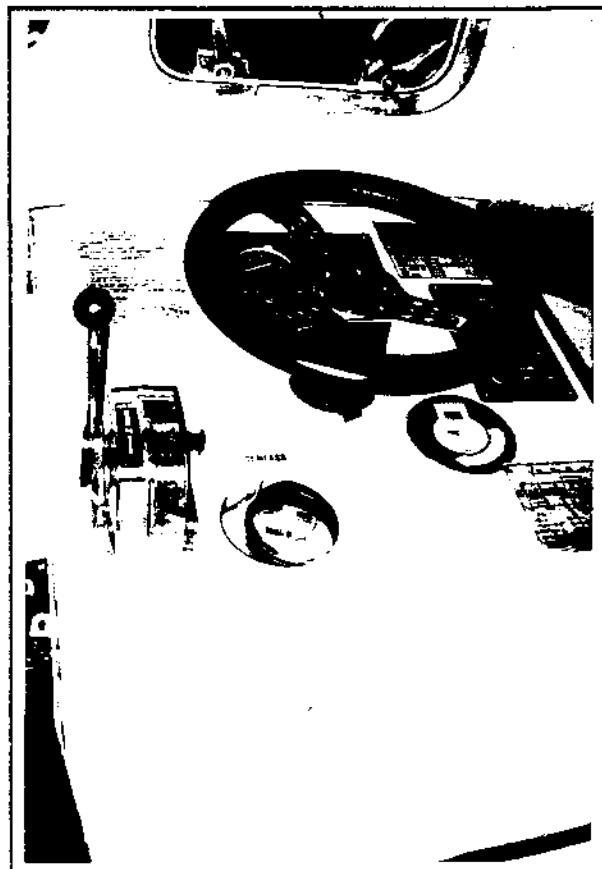
Inspection of the gear-shift lever on the coxswain's control console indicated that the plunger mechanism for locking the gear-shift in the neutral position was broken. This may have contributed to the difficulty experienced by the Second Mate in getting the engine into gear.

Coxswain's position showing gear lever
The black knob on the side of the control was
defective
