**Department of Transport and Regional Development
Bureau of Air Safety Investigation**

INVESTIGATION REPORT

9501246

**Israel Aircraft Industries
Westwind 1124 VH-AJS
Alice Springs, NT
27 April 1995**

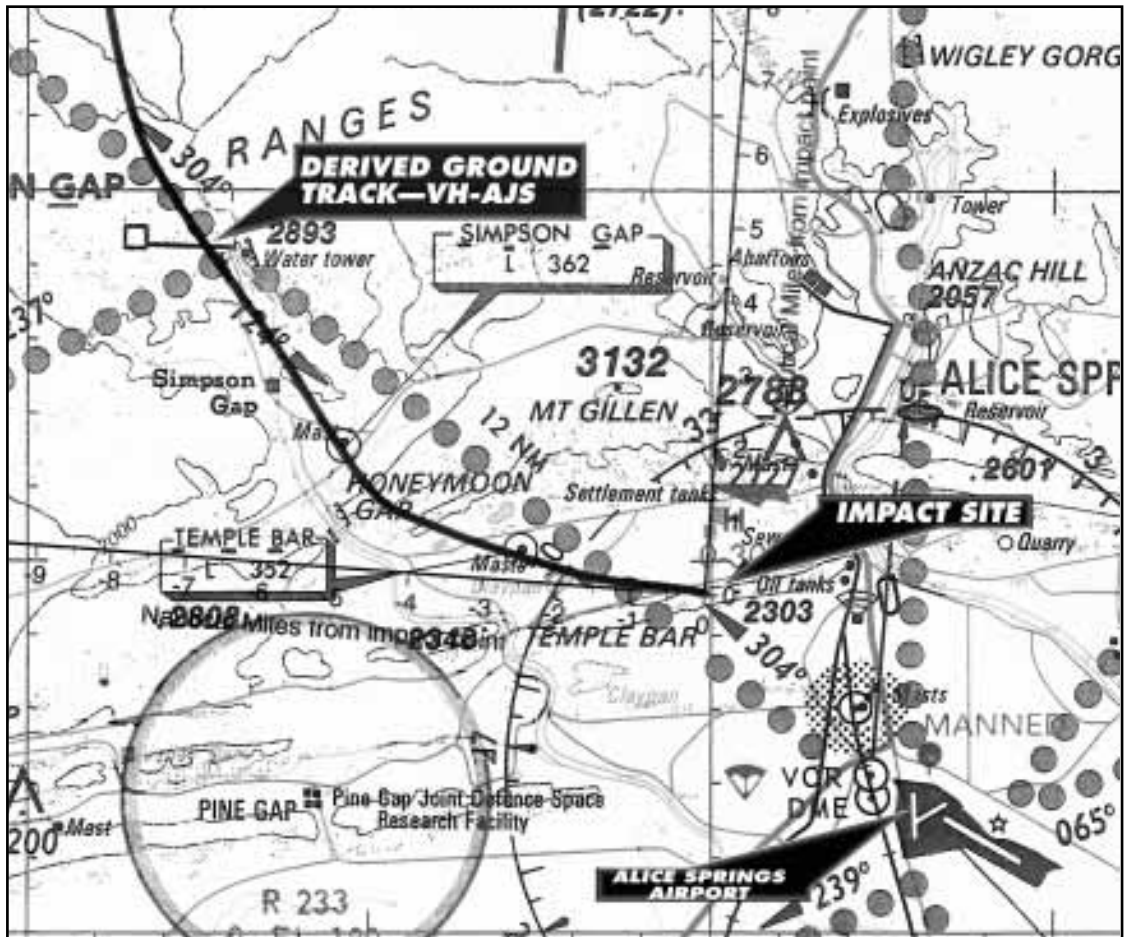
Figure 2. Plan view showing the track of VHS-AJS during the approach

Approaching Simpson's Gap, the aircraft descended through 4,300 feet to about 4,000 feet before climbing back to 4,300 feet. It maintained this altitude to overhead Simpson's Gap before commencing a steady descent at about 1,100 feet per minute. The aircraft reached 3,500 feet a few seconds before passing Temple Bar and levelled briefly before descending again. The aircraft's descent rate was about 670 feet per minute for 18 seconds after passing Temple Bar and then increased to average about 1,500 feet per minute until levelling at 2,250 feet just before impact. The final 3 seconds of data recorded indicate that the aircraft was level at about 2,250 feet for 2 seconds before climbing some 12 feet, at which point the recording ended.

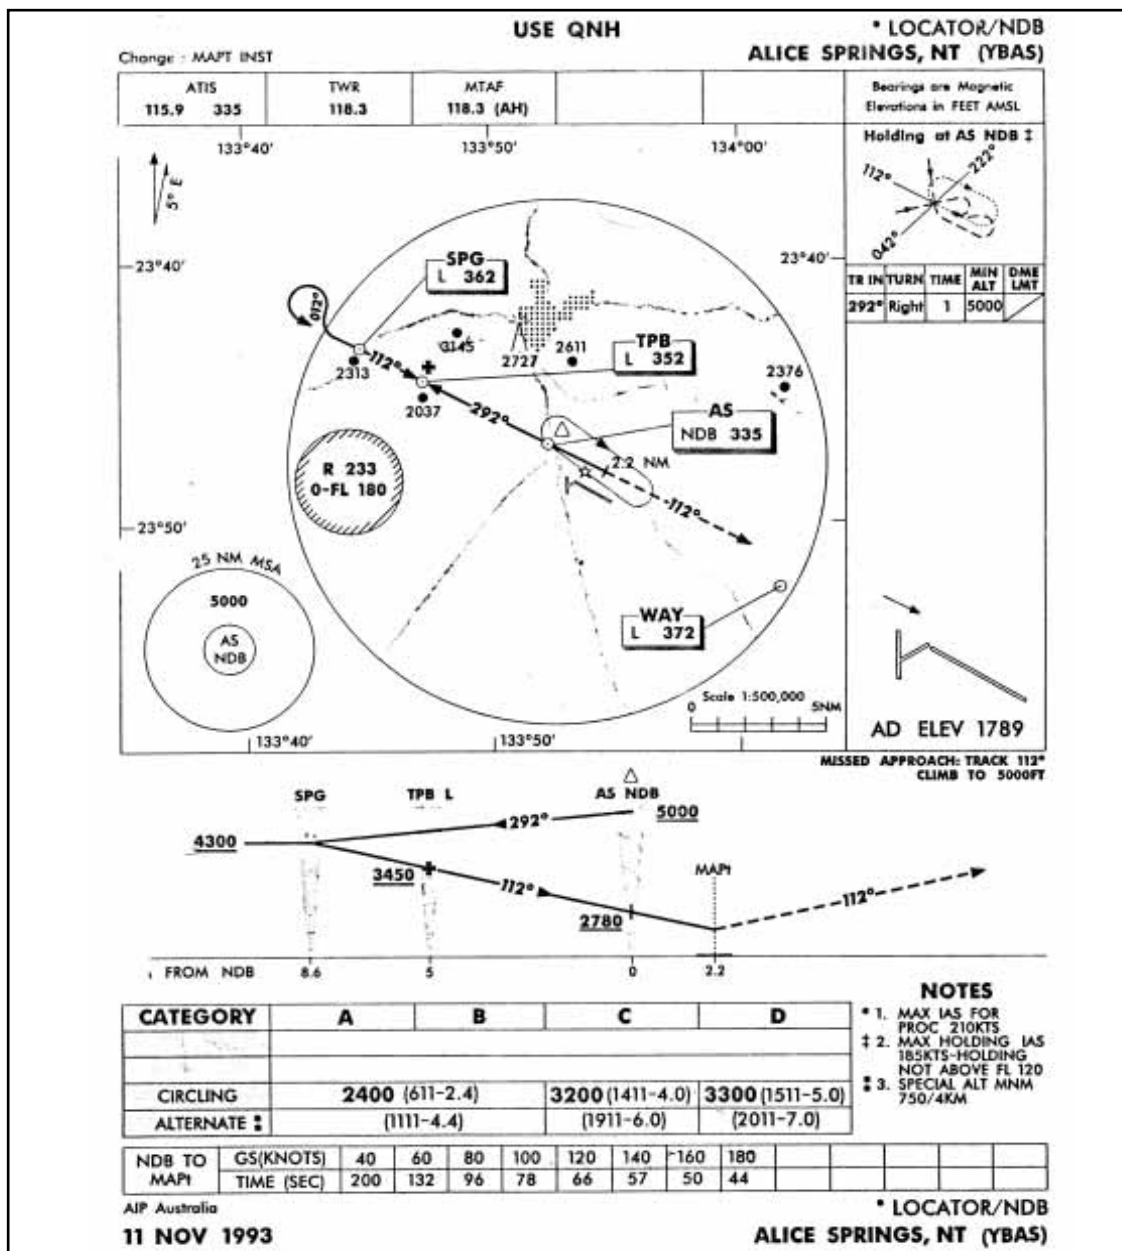
Figure 4. The AIP Australia Alice Springs locator/NDB approach chart dated 11 November 1993.

Examination of the Alice Springs locator/NDB approach chart dated 11 November 1993 revealed the following anomalies:

1. The track between Simpson's Gap and the Alice Springs NDB was depicted incorrectly as 112 degrees instead of 110 and shown as a straight line. However, Simpson's Gap and Temple Bar were aligned with the runway while the Alice Springs NDB was north of this line. In other words, the Simpson's Gap–Temple Bar–Alice Springs track was not a straight line as depicted on the chart. Rather, Temple Bar was south of the Simpson's Gap–Alice Springs NDB track.
2. The locator/NDB chart showed the distance between Simpson's Gap and Temple Bar as 3.6 miles. The runway 12 ILS (Category 1) or LLZ/DME chart correctly showed the distance as 2.67 miles.

A number of deficiencies were noted on the approach charts for Alice Springs. The first of these dealt with the incorrect depiction of the location of the Temple Bar Locator. As a result of these deficiencies CASA reviewed the Alice Springs Locator/NDB approach chart. As a result of this review the chart was reissued on 7 December 1995 with the Temple Bar locator in the correct position.

Additional deficiencies were noted in the depiction of various spot heights on the approach charts. These spot heights were reviewed and an amended chart was issued on 1 February 1996.

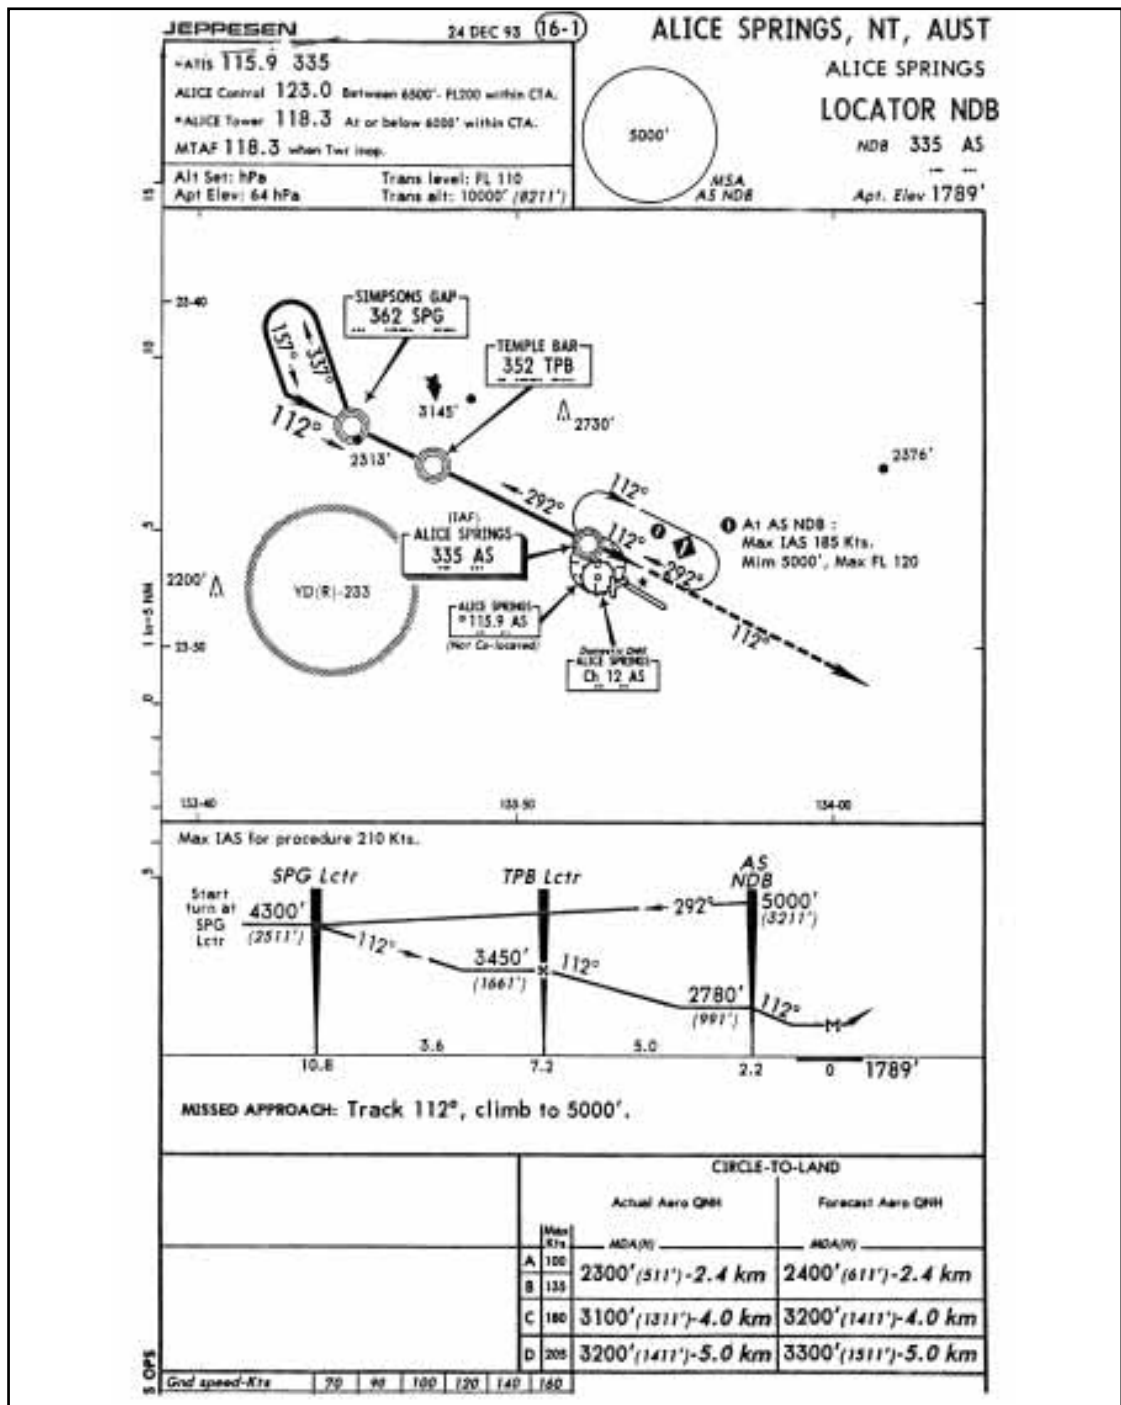
Figure 5. The Jeppesen Alice Springs locator NDB chart dated 24 December 1993.

The AIP and Jeppesen Alice Springs locator/NDB charts current at the time of the accident (dated 11 November 1993 and 24 December 1993 respectively) are at figs. 4 and 5. While the information displayed on each chart was generally the same, a number of differences were noted:
