**Departmental investigation
into the boiler fire aboard the
livestock carrier
MAWASHI AL GASSEEM
in the port of Adelaide
on
9 September 1995**

Report No 85

Published: April 1996

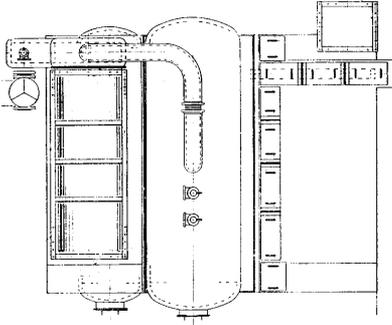
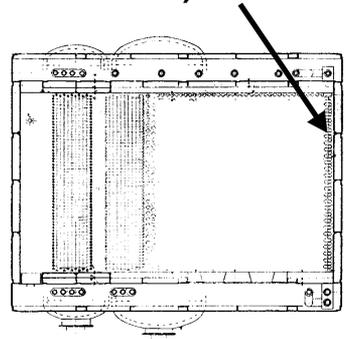
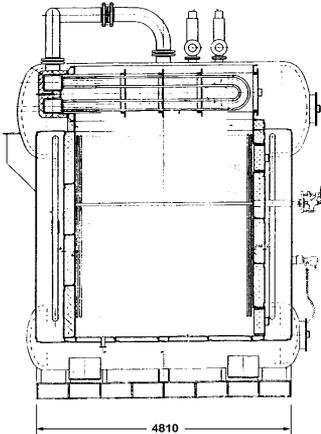
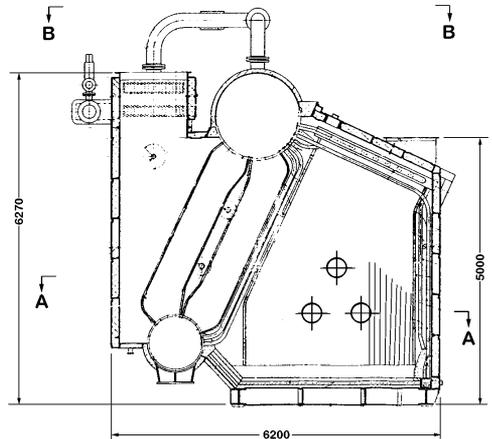
Hitachi Zosen HZA-4SR

Area of most extensive damage
(Port aft corner)

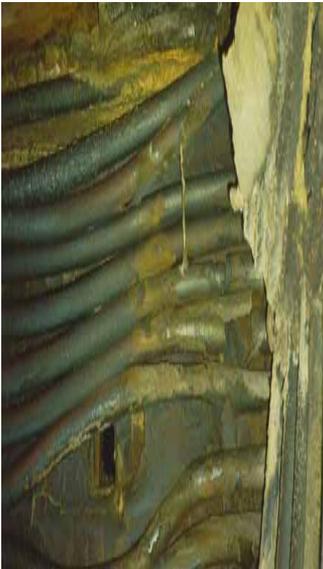
Rear water-wall burnt out tubes

of the rear water-wall were also severely distorted and many had burned away completely in the area in which the worst of the flame impingement appeared to have occurred.

The screen tubes were also badly burned with many of the front few rows having had holes burned through them. Most of the screen and rear water-wall tubes showed signs of having begun to melt, being covered with a skin of melted and oxidised steel in those areas most exposed to the radiant heat from the burner. The molten slag had been flowing in a trickle down many of the screen tubes.

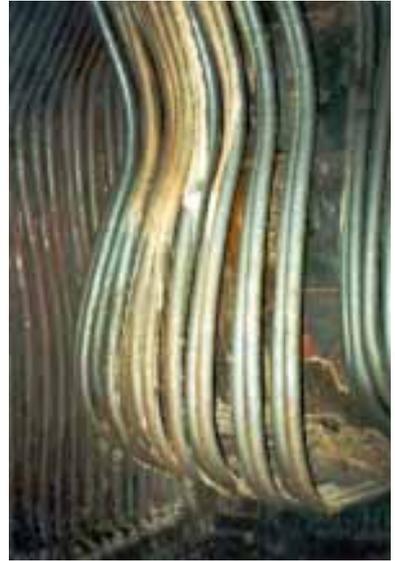
Collapsed side water-wall and refractory

The full length of the side water-wall had collapsed. The tubes had folded into an S-shape, and the refractory had collapsed into the space which had formed behind the sagging tubes. It was through this area of collapsed refractory that the heat had reached the outside of the casing. The damage was worst at the aft end of the side water-wall. The tubes

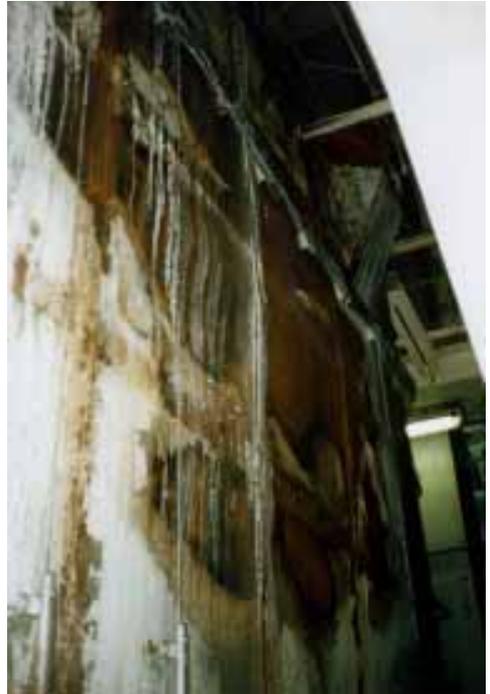
Port side of boiler casing after fire

2. The subsequent symptoms of fire were caused by overheating of the port side boiler casings by intense radiant heat from the furnace, after a collapse of the refractory behind the water-wall on the port side of the furnace. A build up of soot and oil on the tubes and water-walls may have contributed to the incident, these deposits occurring due to poor operating and maintenance procedures.
