Department of Transport and Regional Development
Bureau of Air Safety Investigation

INVESTIGATION REPORT

9601590

De Havilland Canada
Dash 8 VH-JSI
Broome, Western Australia
17 May 1996

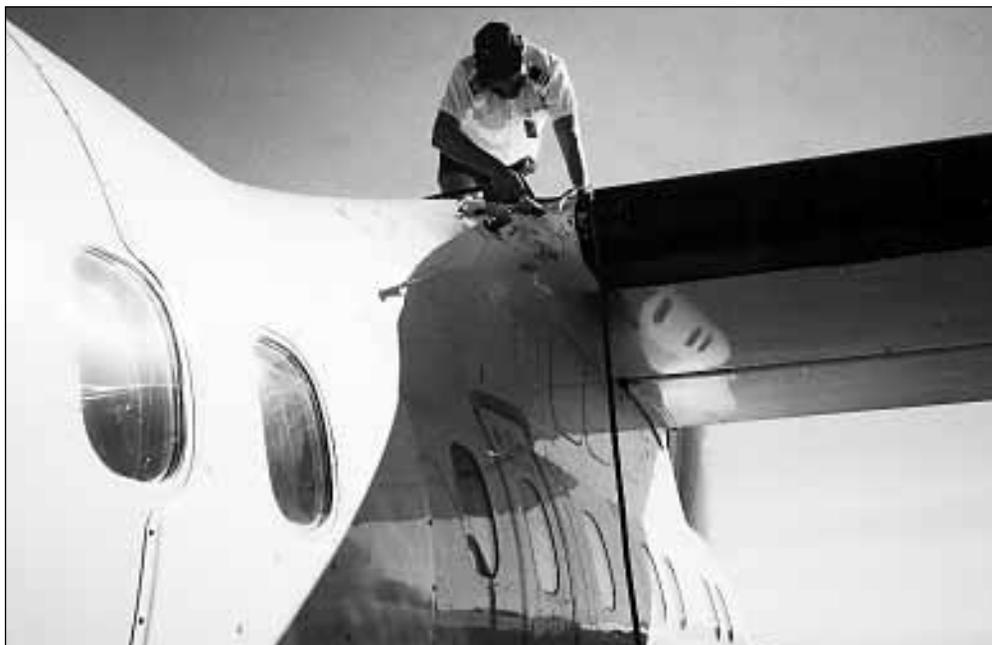
The wiring looms routed along the leading edge of the wing between the left engine nacelle were significantly damaged. At least 30 of the single or twisted pair wires from this area, as well as one of the two main electrical power cables, had been severed during the impact. Maintenance engineers reported that all the wires in the looms routed along the wing inboard leading edge had been severed or stretched. Wires had also pulled from their respective multi-pin connectors, and whole connectors had been ripped from their airframe mounted counterpart.

Figure 2. Damage at wing-fairing to fuselage.

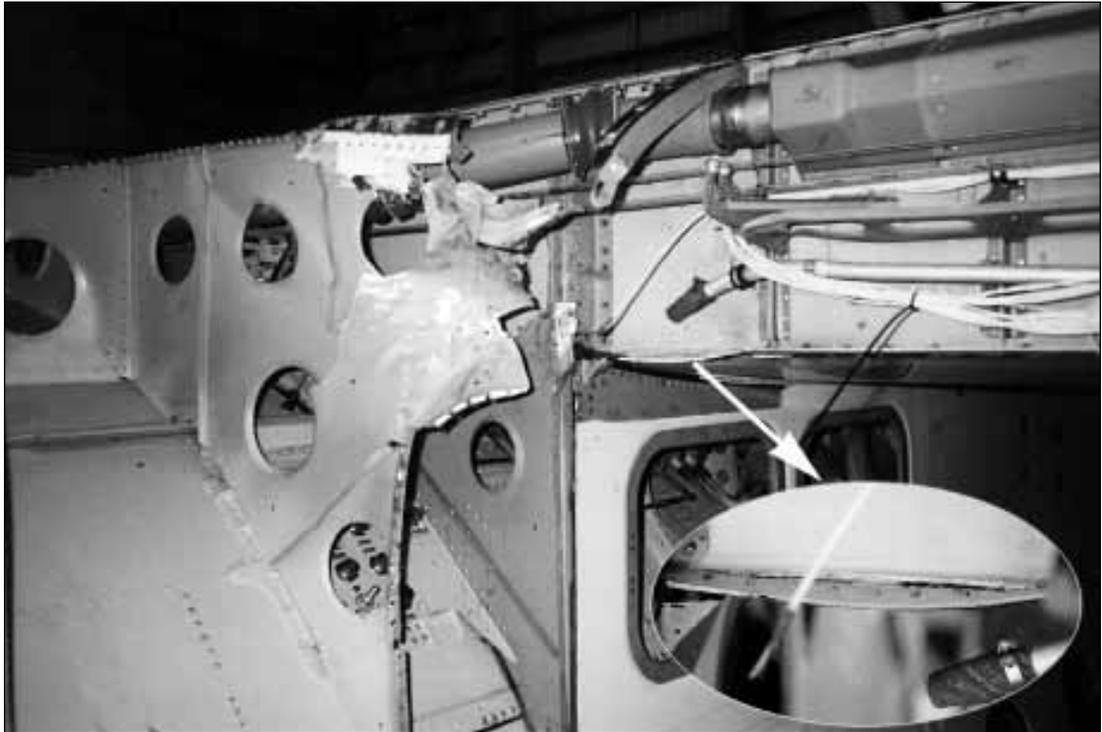
The wing front spar assembly and the wing lift tie strap sustained structural damage. The wing spar web was permanently bowed aft approximately 3 mm, and the lower spar cap forward flange was cracked. The wing lift tie was also deformed, with several solid rivets sheared. The composite wing-to-fuselage fairing and its supporting rib assembly were destroyed by impact forces.

Figure 3. Damage to main spar and associated components.

Structural damage to the aircraft was significant. However, within the framework of Federal Aviation Regulation 25, impact with such a massive bird at high speed was not contemplated.
