Departmental investigation into  
a fall from aloft  
aboard the  
**STS LEEUWIN**  
on 12 June 1996

Report No 93

**Navigation Act 1912**  
**Navigation (Marine Casualty) Regulations**  
**investigation into a fall from aloft**  
**aboard the**  
**STS LEEUWIN**  
**on 12 June 1996**  
**Report No 93**

Published: January 1997

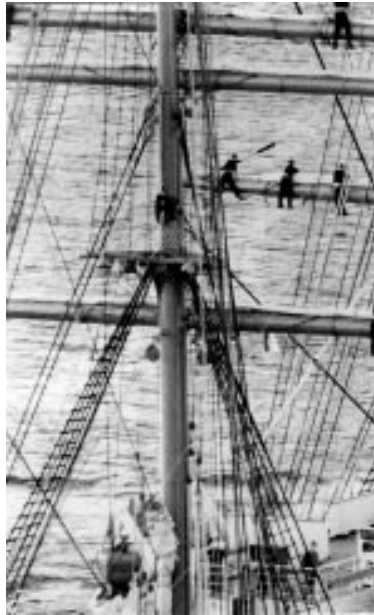
**Arrangement aboard K Ruzenstern**

Arrangements for access to tops aboard STS Joseph Conrad and STS Kruzenstern

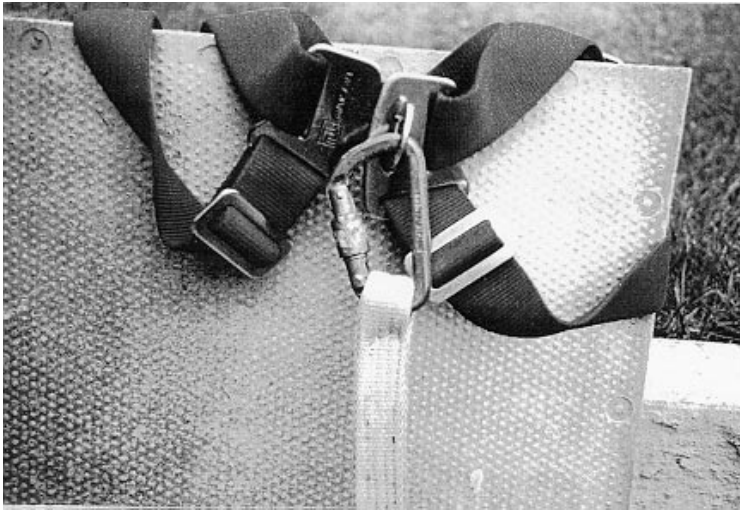
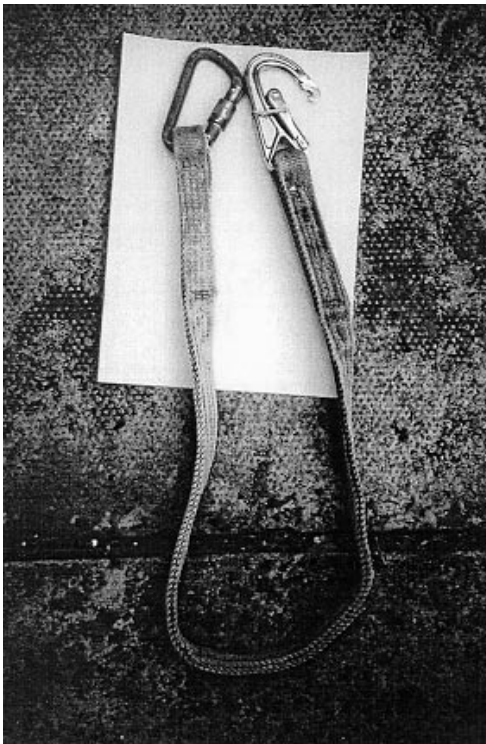
**Safety harness as used aboard STS Malcom Miller**

Working aloft on a sailing vessel has its unique problems. A safety harness must not include loops that can snag while the wearer is moving about the rigging, and buckles must not be of a type that can snag or trip-release. A harness must also be relatively easy to put on and remove, bearing in mind the need to change working apparel according to the varying climatic changes often experienced at sea. However, almost all of the people consulted considered that a "sit in" type harness (one with leg straps) should be used.

Type of safety harness in use aboard STS Malcolm Miller

Although when tested and fastened correctly the belt held the test dummy, conforming to AS2227, it is considered that it would be appropriate for the Leeuwin Foundation to reassess the safety belt used aboard Leeuwin, against the harnesses used by other sail training establishments.
