Departmental investigation
into the accidental release of the free-fall lifeboat
and injury to a crew member aboard the Bahamas flag
geared bulk carrier
MAERSK POMOR
at Gladstone, Queensland on 2 January 1998

Report No. 128

Australia
Department of Workplace Relations
and Small Business

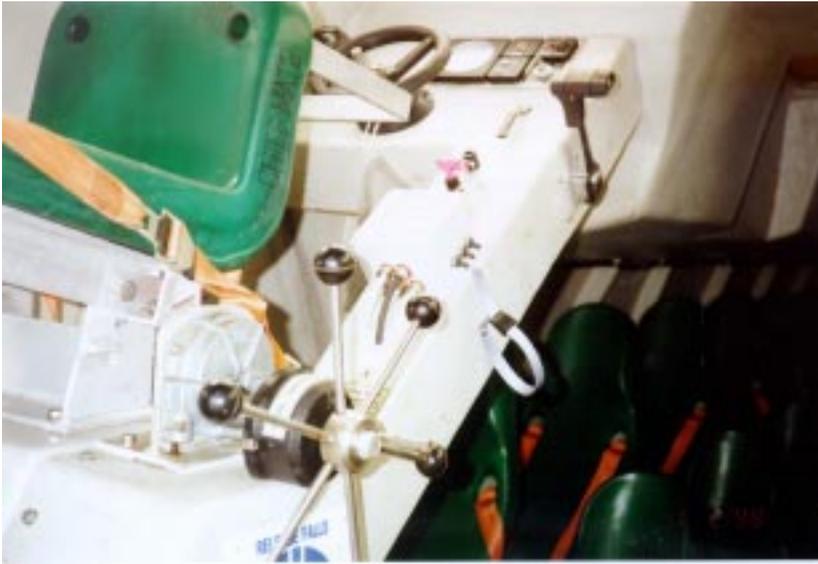
Coxswain's seat and controls

The coxswain's seat is located towards the after end of the lifeboat, on the port side, it faces forward and is raised above the level of the other seats. For launching, the seat is secured in a backwards reclining position. Stencilled on the inboard side of the seat are the words "CHIEF MATE".

The steering wheel, compass, engine ignition and rpm tachometer are located on a console immediately in front of the coxswain's seat, while the engine control, similar to a car's automatic transmission control lever, is located on the inboard side of the console.

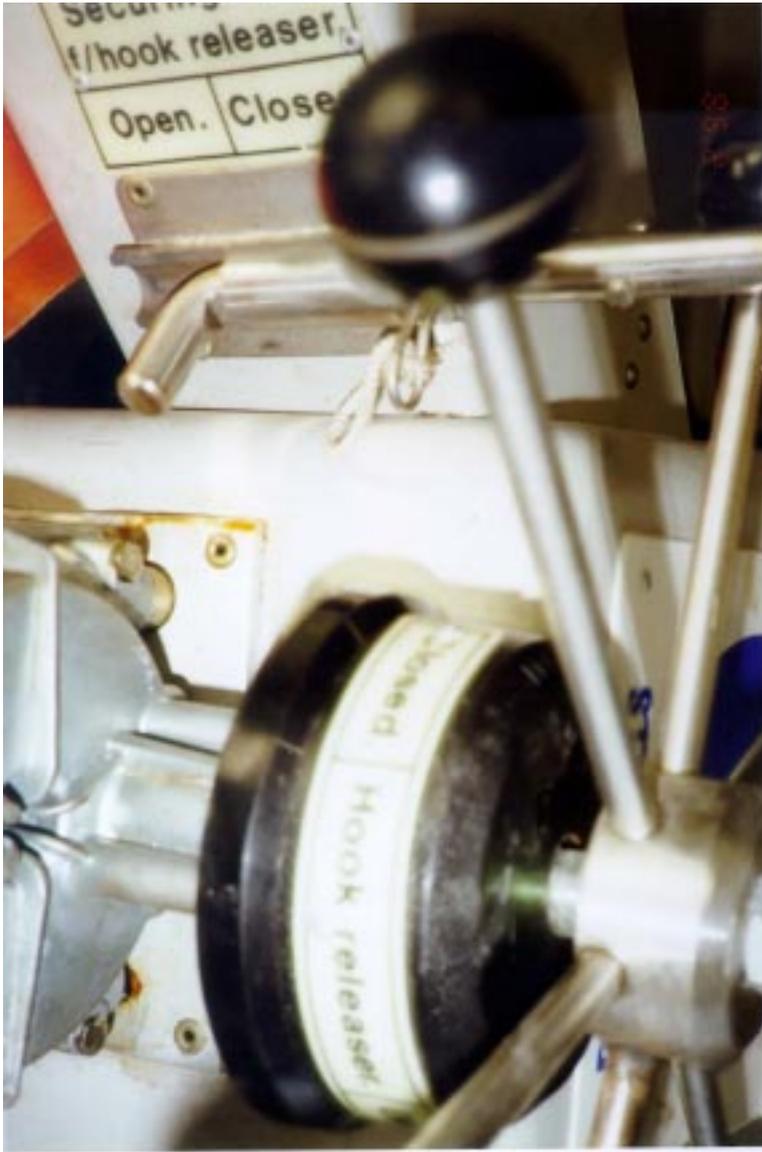
Lifeboat release gear

The release gear, for launching the lifeboat, incorporates a spoked, rimless wheel, located adjacent to the inboard side of the coxswain's seat. To prevent accidental operation of the release gear, the wheel is locked by a stainless steel slip bolt, passed between the spokes, and in turn is prevented from accidental removal by a locking pin.

All instruction labels relating to the release of the lifeboat are in the English language. The release gear is clearly labelled "Hook Releaser", with the open and closed directions of movement, also with an IMO safety

label for “release falls” with a warning note that misuse of the release gear can injure or kill. The securing bolt is also labelled, “securing bolt, hook releaser” and the open and closed positions are marked.
