Report No 145

Navigation Act 1912
Navigation (Marine Casualty) Regulations
investigation into a lifeboat accident
and injury to crew
aboard the Antigua & Barbuda flag vessel
WADDENS
at Cairns Harbour
on
14 February 1999

Issued by the
Australian Transport Safety Bureau
October 2000

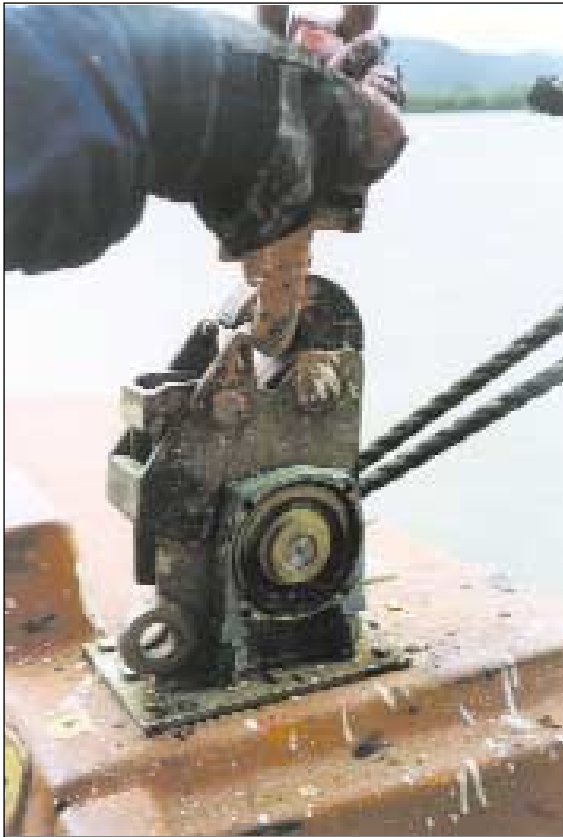
FIGURE 3.
Lifting hook, plate removed

The boat was then hoisted with the hooks not locked by the locking bolts but, as soon as the load came onto the hooks, they rotated and released. This test showed that if the hooks were not properly locked, they would release immediately any weight came on them.

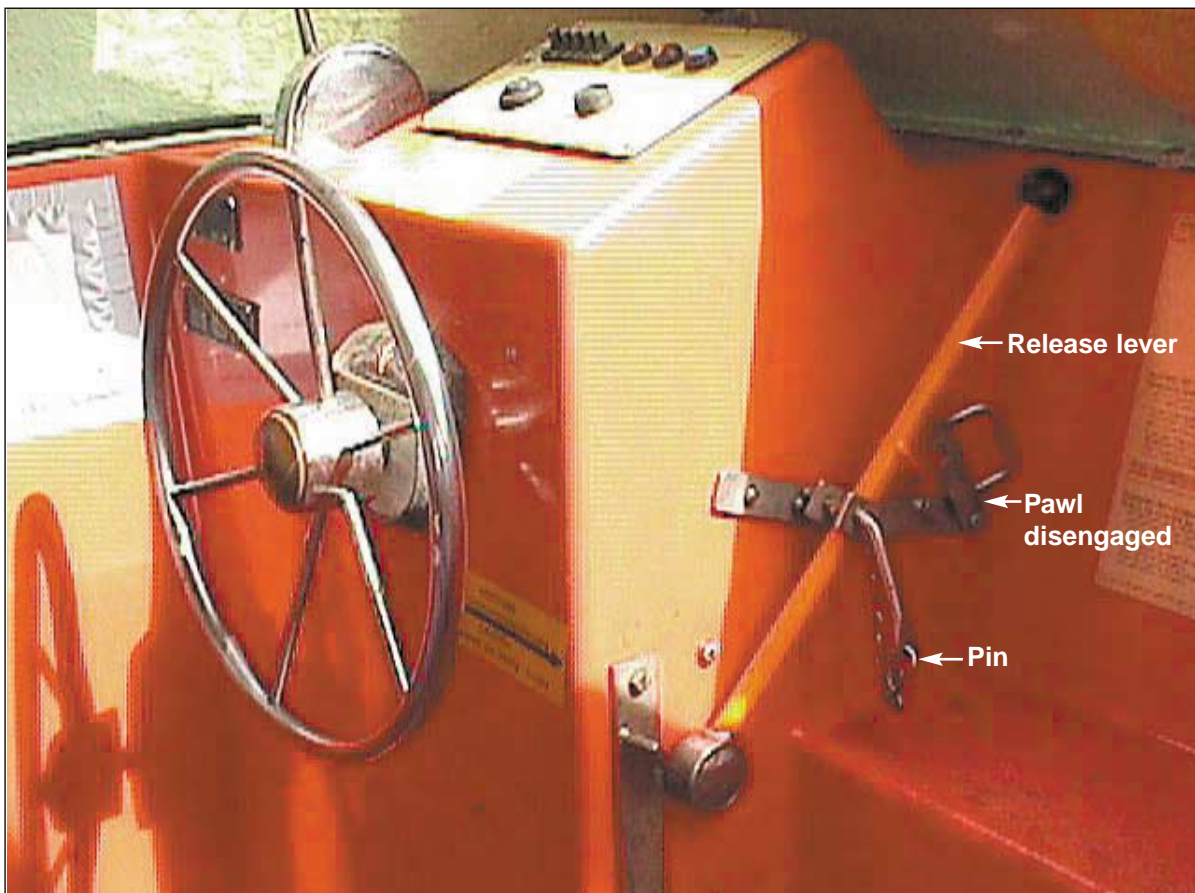
FIGURE 4.
Release mechanism

The release mechanism (see fig. 4 & fig.5 page 8) consists of a release lever fitted at the starboard side of the steering console. The release lever is connected by flexible cables to locking bolts in the hoisting hooks. To release the hooks it is necessary to unlock the release lever and pull it back. The locking bolts rotate, releasing the hooks and disengaging the falls. There are two locking devices for the release lever, a safety pin and a pawl.

The manual for the operation of the boat cautions that the hooks may be released under load in any position. The lever for the release mechanism of the boat is secured by two locking devices, a pin and a pawl. The manufacturer's manual refers to the pin as a safety pin (see fig. 4, page 4).

The safety pin passes through a bracket that houses the release lever, preventing the lever from being moved unless the pin is first withdrawn and the pawl lifted. The pawl, which engages in a lug on the release lever, must be lifted clear of the lug to permit movement of the release lever.

With the release lever secured by the safety pin and pawl, it would not have been possible to operate it. If the safety pin and pawl were not in position however, it is conceivable that the lever could be moved by inadvertent contact with the AB's foot or leg, although that is considered unlikely, due to the lever's position. It is also unlikely that the AB, who was reported to be familiar with the system, would operate the release lever, when the boat was suspended above the water.

The mate mentioned that the AB had been coiling the painter while he was half in and half out of the forward hatch. If the safety pin and pawl were not in position, or if the AB had removed the pin and the pawl to clear a tangle of rope, it is possible that, with the rope and the AB's legs in close proximity to the release lever, the lever was fouled and drawn aft, releasing the boat.

Every indication is that the release lever was operated and, despite the 2nd mate and AB maintaining that the lever was locked, the safety pin and pawl could not have been in place.

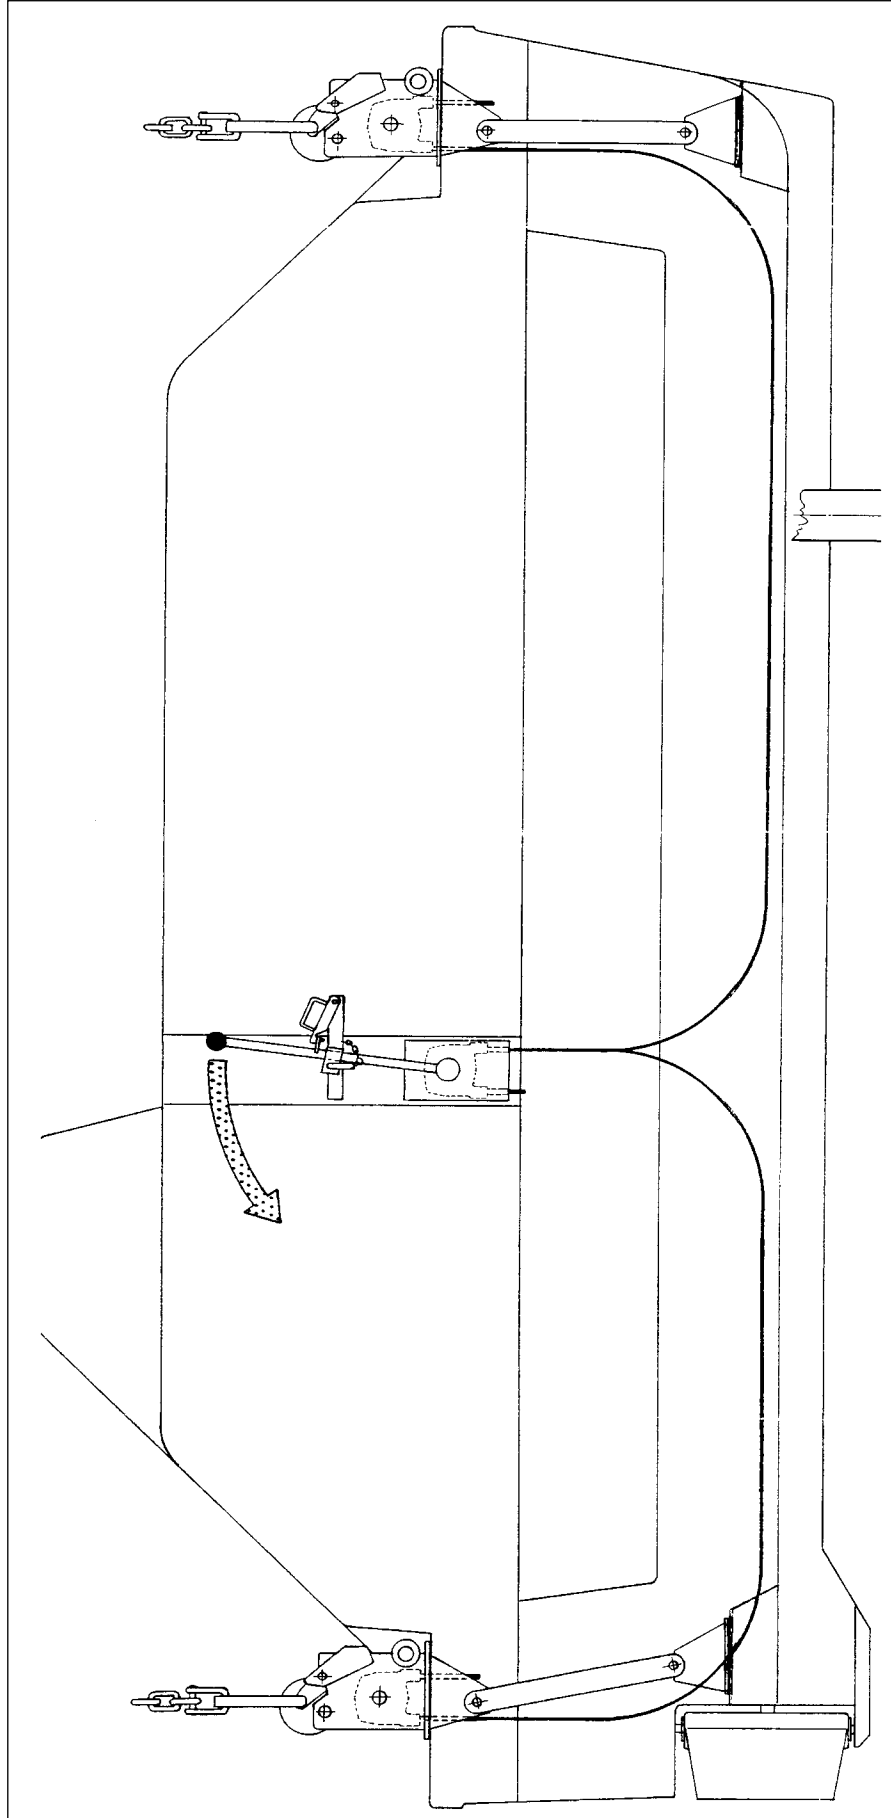
FIGURE 5.
Release lever mechanism diagram

The release mechanism operated as it was supposed to and there was no indication that any mechanical failure might have been a factor in the incident.

The investigation revealed no evidence of mechanical failure. To release the hooks, the release lever would need to be unlocked and then pulled back. The manufacturers also concluded that the release lever would have been operated in this instance though they might not be correct in assuming that the person who caused the release of the hooks was not

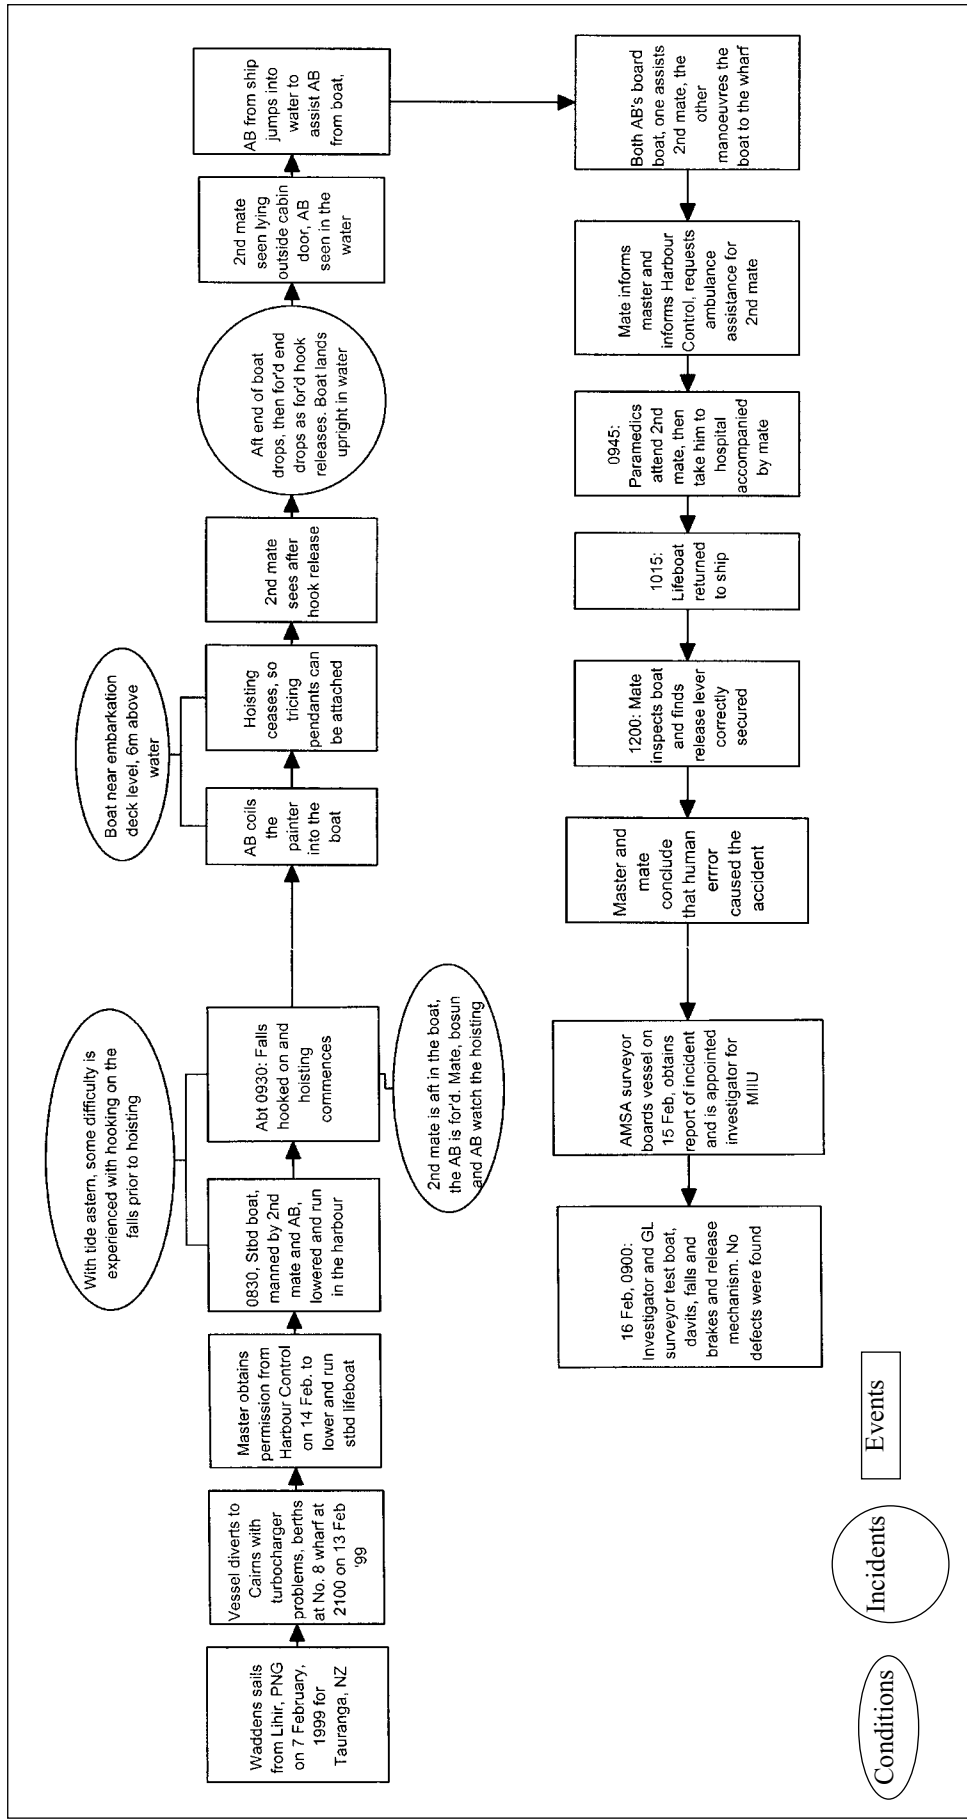
FIGURE 6.
Events and causal factors chart

1. Mechanical failure was not a factor.
2. The locking devices securing the release lever were not engaged.
3. The release mechanism was operated inadvertently, possibly by the boat's painter fouling the release lever.
