MARINE SAFETY INVESTIGATION
REPORT 160

Independent investigation into the lifeboat incident on
board the Philippines flag bulk carrier

Washington Trader

at Abbot Point, Queensland
on 6 August 2000

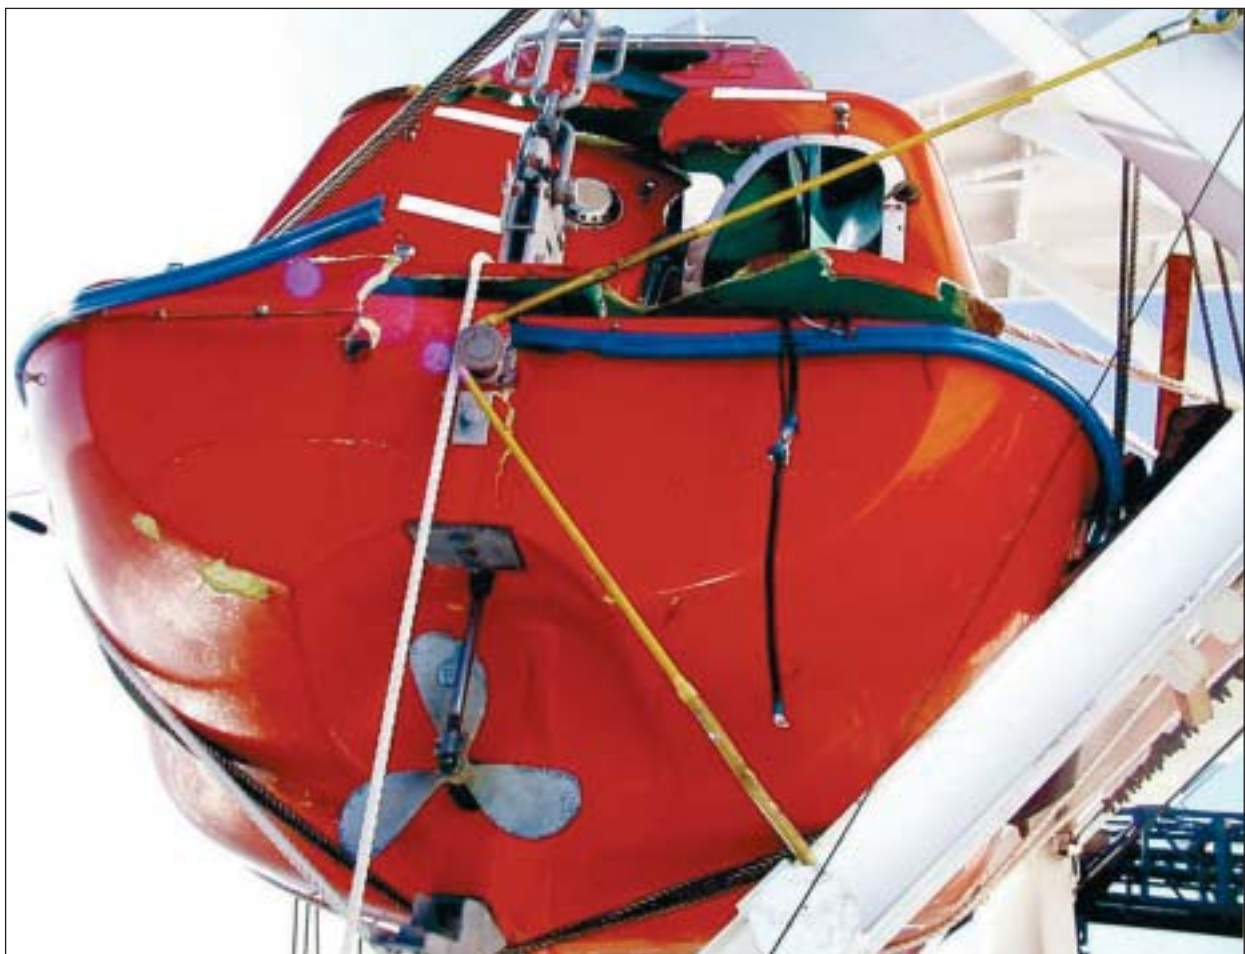
FIGURE 7:
Damage to the stern of *Washington Trader's* port lifeboat

Externally, all of the damage to the lifeboat was confined to the stern (figure 7). The canopy at the stern was extensively damaged with several

large cracks and small sections missing. It was set-in in way of the after hatch which was hanging ajar from its damaged frame. The after deck was extensively damaged with much of the deck around the on-load hook broken up. There were several large cracks in the hull at the transom. The rudder/propeller nozzle had been broken away from the rudder stock and keel block, both of which had been deformed by the impact.

Inside the boat the damage was limited to the fixtures on the after bulkhead with the mounting brackets for the hook release operation unit twisted. The engine exhaust skin fitting on the transom was also damaged.

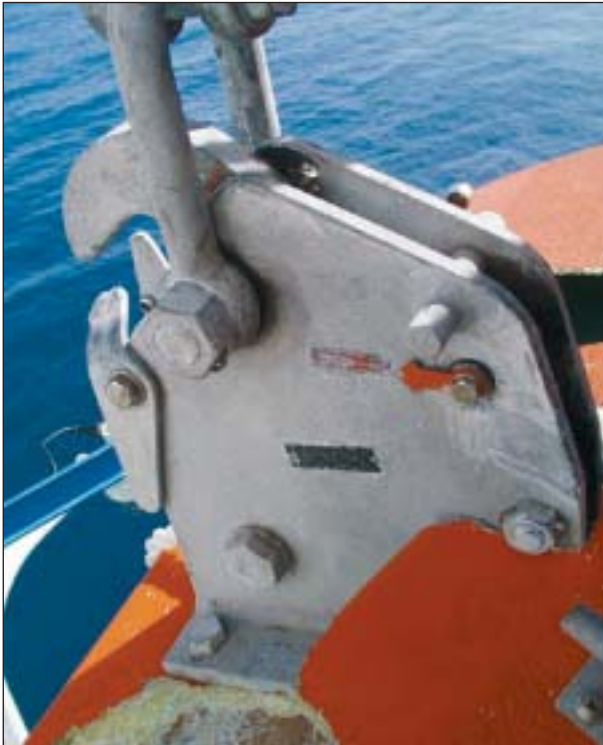
FIGURE 8:
The after hook as found

The after hook was found to be in an un-tripped or closed position (figure 8). The cable reset lever on the after hook was in the reset position although the end of the lever was approximately 20 mm lower than the painted reference marks on the hook side plates. The retaining latch on the hook was damaged with both of its side members bent outboard. The lug at the top of the outboard side member was missing. There were a number of witness marks (scores or damage) on the latch and the suspension ring which were consistent with the ring having been forced past the retaining latch with the hook in a closed position.

The design of the retaining latch on *Washington Trader*'s after on-load release hook was significant in this incident. The damage to the latch and the marks on the suspension ring show that the ring was forced past the latch to detach the after fall. A latch of stronger design fitted to close the opening of what is a relatively shallow hook may have prevented the ring from coming off the hook.

On *Washington Trader's* lifeboats, the relatively light construction of the hook latches would indicate that they are only designed to guard the suspension rings when they are loose in the hook. They are not designed to restrain a suspension ring under load. When the after suspension ring slid or jumped to the point of the hook during the incident, the lightly constructed latch would have presented minimal resistance to the heavily loaded suspension ring (of 20 mm cross-sectional diameter) as it exited the hook.

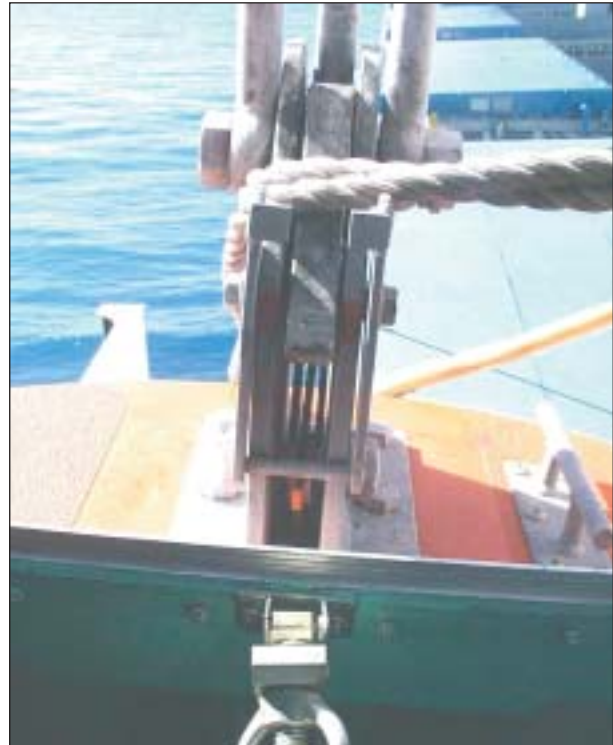
FIGURE 9:
The forward hook as found

The forward hook was found to be in a tripped or open position (figure 9). The cable reset lever was in a partially reset position with the end of the lever approximately 25 mm above the fully tripped position. There was no damage evident

to any part of the forward hook mechanism including the suspension ring or retaining latch. The position of the cable reset lever indicated that the forward hook may not have been fully reset after the previous boat drill, or that the hook may have been forced open when the full weight of the boat was transferred to the forward fall.

The forward hook, as found after the incident, was open with the painted end of the cable reset lever approximately 25 mm above the fully tripped position. Full travel of the lever from the tripped position to the fully reset position involves a movement of approximately 140 mm. Providing the forward cable reset lever had not been moved after the incident, the position of the lever indicates two possibilities. Either the hook had not been correctly reset after the previous lifeboat drill and/or the transient load on the hook at the time of the incident was large enough to force the hook open, moving the cable reset lever to the partially reset position in the process.

Resetting each hook unit is, because of the limited access to the forward and aft decks, a one-man operation. In the final stage of resetting, the cable reset lever must be moved, without any mechanical advantage assisting, against any resistance in the length of the operating cable and the operation and hook unit mechanisms. *Washington Trader's* forward hook unit cable reset lever was found to be very stiff. When resetting the hook after the incident, considerable force was required to move the lever through its full range of movement. Resetting of the lever was made even more difficult because the bar at the bottom of the retainer latch obstructs access to the lever in one section of travel. The force opposing the movement of the lever was due mainly to friction in the operating cable. The operating cables are fitted with oil seals at each end, and so it is unlikely that the cable friction was a result of the boat's immersion in seawater. Further evidence of past difficulty resetting the forward hook was found in the form of a short, bent, extension pipe in the bottom of the lifeboat. The investigator noted that this pipe was just the right size and shape to fit over the end of the cable reset lever to assist in resetting it. This difficulty in moving the cable reset lever may have been why it appears that the forward hook was not fully reset during the previous lifeboat drill.

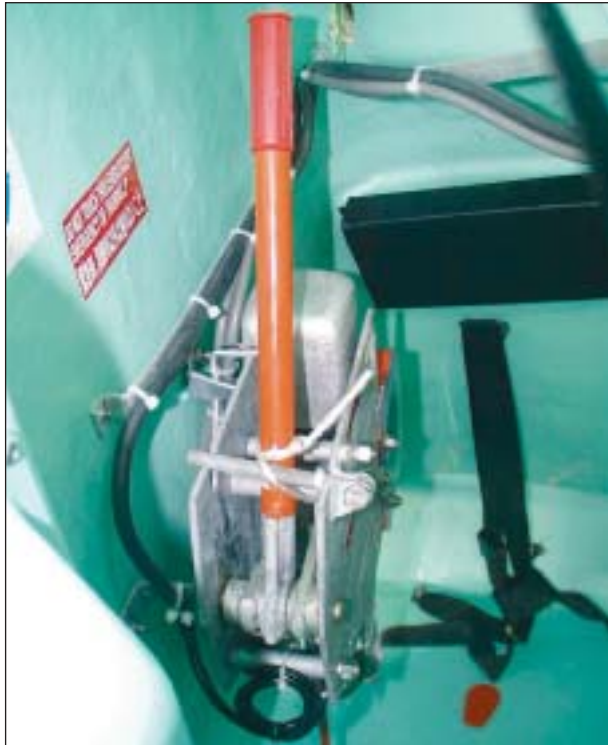
FIGURE 10:
Operating unit as found

The release handle of the operation unit was in the un-tripped position with a piece of twine fastened around the handle and the safety pin (figure 10). The pivoting safety pin was slightly bent adjacent to the eye at its pinned end and thus could not be seated in the notch of the opposite operation unit side plate. The after hook cable connection arm was found to be in the reset position with the forward hook cable connection arm in a tripped position, ie. the after arm was down and forward arm was up. The hydrostatic interlock lever was disengaged due to the tripped position of the forward cable connection arm. There was no sign of damage to any component of the operation unit other than

some deformation of the mounting brackets attaching it to the after cabin bulkhead.
