AVIATION SAFETY INVESTIGATION

200102710

# Embraer Bandeirante VH-OZG Cootamundra NSW

INVESTIGATION REPORT  
200102710

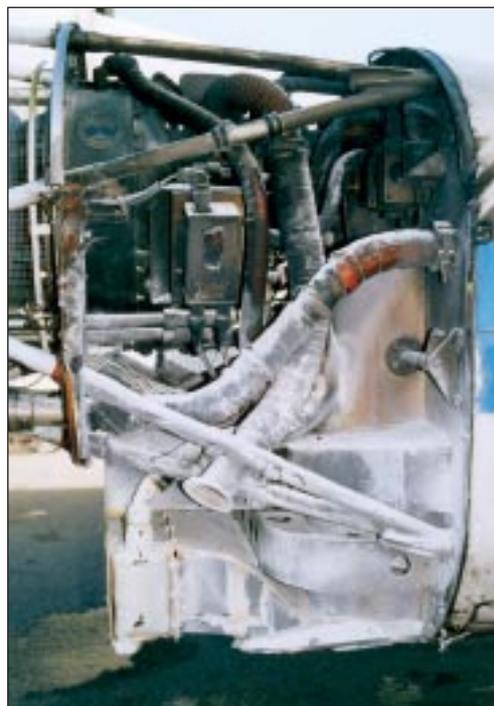
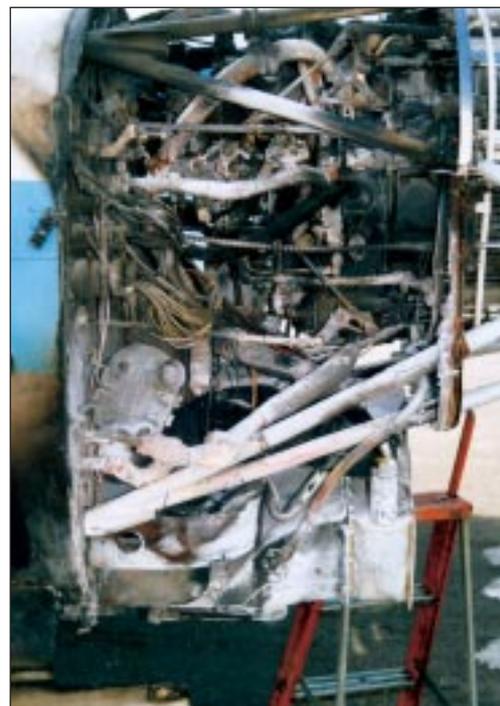
**FIGURE 1:**  
**Damage to the inboard and outboard sides of the right engine accessory compartment**

Evidence of the in-flight fire was confined to the right engine nacelle between the rear seal and the firewall (see fig 1). The wheel well area and components behind the firewall had sustained damage from heat transferred through the firewall. The right engine upper cowl showed no signs of fire damage and although it was lightly sooted on the inside, the paint was not blistered. Fire damage to the lower cowl was evident on the outboard side. Smoke stains and an elongated hole, approximately 400 mm long, running in a longitudinal direction between the rear seal and the firewall were the only external signs of an engine compartment fire.

Components on the inboard side of the compartment showed almost no evidence of fire damage and were only lightly sooted. Soot stops depositing at temperatures over about 370 °C. Those components and the systems located on the outboard side, including fuel system components, connecting lines, and engine and propeller controls, were not sooted and exhibited evidence of having been exposed to a high temperature. The insulation on the cable looms and individual wires had either melted or burned away, exposing the wires. The outside protective layer on some of the red-coloured, silicon-fibreglass fire sleeves was blistered and flaked, or burned away.

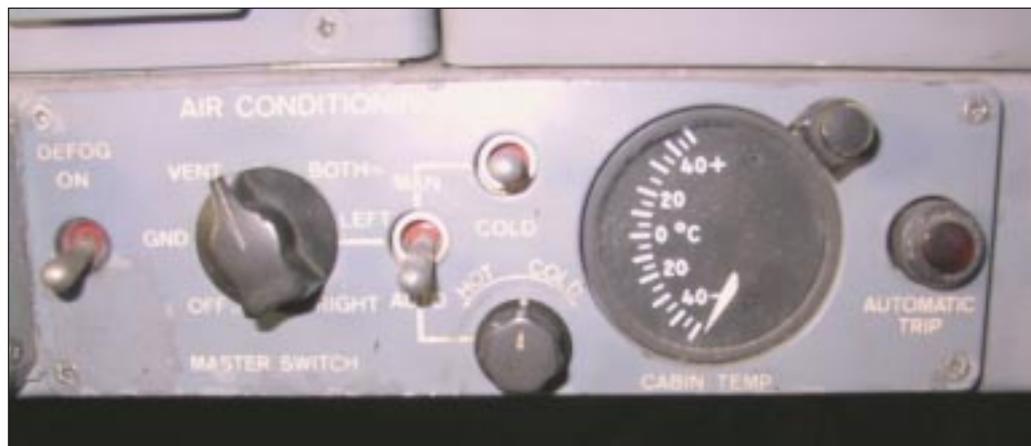
**FIGURE 2:**  
**Air conditioning control panel**

The air conditioning control panel, shown in figure 2, had a six-position rotary master switch that could be positioned as follows:

Figure 2 shows the configuration of the air conditioning master switch and figures 5 a. and b. show the left and right ram air supply 'T' handles of the occurrence aircraft after the landing at Cootamundra.

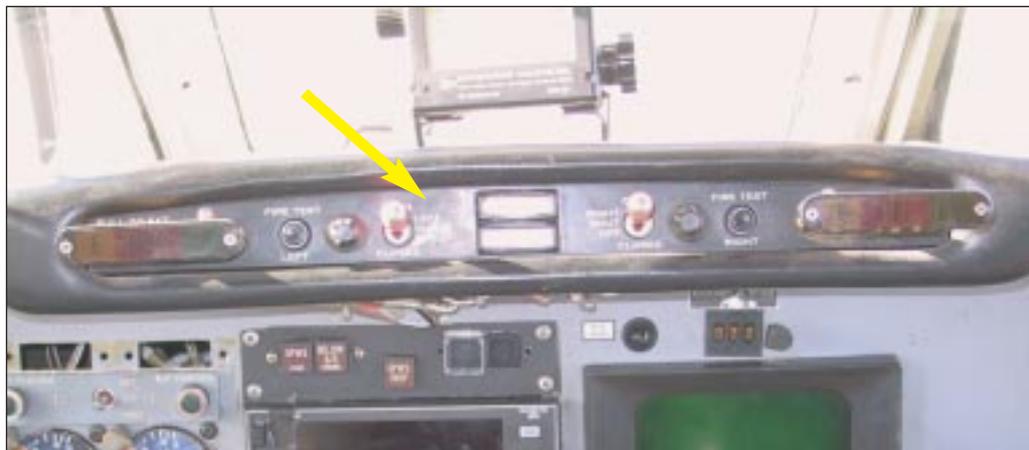
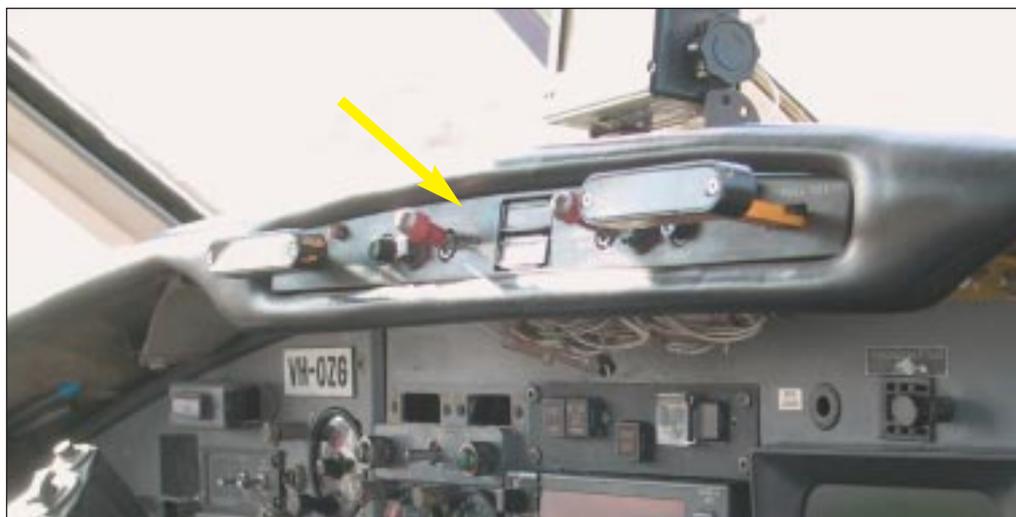
**FIGURE 3A:**  
**Engine fire detection and extinguisher system panel**

Figures 3 a. and b. show the configuration of the occurrence aircraft's engine fire detection and extinguisher system panel after the landing at Cootamundra.

After the aircraft landed at Cootamundra, the right engine fire extinguisher 'T' handle shut-off was found in the discharge position. However, the right shut-off valve was found to be in the OPEN position, as shown in figures 3 a. and b.

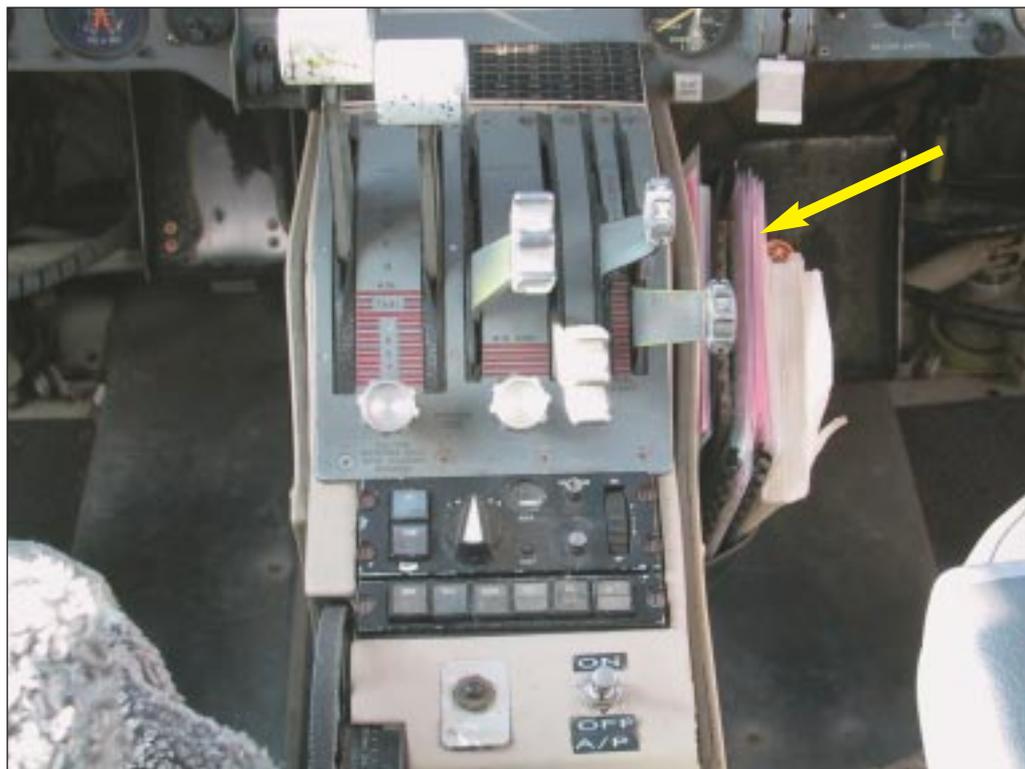
**FIGURE 4:**  
**Location and condition of aircraft checklists**

The location and condition of the operator's normal and emergency checklists that were found in the aircraft after the landing at Cootamundra are shown in figure 4.

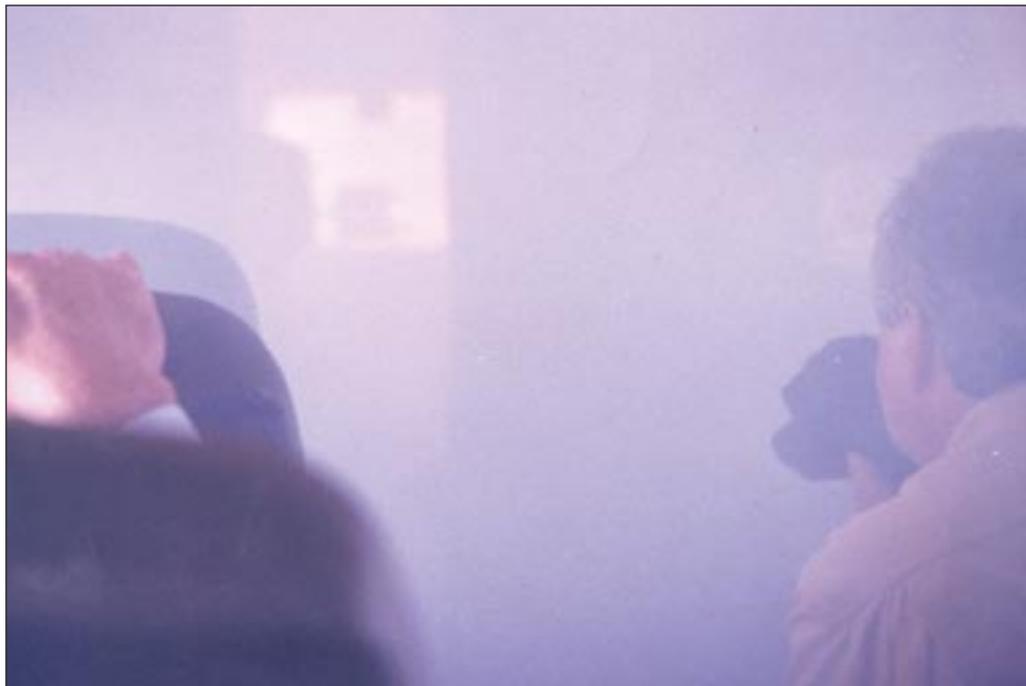
**FIGURE 6:**  
**The smoke-filled cabin looking forward**

Passengers reported that the smoke appeared to enter the cabin through the floor near the over wing area against the right wall. The smoke was described as being greyish-white at first, like cigarette smoke, but as it began to intensify it became acrid and its colour became dark grey to dark brown. It was variously described as having an oil or rubber smell, or smelling of burnt plastic or fibreglass.

Smoke reduced visibility in the cabin to the point that some passengers could not see other passengers that were seated two rows away. Passengers seated toward the rear of the cabin reported that they could not discern the cockpit. The pilot reported that he had not experienced any reduced visibility from the smoke. Shortly before landing at Cootamundra, passengers reported that the pilot was surrounded by strong brown smoke, which he waved away with his headset.

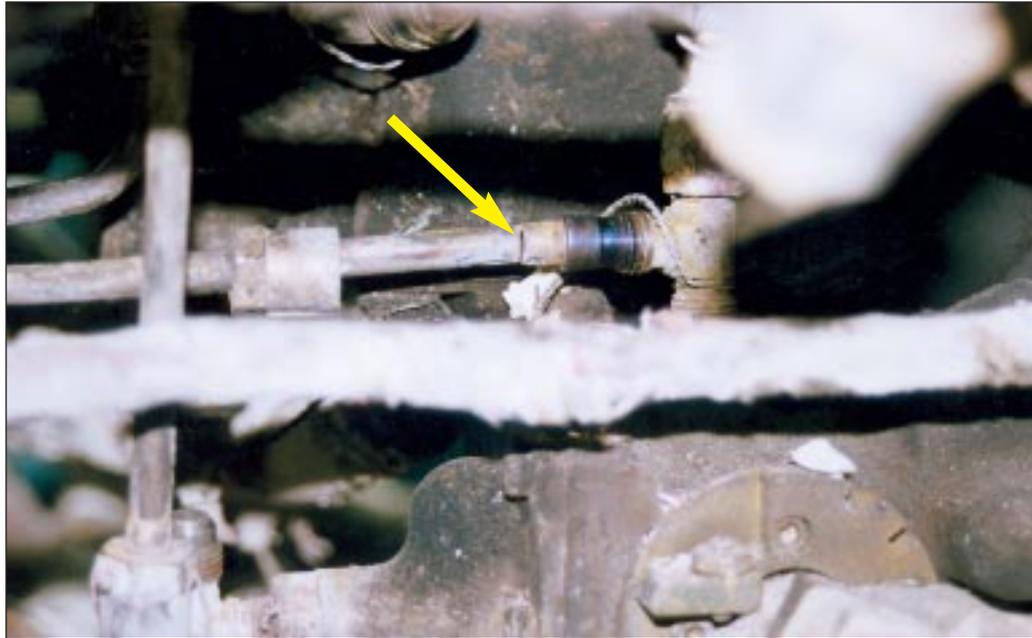
**FIGURE 7:**  
**The cracked rigid fuel return line**

The rigid fuel return line between the fuel control unit (FCU) and the ‘T’ piece above the start flow controller (SFC) was cracked. It was subsequently examined by the ATSB, and the results of that examination are discussed in sub-section 1.16.

A fatigue crack was found in the rigid fuel return line between the fuel control unit (FCU) and the 'T' piece above the starting flow controller (SFC). Fractures had started on the outer surface of the line at two separate locations, next to the 'T' piece as shown in figure 7.

Laboratory examination of the cracked, rigid fuel return line determined that the crack resulted from progressive fatigue cracking and that the cracking had initiated and propagated from vibration loads. No pre-existing condition was found and there was no evidence that the fuel line had been loose or poorly installed.
