TECHNICAL ANALYSIS REPORT No: 9/02

**Analysis of a failed
Pratt & Whitney JT9D-7R4
turbofan engine**

Boeing 767-238, VH-EAQ

27 November 2001

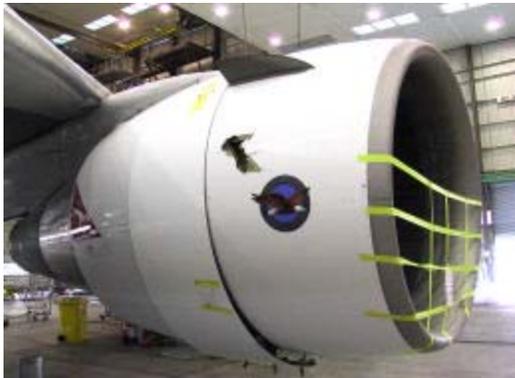
Initial inspections by airport ground personnel found severe damage to the engine nose-cowl and fan assembly, including several holes where debris had passed through the cowl (figure 1). The engine fan had lost the majority of one complete blade, with many others showing severe impact damage and distortion along the tip edges (figures 2 & 3). A blade opposite to the fractured item had lost material from the tip.

Fig. 1 (Top L). Right side of the failed engine, showing the nose-cowl puncture.

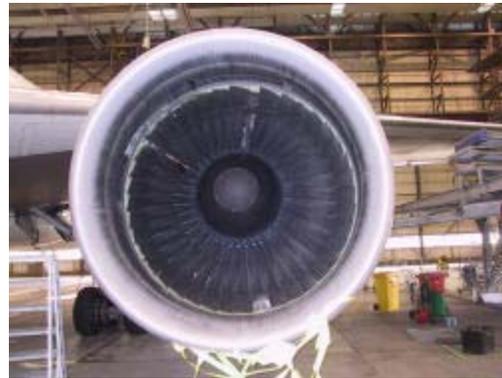
Fig. 2 (Top R). Intake of the engine – general view.

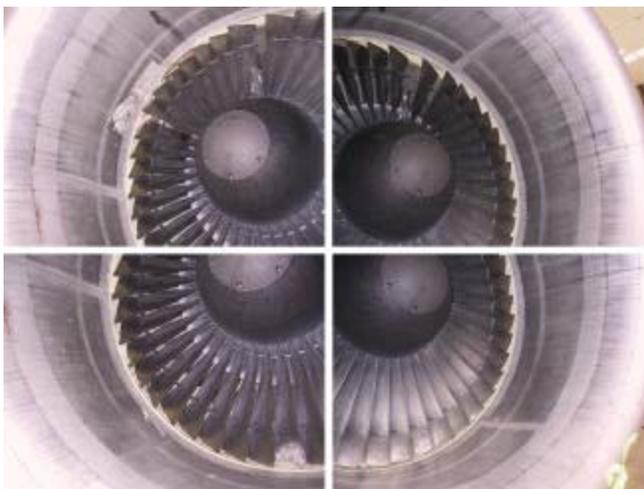
Fig. 3 (Left). Montage image of the engine fan and intake internal surfaces.

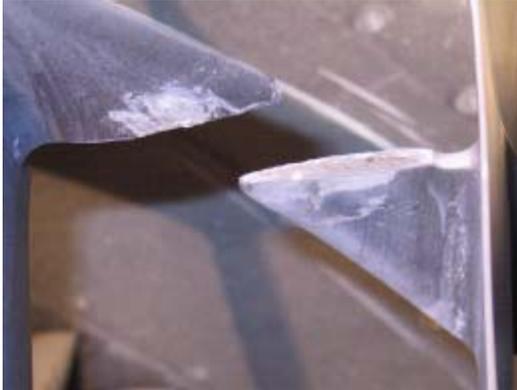
Fig. 4 (Top L). Damage to the contact surfaces of the fan part-span shrouds.

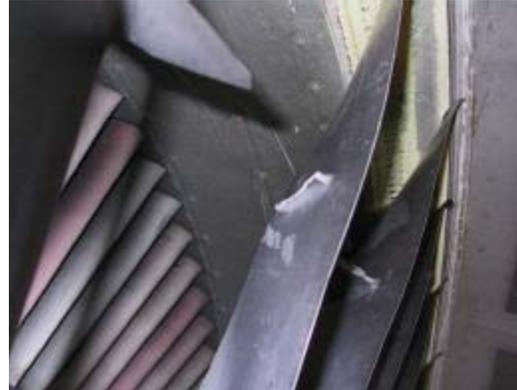
item had broken away under bending loads (figure 5). The blade diametrically opposite the fractured item had lost around 25 millimetres of material from the tip edge, with the associated fractures showing features typical of ductile shear and tearing (figure 6).

Fig. 5 (Top R). Breakage of the rear part-span shroud from the blade adjacent to the failed item.

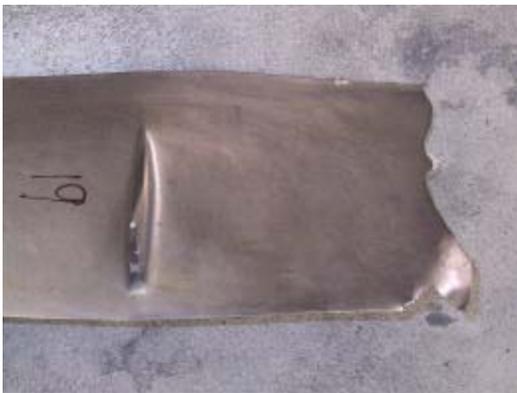
Fig. 6 (Left). Blade opposite to the failed item, showing the degree of metal loss from the tip.

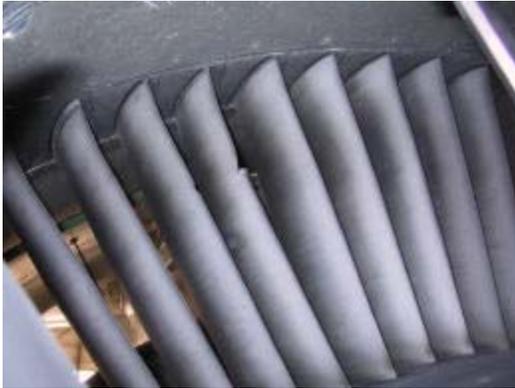
The inspection found no evidence of impact damage to the blade at or below the point of failure. Most other blades presented deformation of the tip edges and leading edge chipping, typical of debris impact. Several of the outlet guide vanes behind the fan also carried impact damage (figure 7) and a large section of the intake lining from behind the fan had lifted and folded up against the vane edges (figure 8). The attrition lining around the blade path showed severe wear and gouging for the full circumference and contained an angled impact mark immediately below the mounting point of the fan speed (N1) sensor (figure 9). The orientation of the impact mark matched the pitch angle of the blade aerofoil tip. Inspection on the outside of the fan case revealed a large outward bulge associated with the impact location, as well as damage to an adjacent wiring loom. The N1 sensor itself was not present – all mounting bolts had failed in overload and the cowling above the sensor position had a 50 x 100 millimetre hole punctured through to the outside (figure 10). Along the right side of the fan case, the strengthening rib had buckled slightly and showed deformation associated with the distortion of the fan case (figure 11). A vibration sensor from the low-pressure compressor assembly was recovered loose from within the right fan cowling, having broken away from the engine casing and wiring looms.

Fig. 7 Impact damage to the engine outlet guide vanes.

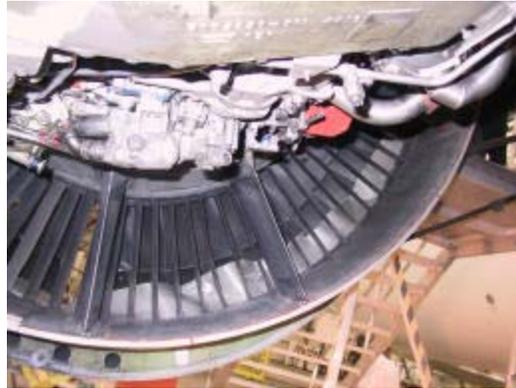
Fig. 8 Lifting of a section of the bypass duct lining in front of the outlet guide vanes.

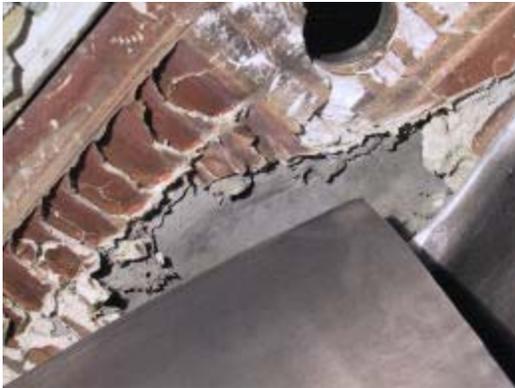
Fig. 9 (Top) Principal impact point of the failed blade on the fan case.

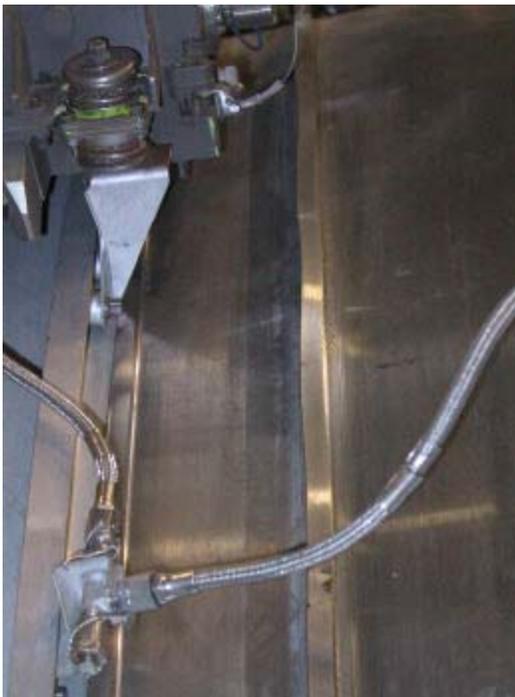
Fig. 11 (Bottom) Buckling and distortion of a fan case rib, below the impact point.

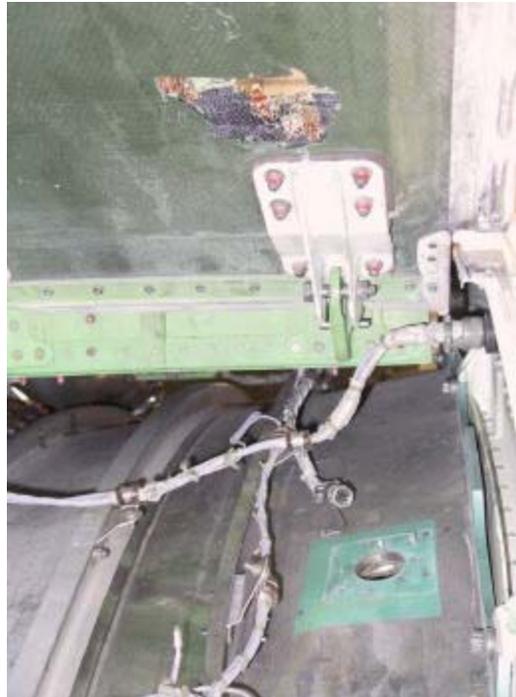
Fig. 10 (Top) N1 sensor location and the hole through the fan cowl panel immediately above.

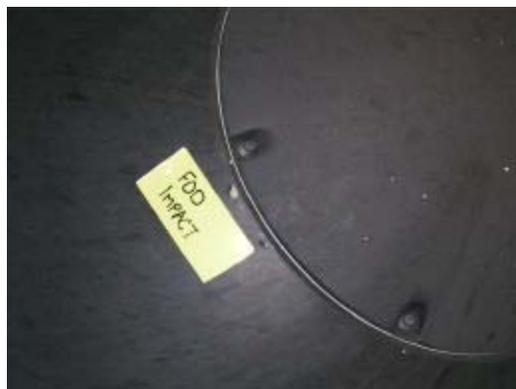
The composite spinner assembly showed a small (10mm x 10mm) chip adjacent to the spinner cap (figure 12). The appearance and localised nature of the chip was consistent with foreign object impact damage.

Fig. 12 (Bottom) Suspected foreign object impact point on the engine spinner.

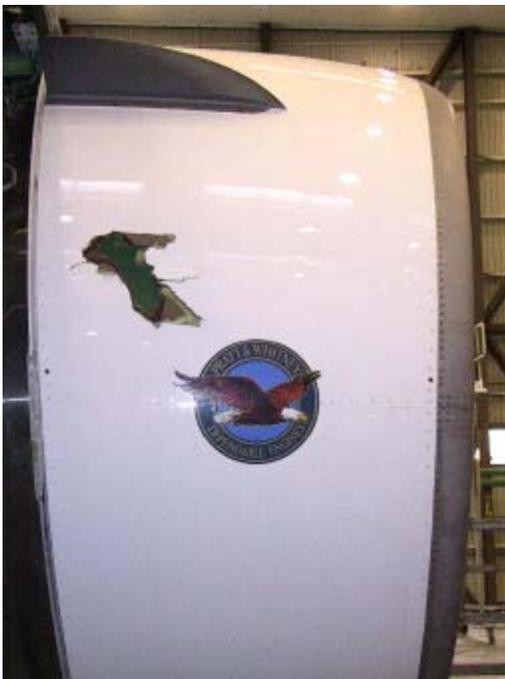
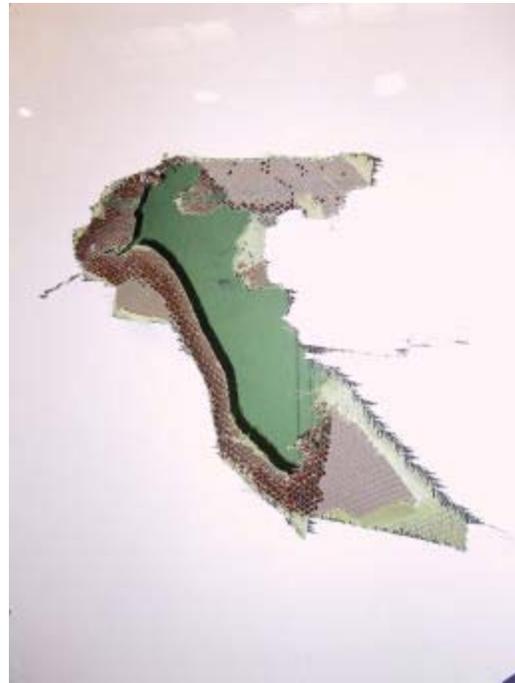
Externally, the nose-cowl of the JT9D engine contained a single large perforation near the three o'clock position (figures 13 & 14). Measuring approximately 300mm x 150mm and around 200mm forward of the edge of the fan case, the perforation represented the exit point of a large piece of debris (presumably the outer section of the fan blade) as it was liberated from the rotating assembly. The internal impact point was around the two-o'clock position and showed progressive crushing of the internal honeycomb structure as the debris (blade) impacted and then passed through the cowl wall with a tangential trajectory (figure 15). A repair panel adjacent to the upper section of the internal puncture also showed damage typical of a glancing impact with debris. Two other internal penetrations of the nose-cowl were evident at the five and six o'clock positions, however neither of these damaged areas extended through to the external surface.

Figs. 13 & 14 External perforation of the engine nose-cowl and damage to the composite outer skin.

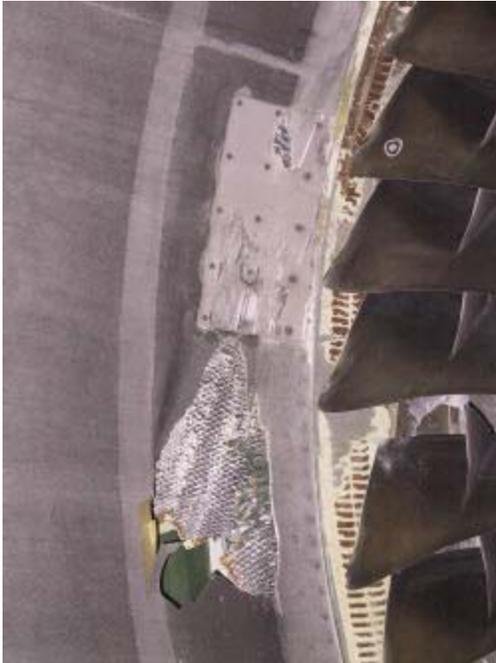
Fig. 15 Internal damage to the engine nose cowl, leading to the perforation shown in figures 13 & 14. Upper panel is a previous repair.

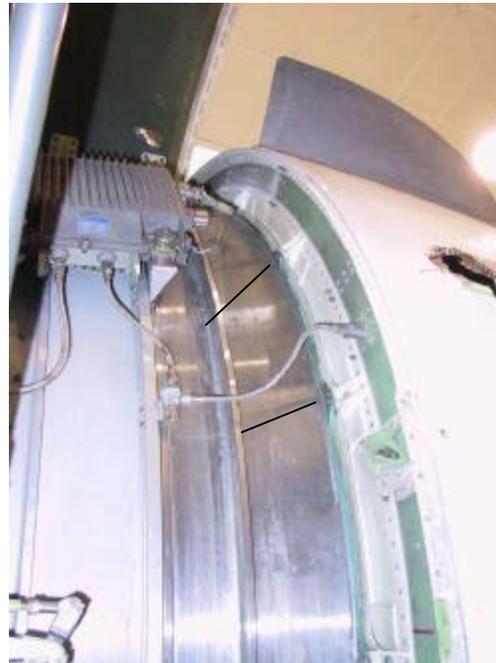
Fig. 16 Location of several nose cowl bolts fractured during the blade separation event.

Four nose-cowl lip bolts on the right side of the engine had fractured under radial shear loads (figure 16), with significant associated elongation of the fan case mounting holes and the adjoining cowl structure (figure 17). Several of the bolt heads and washers were recovered loose inside the fan-cowls, including two items that had forcefully embedded into the cowl inside surface (figure 18). Other damage to the fan-cowls included the 50 x 100 millimetre puncture above the N1 speed sensor position and a smaller 20 x 20 millimetre perforation at the 2 o'clock position, caused by another of the failed nose-cowl lip bolts (figure 19).

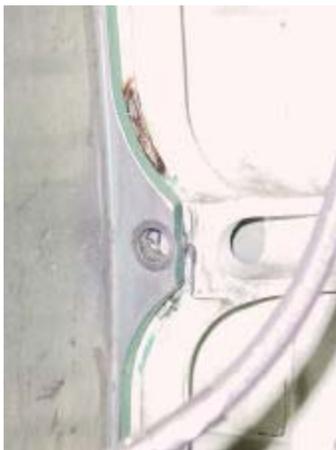
Fig. 17 Elongation of the nose cowl mounting flange bolt holes.

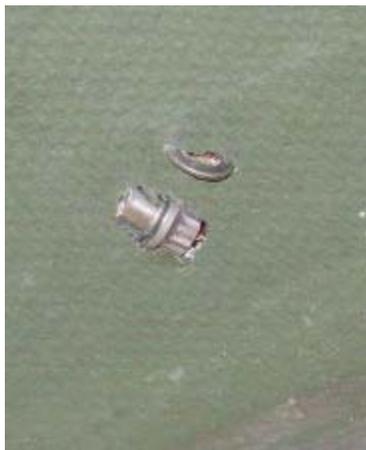
Fig. 18 Nose cowl bolt head and washer embedded into the underside of the right fan cowl.

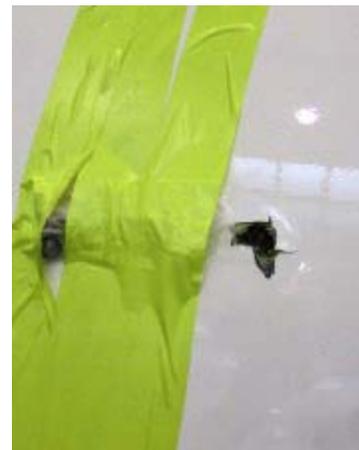
Fig. 19 Small puncture in the right fan cowl caused by a fractured nose cowl bolt head.

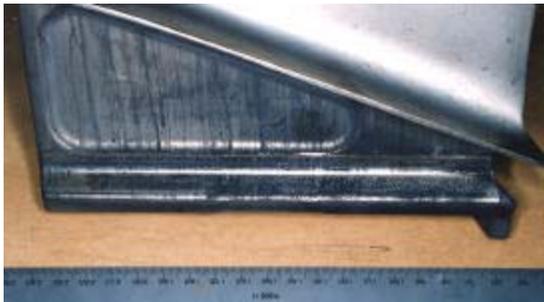
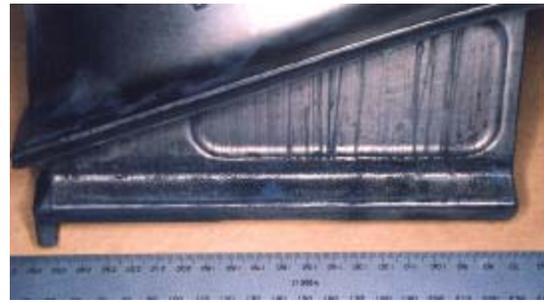
Figs. 20 & 21 (Top) Blade dove-tail root surfaces – free from significant galling and fretting damage and showing remnant dry lubricant.

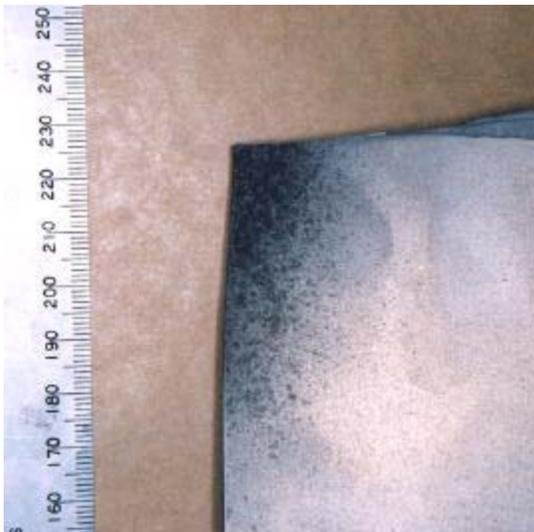
Measurement of the failed blade's chord width at the point of failure (181.14mm) found it to be below the minimum specified dimension (182.12mm) for the particular distance above the root (z-plane) at which the fracture had occurred (288mm)^[1]. This was attributed to an area of localised material removal from a previous trailing edge blending operation (figure 22).

Fig. 22 (Left) Trailing edge of the failed blade around the point of fracture initiation. Note the thinning of the section width attributed to a prior blending operation.

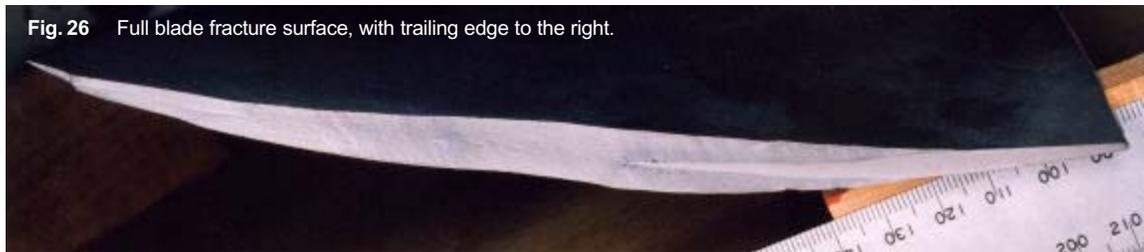
As evident during the general inspection, the failed blade had fractured through the aerofoil section, approximately 280mm / 190mm above the blade root platform at the leading and trailing edges. The fracture presented two characteristic zones – a flat region of progressive fatigue cracking extending for 85 millimetres from the trailing edge, and an angular ductile shear fracture (typical of tensile overload) for the remainder of the section (figure 26 & 27).

Fig. 26 Full blade fracture surface, with trailing edge to the right.

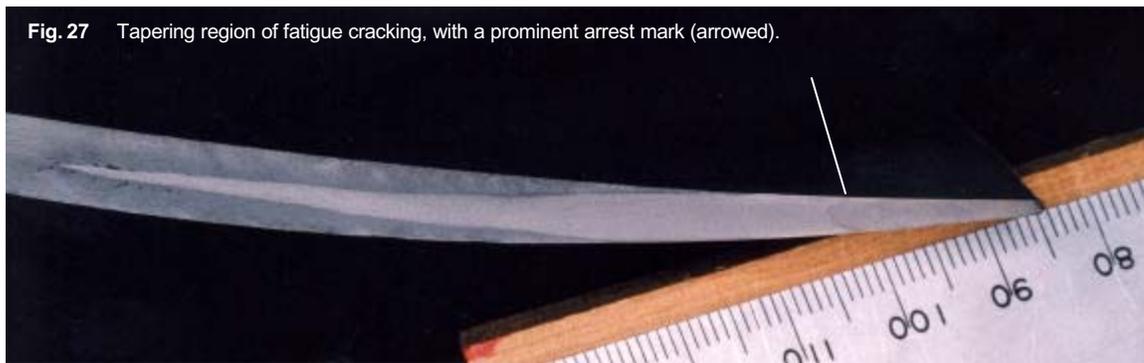
Fig. 27 Tapering region of fatigue cracking, with a prominent arrest mark (arrowed).

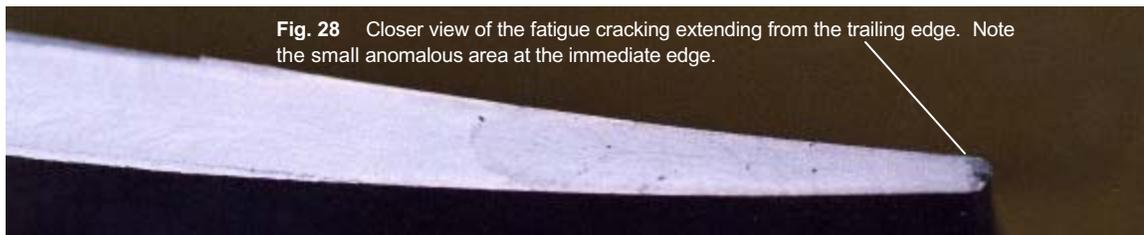
Fig. 28 Closer view of the fatigue cracking extending from the trailing edge. Note the small anomalous area at the immediate edge.

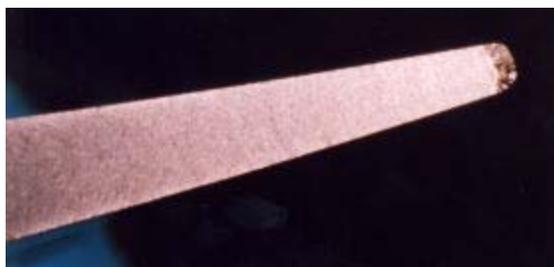
Fig. 29 (Above) Low-magnification view of the early stages of the fatigue cracking – vague arrest marks evident radiating out from the blade edge.

Low-power stereomicroscopic examination of the fatigued region found approximately eight to fifteen arrest lines between the trailing edge and the ductile shear transition. The definition and spacing of the marks generally increased with distance from the trailing edge, with the majority being present within the first fifteen millimetres of cracking. The most prominent arrest mark was found at a distance of 28 millimetres from the trailing edge (figure 28). All arrest marks and general fracture morphology indicated fatigue crack initiation from the immediate trailing edge of the blade. At elevated magnifications, an isolated region was identified at that point and extended to a depth of 0.62 millimetres (figures 29 & 30). The region showed a clear transition to the area of fatigue cracking and also showed evidence of elevated temperature oxidation (heat tinting).

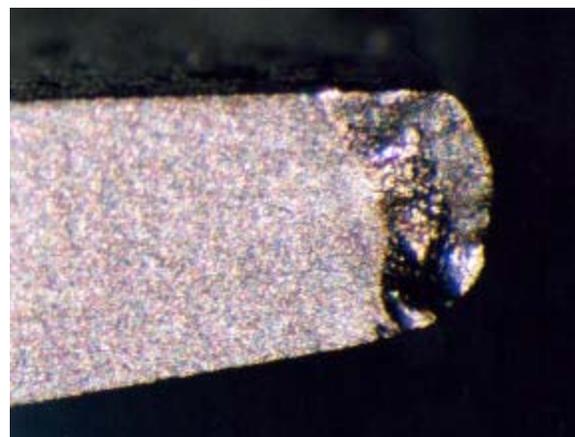
Fig. 30 (Right) Defect at the blade edge, showing tinting consistent with elevated temperature exposure.

The physical characteristics of the initiation site identified it as a crack-like feature formed under localised tensile loads. 'Heat-tinting' (oxidation) of the defect surfaces indicated their exposure to elevated temperatures associated with the aerofoil straightening procedures that were carried out twice during the life of the blade. As such it was evident that the defect existed before, or was formed during the straightening procedures. Routine non-destructive procedures carried out following the blade re-work had failed to detect the presence of the trailing edge defect before the blade was re-introduced into service within engine P716610.

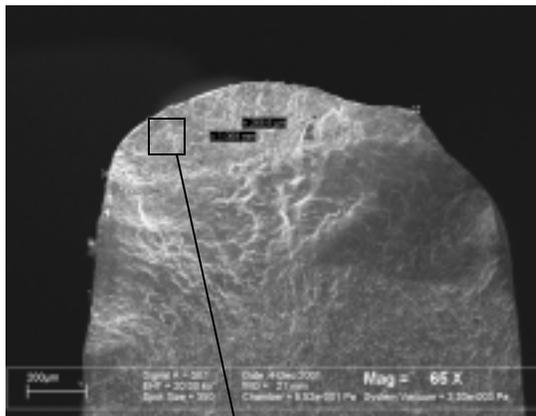
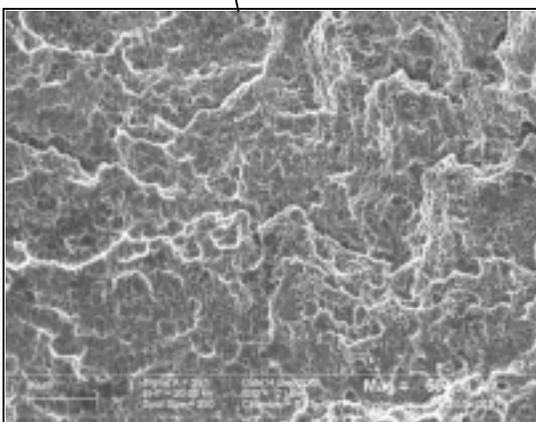
Scanning electron microscopy of the trailing edge fatigue origin identified two sub-regions with distinctly different morphologies (figures 31 & 32). The outermost zone (depth of 260µm) presented an irregular, dimpled surface - characteristic of ductile tensile overload failure (figure 33). Beneath this area was a 350µm deep zone of rubbed, smeared surface (figure 34). Neither of the regions showed any evidence of material defects or the influence of external (foreign object) damage. Both regions also showed light surface oxidation, consistent with the heat tinting observed visually. Electron imaging of the trailing edge leading up to the fracture showed no signs of impact damage or other discontinuities that could have been associated with the initiation of fatigue cracking (figure 35).

Figs 31 & 33 (Above) Dimensions and morphology of the outer region of the edge defect. Features typical of ductile tensile fracture.

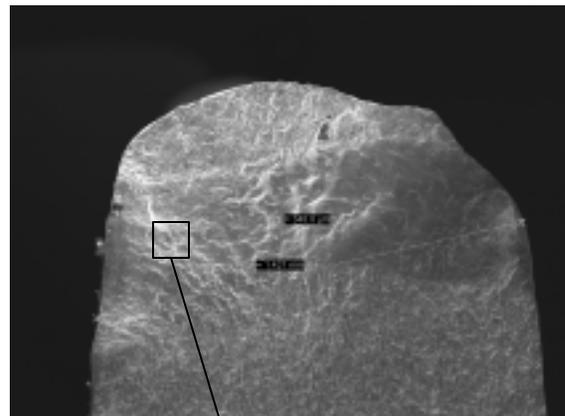
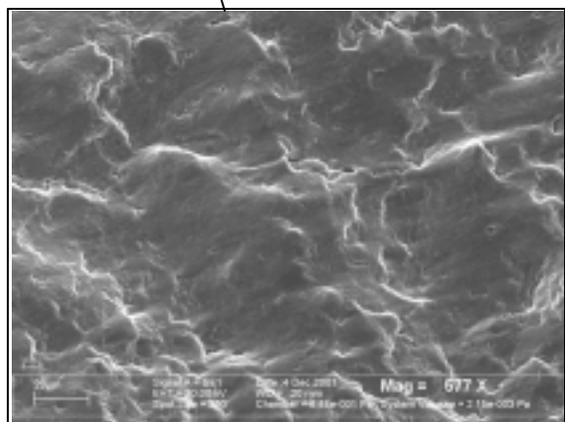
Figs 32 & 34 (Above) Dimensions and morphology of the inner region of the edge defect. Typically rubbed and flowed surfaces.

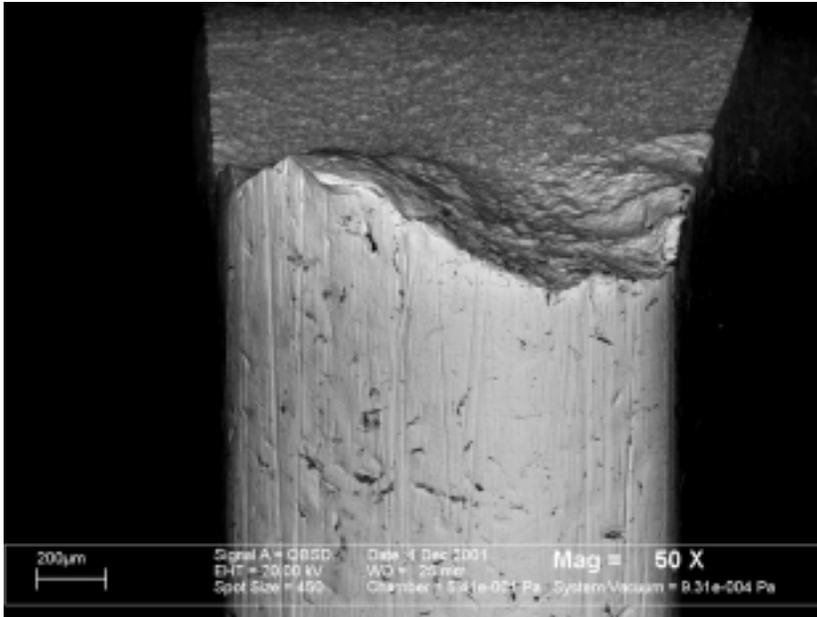
Fig. 35 Electron image of the blade trailing edge at the fatigue origin. The area was completely absent of any indications of mechanical or impact (foreign object) damage.

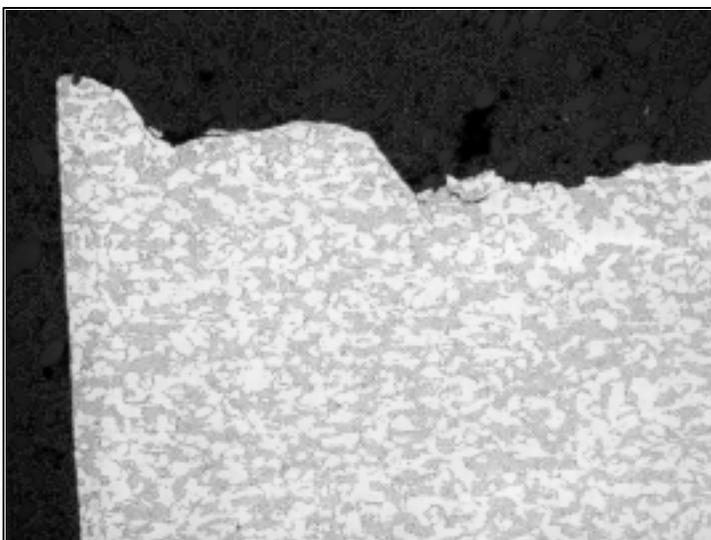
At no location along or beneath the fracture profile at the fatigue origin did the blade material exhibit any microstructural anomaly or other metallurgical feature that could have contributed to the initiation of fatigue cracking (figure 36). Cracking was predominantly transgranular and showed little evidence of branching. The material microstructure was typical of a forged and heat-treated Ti6Al4V material, showing preferentially oriented α grains in a fine α - β matrix. The structure was uniform throughout the sample examined.

Fig. 36 Metallographic cross-section taken through the fatigue origin. The microstructure was typical of the blade material and the origin area completely free of any inclusions, anomalous structures or other material-related defects. Kroll's reagent etch. Magnification X140
