MARINE SAFETY INVESTIGATION
REPORT 164

Independent investigation into the lifeboat
incident on board the Maltese flag bulk carrier

Alianthos

at Geelong, Victoria
on 24 January 2001

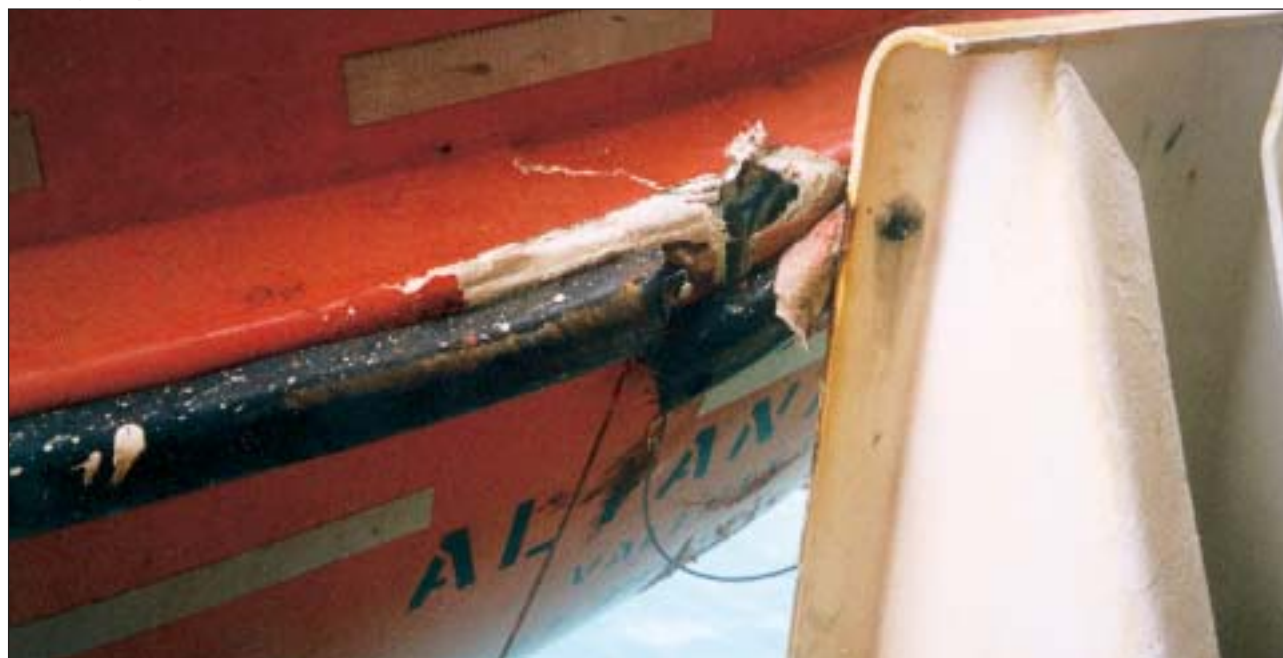
FIGURE 6:
Damage to port lifeboat

The port lifeboat and davit were both damaged as a result of the after fall being released. The damage to the port lifeboat consisted of a small hole and several cracks on the rubbing strake on the starboard side where the canopy joins the hull (figure 6). The rubber fender was also damaged in way of the hole. The damage was consistent with the boat making hard contact with the side of the ship as a result of the after fall releasing and the subsequent failure of the forward davit cradle.

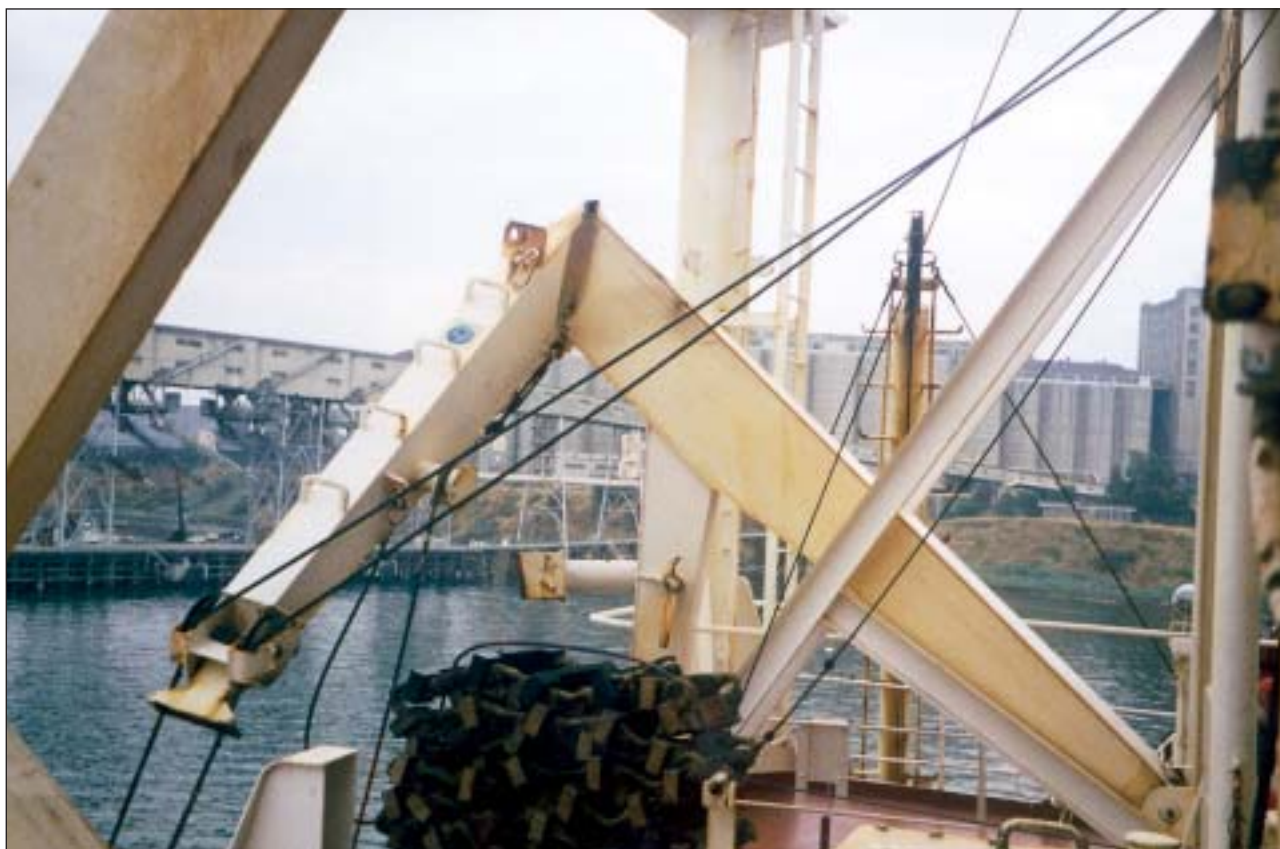
FIGURE 7:
Damage to port lifeboat davit

Damage to the port lifeboat davit was extensive (figure 7). The forward cradle was severely damaged and bent down and aft at approximately 90°, halfway along its length. The davit frame supporting the forward cradle was twisted approximately 5° in the same direction (aft). From the damage it was apparent that the davit had experienced a large load mostly in a vertical plane but with a lateral component directed aft. The damage was consistent with the effect of the large dynamic loading of the swinging lifeboat when the after fall released.

2. The forward davit cradle failed as a result of the sudden increase of load, applied dynamically, when the whole weight of the lifeboat was suspended suddenly from the forward fall.

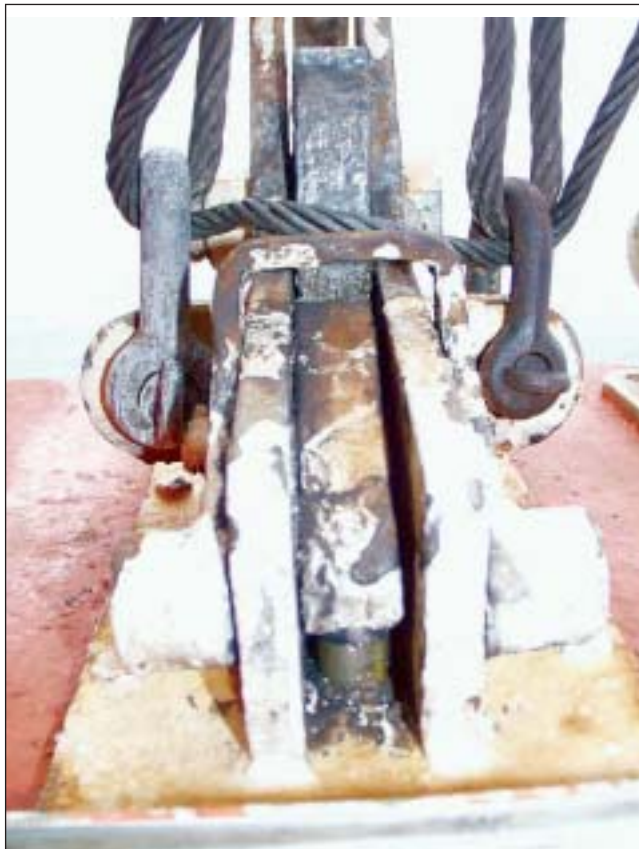
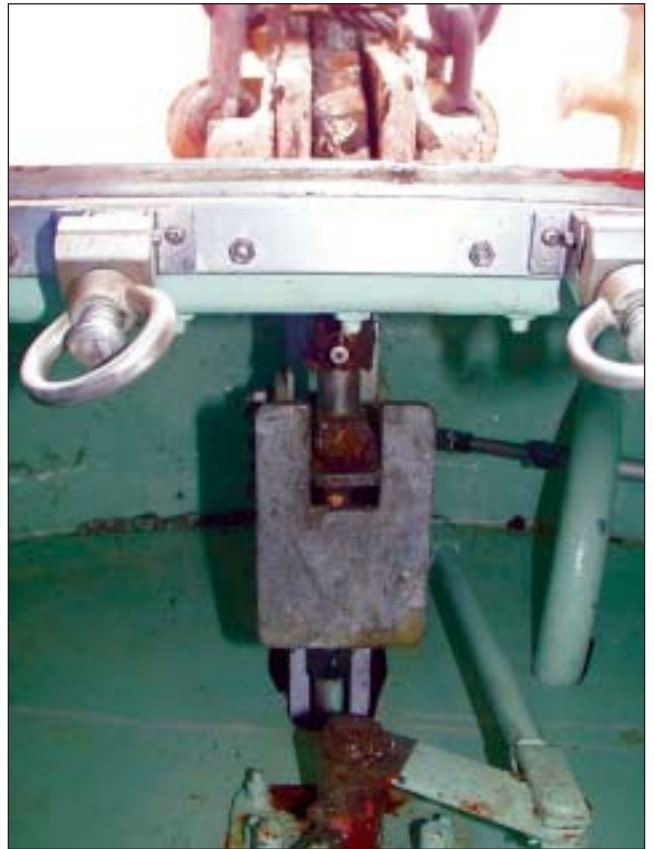
FIGURE 8:
After hook as found

The after hook was found to be in a tripped, or open, condition (figure 8). The hook locking mechanism was in a partially reset position indicated by the position of the cam plate on the no.3 hook bearer (refer to figure 3). The link stopper on the hook was undamaged with no witness marks to suggest that the suspension ring may have been forced past the stopper and off the hook. The disposition and condition of the various components of the after hook

Various measurements were taken of the forward and aft hook mechanisms. Initially the distance between the bottom of the no.2 hook bearer and the bottom of the slot in the adjacent bracket ('A' on figure 3) was measured to reveal: 30 mm for the forward hook, 18 mm for the after hook. As a reference for this measurement, the distance between the point of contact between the no.1 and no.2 hook bearers and the hook base plate ('B') was also measured

to reveal: 45 mm for the forward hook and 35 mm for the after hook. According to these measurements the forward hook's no.2 hook bearer was 10 mm higher (more reset) than the after hook.

The travel of each teleflex cable (indicated by the grease marks on the rods attached to the no.3 hook bearer, ('C') was measured: forward hook 72 mm, after hook 35 mm. These measurements indicate that the teleflex cable operating the forward hook mechanism was extended 37 mm more in the resetting direction than the after hook.

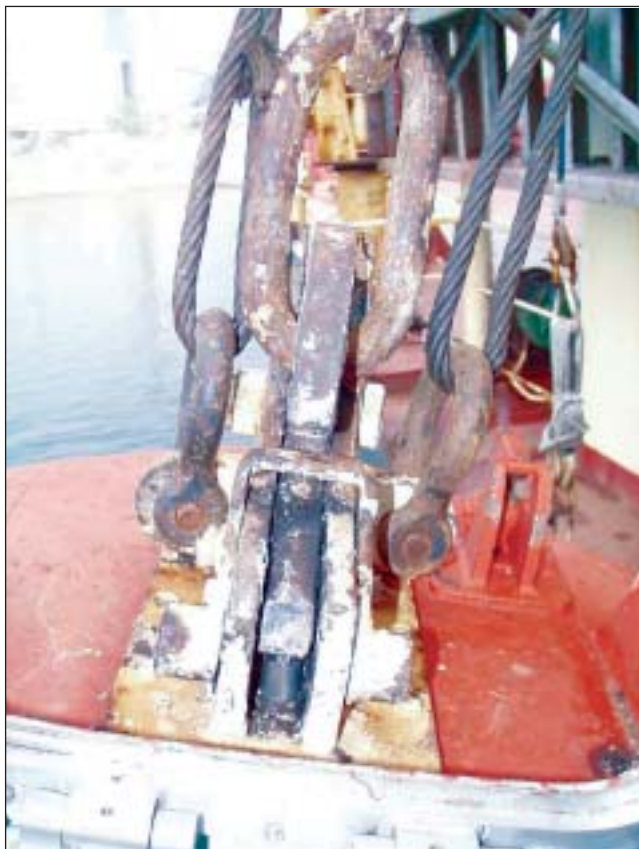
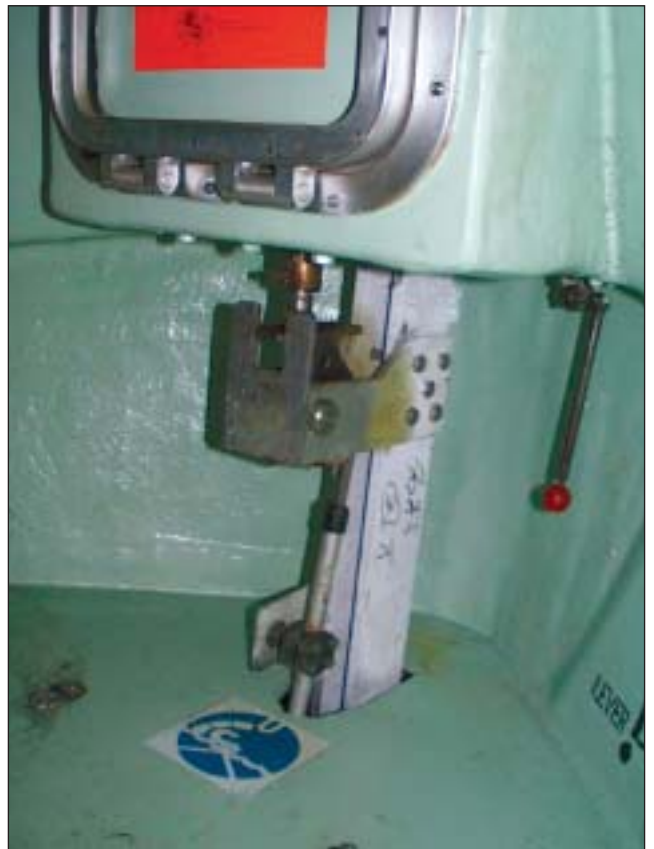
FIGURE 9:
Forward hook as found

The forward hook was found to be in an untripped, or closed, condition. Its locking mechanism was also found to be in a partially reset position, indicated by the position of the cam plate on its no.3 hook bearer but closer to the fully reset position than was the after hook mechanism (figure 9).

The cable system operating the forward hook was also inspected. There was no significant lost motion found in the system. It appeared that the forward hook was not moving to a fully reset position as a result of incorrect adjustment of the turnbuckle.

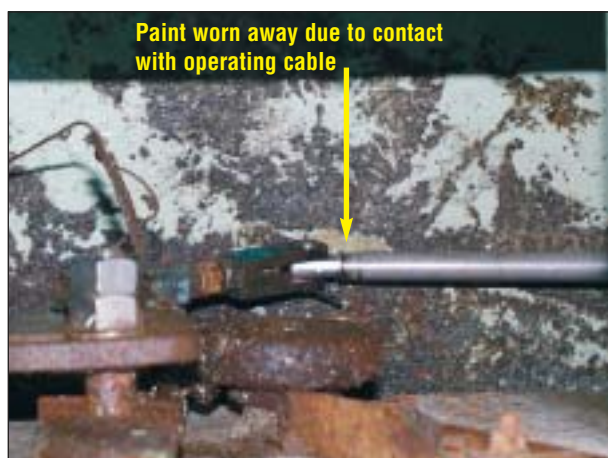
FIGURE 10:
After hook operating cable system

Closer examination of the operating unit mechanism and the after hook mechanism revealed that there appeared to be some lost motion in the operating cable connecting the two. To allow an inspection of the cable system operating the after hook, the screws securing the footplate under the operating mechanism were removed and the footplate lifted.

With the after operating cable system exposed, the operating lever was actuated several more times. When the operating lever was moved to reset the hooks the end of the teleflex cable was deflecting downward, so that the turnbuckle clevis attaching it to the operating lever was making contact with the bottom of the boat. Thus, each time the operating lever was moved to reset the after hook, instead of sliding the rod longitudinally inside the outer sheath of the teleflex cable, the end of the cable was being forced down in a 'bend' to touch the bottom of the boat. The motion lost as a result of this deflection was at least 60 mm in the resetting direction. Where the clevis attached to the end of the teleflex cable had been making contact with the bottom of the boat the paint had been worn away (figure 10). This indicated that the after hook operating cable had been deflecting in this fashion for a lengthy period of time.

The rod on the teleflex cable at the operating mechanism end was dry indicating a lack of lubrication. The swivel bracket securing the end of the teleflex cable to the side of the engine casing, although securely fastened to both the cable and the casing, was worn enough to allow the end of the cable to swing relatively freely. The after hook could only be fully reset by manually supporting the operating cable, at the union between the end of the rod and the turnbuckle, to prevent it deflecting when the operating lever was actuated. When resetting the after hook in this fashion, a higher than normal force was required to move the resetting lever the last portion of its throw. This stiffness in the system was apparently due to some binding within the teleflex cables.

Alianthos had been in service for about 12 years with no evidence that the lifeboat teleflex cables had ever been replaced. Over this period of time, the cables had become progressively stiffer. In the case of the after hook in the port lifeboat, as the cable stiffness increased, the swivel mounting on the cable clamp adjacent to the operating mechanism would have been required to react with progressively more force in both the tripping and resetting operations. Eventually the swivel mount on the clamp had worn to the point where it was not maintaining the alignment of the cable end with the operating quadrant. Once there was sufficient misalignment the end of the cable was relatively free to deflect during each resetting operation, pivoting about the clevis pins in the turnbuckle. With both turnbuckle clevises aligned, there was an easy degree of freedom for the cable end to deflect in the vertical plane, in this case downwards, until it was in contact with the bottom of the boat.

1. Owners and operators of ships carrying Shigi lifeboats fitted with SZK-5 on load release systems should seriously consider retrospectively fitting hydrostatic interlocks.
2. Indicators be fitted on Shigi lifeboats to clearly show crew when the on-load release hook mechanisms are fully reset.
3. Regular programmed planned maintenance and inspection of lifeboat on-load release systems by specifically trained and qualified personnel should be instigated.
