MARINE SAFETY INVESTIGATION

REPORT 173

Independent investigation into the lifeboat
accident and injury to crew aboard the
Panama flag bulk carrier

Cape Kestrel

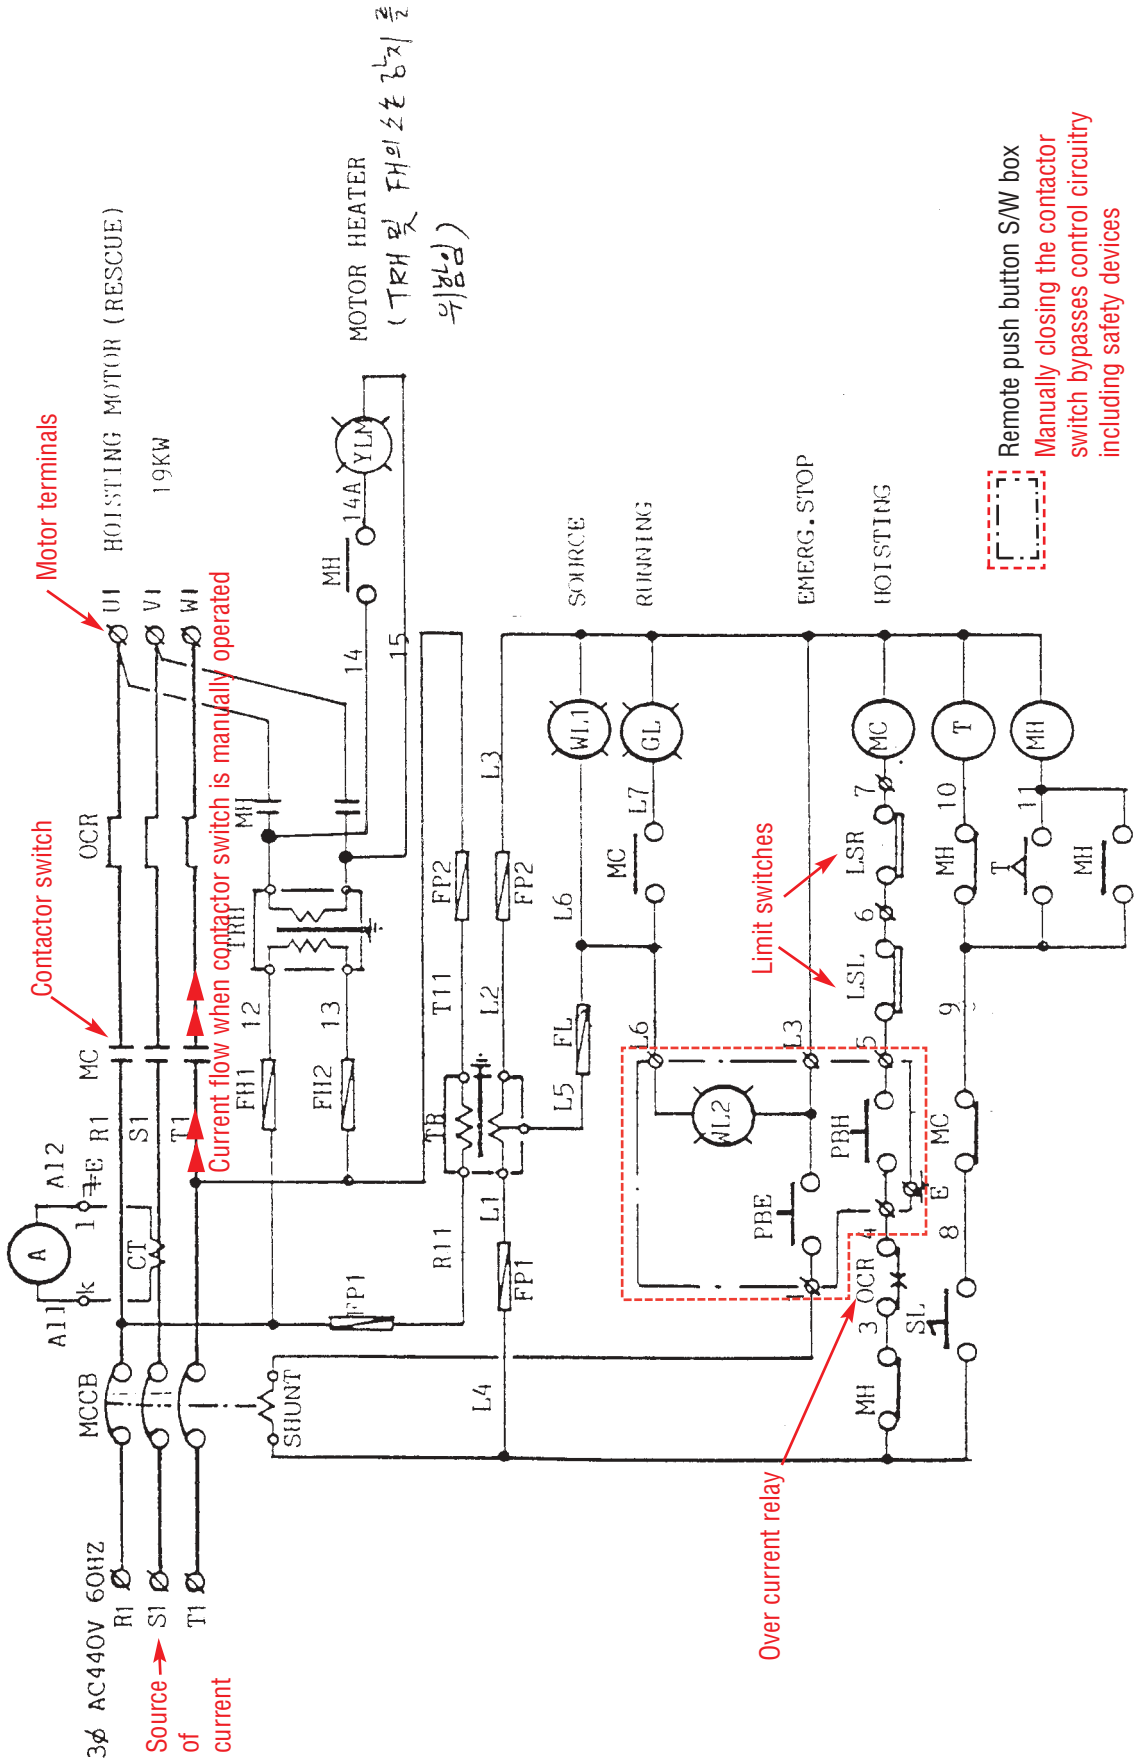
FIGURE 6:
Control circuit for rescue boat winch

The first engineer seemed unaware that operating the winch with the motor contactor meant that all the electrical safety interlocks, which were provided to prevent damage to the davits and the boats, had been bypassed. The chief engineer, who was aware of the manner in which the boat was being hoisted, should have warned the first engineer that hoisting of the boat should have been stopped before the limit switches were contacted.

1. Warning notices should be posted at the starter box for all lifeboat winches drawing attention to the hazard of operating the winch with the contactor, particularly if there are personnel in the boat.

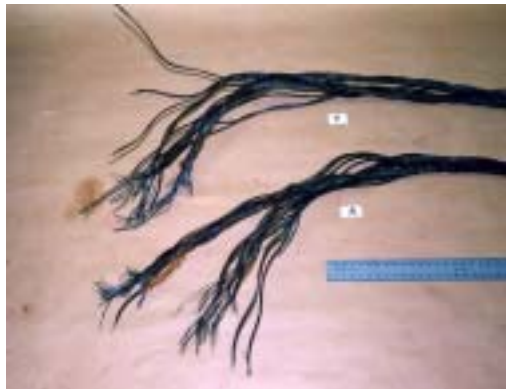
Figure 6 shows the fractured ends from the forward (F) and aft (A) davit wires. Both showed the unravelling of the outer strands for around 30 centimetres back from the point of failure, exposing the inner strands which typically splayed outward for only 5 centimetres (figure 7). Each of the eighteen fractured rope strands was examined individually at low magnification. In all cases, the wire elements showed evidence of localised plastic deformation or ‘necking’ of the material at the point of fracture. This was most evident on the core wire of each strand (figure 8), however the corroded outer wires also showed the effect (figure 9). Localised reduction of area (necking) at the point of fracture is a characteristic indication of tensile overload in ductile materials.

Figure 6. Forward and aft davit ropes at the point of failure. Note the splaying of the outer strands.

From the examinations conducted and reported herein, it was apparent that both the forward and aft lifeboat davit ropes had failed under tensile overloading conditions. The characteristic ‘necking’ or reduction in area visible on most wire elements was typical of this mechanism.

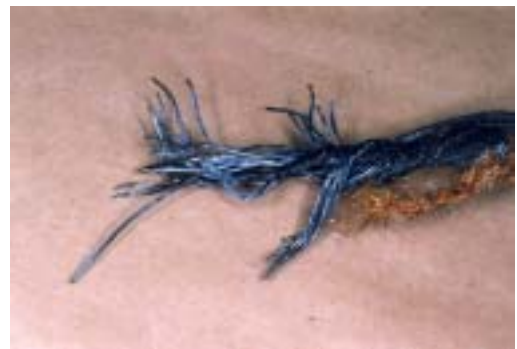
Figure 7. Inner wire strands at the point of failure.

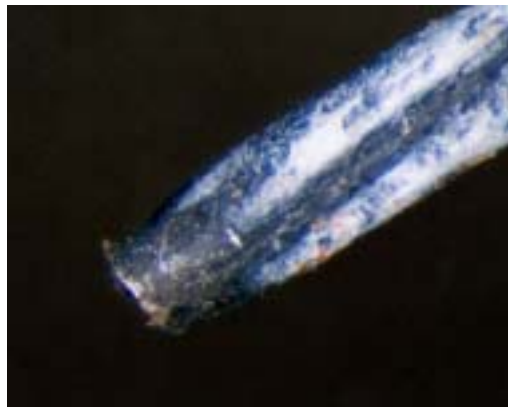
Figure 8. Ductile 'necking' of a strand core wire. Classic cup-cone style tensile fracture.

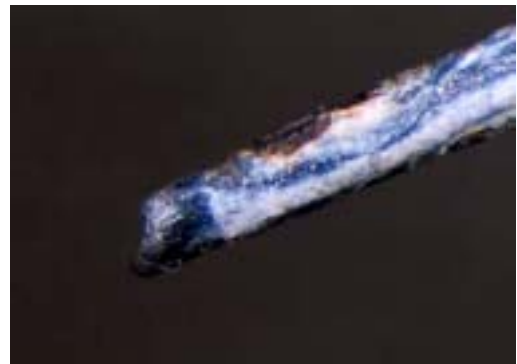
Figure 9. Strand outer wire also showing localised necking.

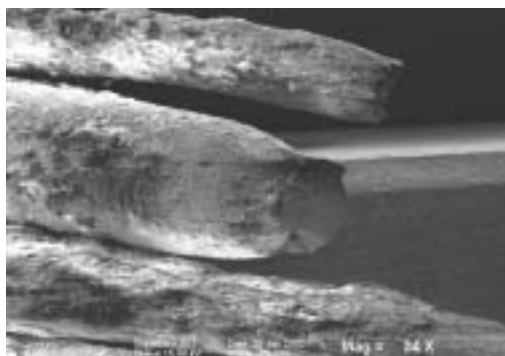
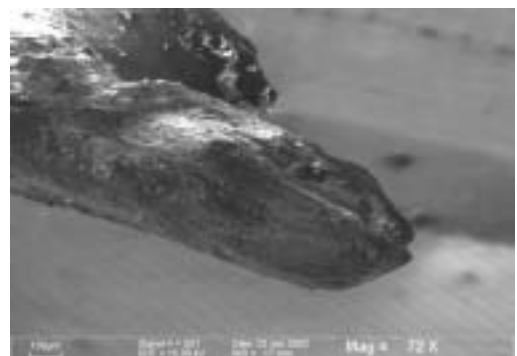
Samples of failed wires from both davit ropes were examined using the scanning electron microscope. This study confirmed the visual observations relating to the ductile tensile overload failure of the wires (figures 10 & 11).
