MARINE SAFETY INVESTIGATION
No. 188

Independent investigation into the lifeboat incident
on board the Hong Kong flag bulk carrier

Ma Cho

at Devonport, Tasmania
9 December 2002

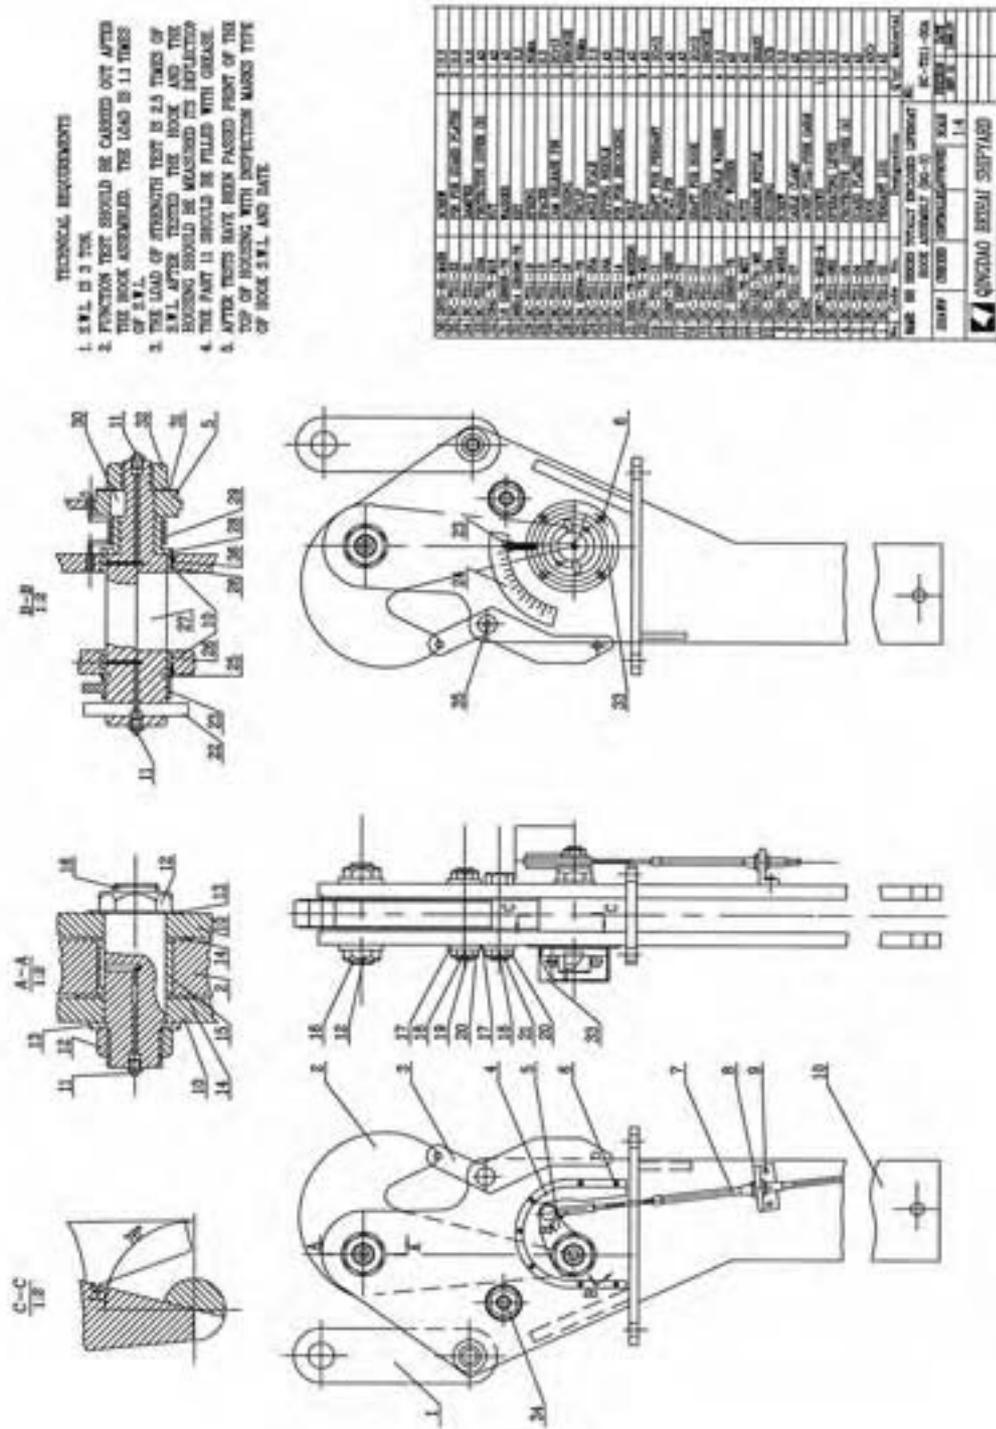
FIGURE 3:
Hook mechanism

Each hook is held closed by a cam release pin, which bears on the tail of the hook. The tripping motion transmitted by the operating cables to each hook mechanism, rotates the cam release pin, via the operating lever (a bell-crank keyed onto the cam release pin shaft), until the tail of each hook clears the cam. The hooks are then free to rotate open and release the suspension rings (long links) attached to each davit fall.

The hook units were inspected initially to ascertain the state of the system. Both hooks were found to be indicating fully reset. Inspection of the locking cams (visible between the side plates of the hook unit) confirmed that the indicators were correct. The metal covers on both sides of both hook units were removed to allow the cam release pin drives and indicator drives to be inspected. All of the main components of both hook units were found to be fully operable. There was no evidence to suggest that the incident was the result of a failure of any component in the aft hook unit mechanism.

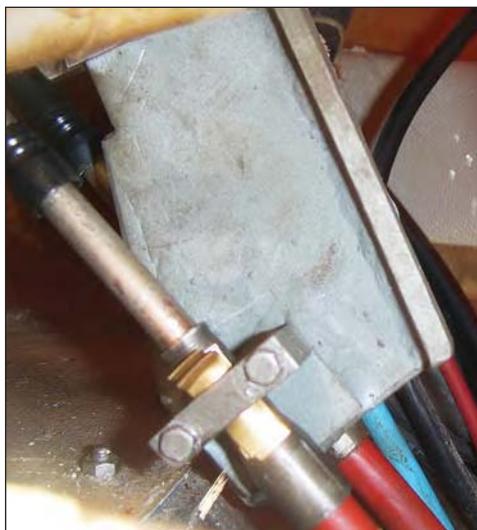
a. Operating mechanism end

The teleflex cables are fixed at each end adjacent to the operating and hook mechanisms. The securing arrangement adjacent to the operating mechanism consists of a saddle clamp fitted over the metal ferrule at the end of the outer sheath of the cable and secured by two bolts (figure 4a). Adjacent to the hook, the steel ferrule on the outer sheath of each cable is threaded and this section is secured by locking nuts in a metal bracket fixed to the keel stay (figure 4b).

When the lifeboat was lowered to the water in Devonport after the incident, the second engineer examined the on-load release system and correctly identified why the after hook had opened inadvertently under load. After opening the enclosure under the coxswain's console, he found that the operating cable for the after hook was sliding inside the clamp beneath the operating mechanism (figure 4a) causing lost motion each time the mechanism was actuated. Rather than moving the inner cable inside the outer sheath, the outer sheath was sliding through the clamp for a part of the resetting movement. When he removed the outer saddle on the cable clamp he found that it had been modified sometime in the past. The semi circular ridge on the clamp, which is designed to mate with a groove on the operating cable's metal ferrule, had been removed, apparently with a file. He found that even when the bolts securing the outer saddle were tight, the operating cable was still sliding inside the clamp. This led to the temporary fitting of the brass shim material under the outer saddle to increase the clamping pressure on the cable.

The relative movement between the aft hook operating cable and the clamp adjacent to the operating mechanism compromised the on-load release system in two ways. The loose clamp resulted in lost motion in the operating cable, which meant that the hook could not be fully reset. In addition, any opening force resulting from the load on hook could not be effectively opposed by the operating mechanism. In a partially reset condition, the loaded after hook mechanism would have been subject to greatly increased opening forces which could not be transmitted to, and reacted by, the locked operating mechanism. A force high enough to overcome the friction in the hook mechanism and operating cable would cause the hook to open.

The ill conceived modification made, at some time in the past, to the outer saddle of the after operating cable clamp was directly causal in the incident. Had the cable clamp been corrected fitted, the operating cable's outer sheath would have been securely fixed with respect to the operating mechanism and the system would have performed as designed.

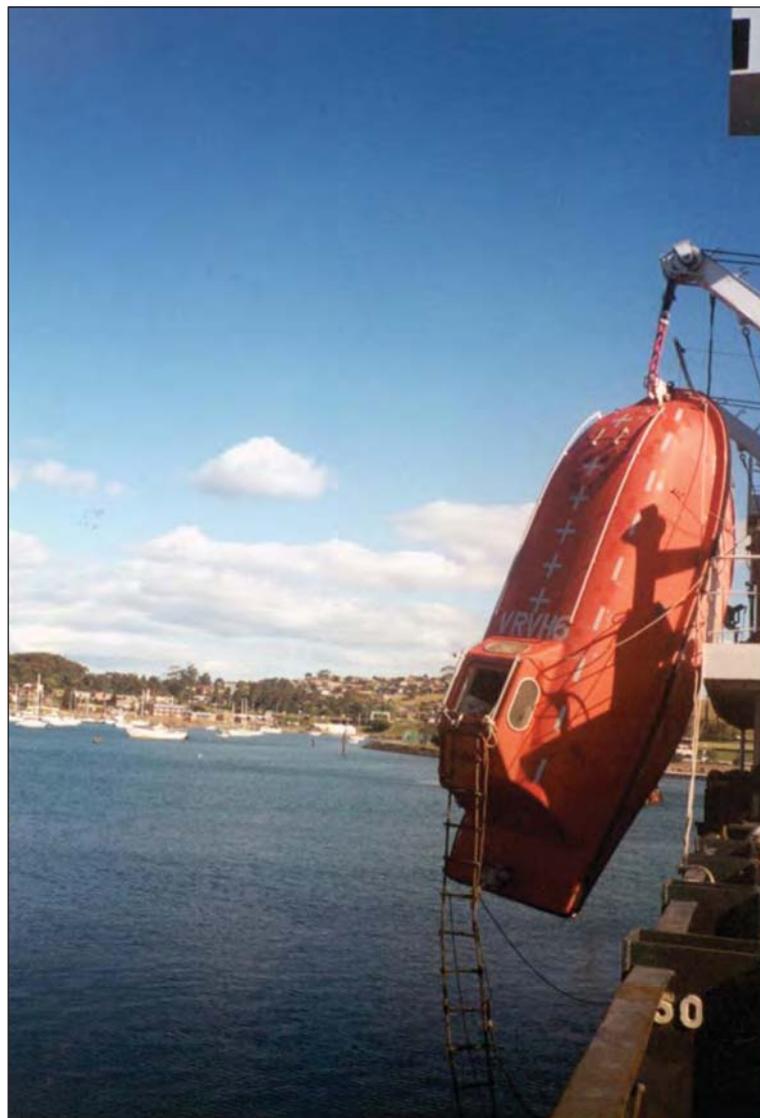
FIGURE 5:
***Ma Cho's* starboard lifeboat after the incident**

of the crew operating the davit winch brake from the deck. When the boat had been lowered approximately two metres from the davit head, the after on-load release hook suddenly opened, releasing the after fall. The lifeboat's stern fell to leave the boat suspended vertically by the remaining, forward, fall its stern swinging approximately five metres above the water. The forward fall and hook continued to hold the weight of the lifeboat although the heavy steel fall suspension ring had been bent during the boat's fall. The crew inside the boat were shaken by the incident but remained secured in their seats inside the now vertical lifeboat. The second mate had sustained a small cut over his left eye.

After checking on the condition of the crew inside the boat, the master contacted Devonport harbour authority to inform them of the situation. He was told that the pilot boat was busy and would take 20 minutes, or so, to reach the ship. The master decided not to wait for the pilot boat and instructed the crew to rig a ladder from the handrails adjacent to the lifeboat's upper hatch. When the ladder had been satisfactorily rigged, the crew exited the vertically suspended lifeboat, one at a time, until they were all safely back on the deck of the ship (figure 5).

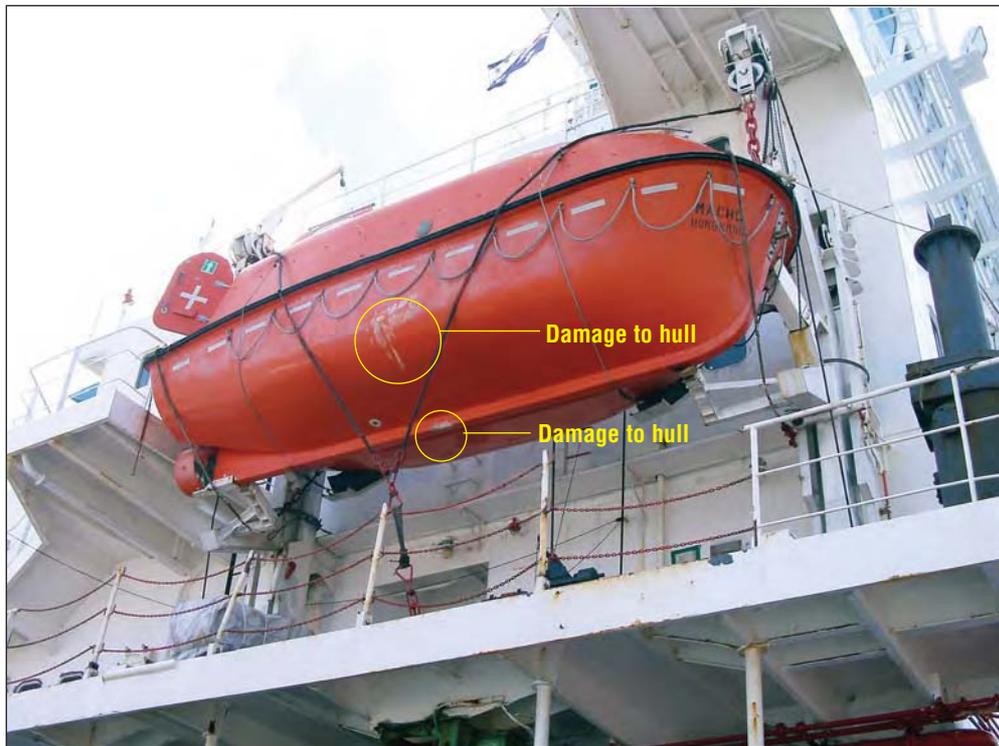
FIGURE 6:
Damage to starboard lifeboat

The damage to *Ma Cho*'s starboard lifeboat was minor and consisted of:

- some scratches on the starboard side of the hull (figure 7)
- a small area of damage on the keel (figure 7)
- some damage to the port side of the stern boarding platform
- some cracking in the fibreglass at the join between the hull and canopy around the forward hook keel stay bar
- distortion of the forward fall suspension ring.

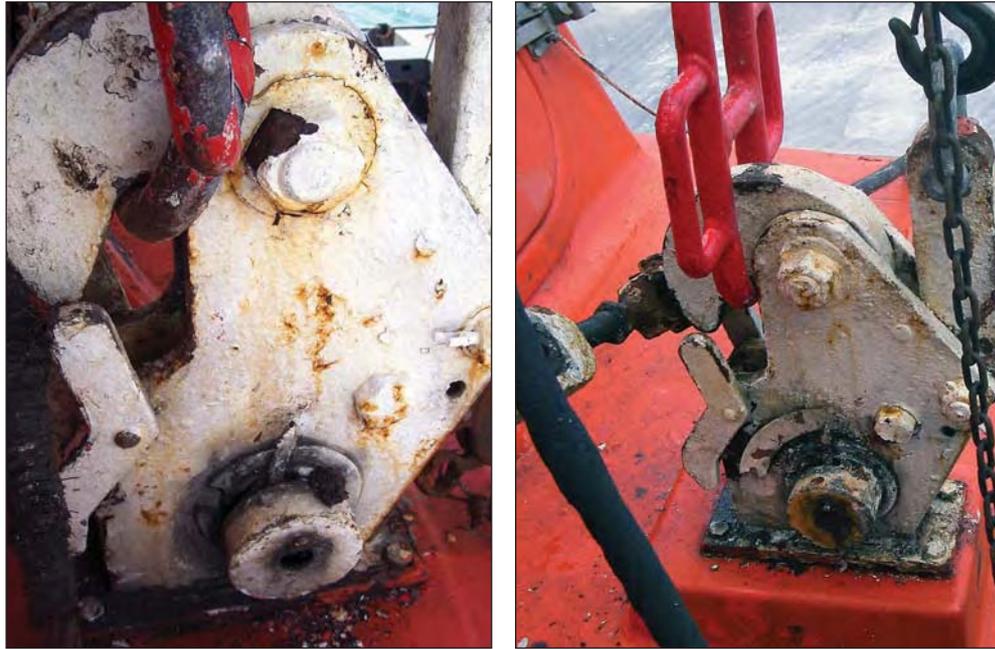
FIGURE 7:
Forward and aft hooks

In general the on-load release system showed surface corrosion and flaking paint on all external components. The cover for the hydrostatic interlock emergency bypass button, on top of the operating unit, was also missing. Given the age of the vessel (approximately six years) the condition of the lifeboat's on-load release equipment was poor which indicated a lack of regular maintenance, apart from greasing (figure 7).

The full-scale deflection of each hook indicator is 76 degrees, which coincides with the angular rotation of the cam release pin. For the hook to be fully reset, the cam release pin (and thus the indicator) must be rotated through this angle to leave the flat face of the cam release pin in linear contact with the tail of the hook. It is possible that a small change in the final 'reset' position of the aft hook indicator may not have prompted remedial action by the crew because it had been occurring over a period of time and had been accepted as the 'normal' position. In addition, the indicator scale on the aft hook had been painted over (figure 7) and thus there was no readily visible marking to indicate the fully reset position. These factors may account for the master's perception that the after hook appeared to be fully reset immediately prior to the incident.

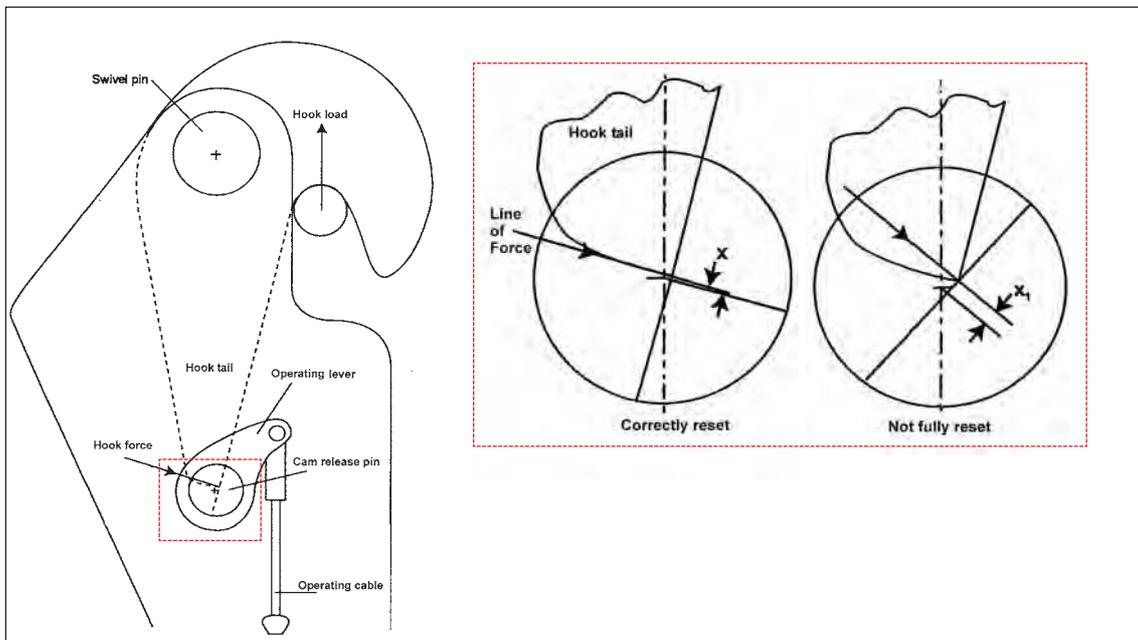
FIGURE 8:
Diagram of hook mechanism

It can be seen from the diagrams that when the hook mechanism is in the fully reset position the force transmitted to the face of the cam release pin by the tail of the hook acts on a relatively small effective moment arm X. This produces a relatively small hook opening force which is transmitted to the operating mechanism via the operating lever and operating cable. The spring and friction forces in the hook

mechanism and operating cable and the operating mechanism (which is locked) oppose this opening force. A loss of motion in the operating cable will result in the release cam face at an angle to the hook tail ie. not fully reset. This substantially increases the turning moment on the cam and thus the opening force, by increasing the moment arm length from X to X1.

In service, the tail of the hook wears at the point of contact with the release cam face, particularly if the hook is released under load. Such wear has the effect of increasing the effective length of the moment arm as does wear on the swivel pin and bush. This normal wear, in combination with a relatively small loss of motion in the operating cable, will dramatically increase the opening force which must be opposed by the operating mechanism and by the operating cable and hook mechanism friction/spring forces. In the case of the *Ma Cho's* after hook, the loose cable clamp meant that the opening force could not be effectively transmitted to the operating mechanism. This resulted in the hook opening when the load became high enough to produce an opening force greater than the opposing forces in the operating cable and hook mechanisms.

Given its increased susceptibility to accidental release when subject to 'normal' in-service wear and the history of incidents on similar designs, it is doubtful if *Ma Cho's* hook locking mechanism can be considered to be safe.

It is recommended that Qingdao Beihai Shipyard review the design of their BG-3 on-load release system in respect of the hook locking mechanism in light of the incident aboard *Ma Cho*.

It is recommended that classification societies issuing approvals for on-load release systems review the in-service safety of designs with hook locking mechanisms using the same principle as that used on *Ma Cho*'s lifeboats.
