# Lifeboat accident at Port Botany, NSW

## 20 October 2003

## Lifeboat accident injures officer aboard *Port Arthur*

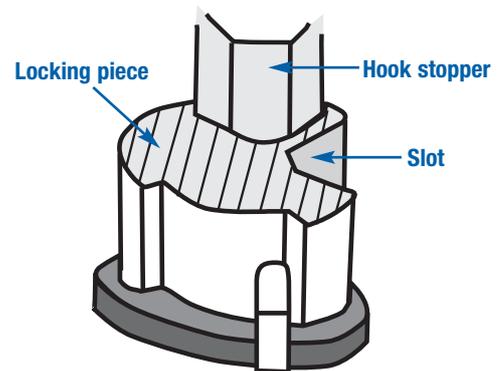
**FIGURE 4:**  
Hook stopper in fully reset position

If excessive force on the release lever is required to reset the hooks, it will generally mean that the end of one hook stopper has not rotated clear of the slot in its locking piece and is preventing the locking piece from turning into the reset position. For the hooks to be fully reset and thus in a 'safe' condition the end of the hook stopper for each hook must be fully seated on the flat surface adjacent to the slot in its locking piece (figure 4).

In this condition, the ends of each hook stopper were probably bearing on the slightly tapered faces inside their locking piece slots. The turning force being transmitted via the teleflex cables to each locking piece by the loaded release lever was the only force preventing the hook stoppers from rotating downward and releasing the loaded hooks. While the boat was successfully recovered on 10 October, the system was in an extremely dangerous condition and prone to spontaneous release if the hook load became high enough.

It was difficult for the ship's crew to verify visually whether or not the hooks were correctly reset. The tops of the locking pieces and the hook stoppers were not visible under the hook cover plates from within the boat. There were no inspection ports in the hook cover plates to allow the relative positions of the hook stoppers and locking pieces to be observed. The primary indication that the hooks may not have been correctly reset would have been the large amount of force required to move the operating lever to the reset position.

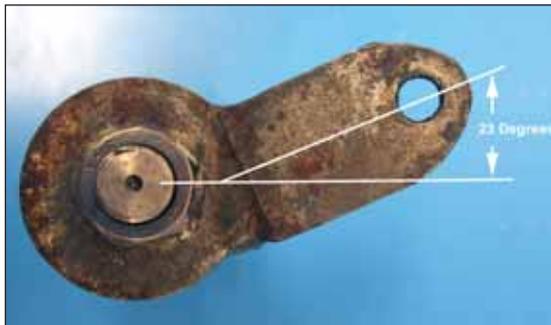
**FIGURE 5:**  
**Bent connecting lug**

An examination of the lifeboat releasing mechanism on 21 October revealed that the connecting lug at the base of the locking piece for attachment of the teleflex cable for the after hook was bent through an angle of about 23° (figure 5). While it was not possible to determine when the lug had been deformed, it is possible that it was in this condition on 10 October 2003. The deformation in the lug would have resulted in lost resetting motion and could account for the after hook not being fully reset when the boat was recovered on 10 October.

...We were surprised to know that the connection lug of the after hook was bent about 23 degree so large. We think this is very peculiar. The connecting lug is so rigid that it cannot be bent by human power during the operation even if it is abnormal.

3. The connecting lug at the base of the locking piece on the after hook was deformed, possibly resulting in the incorrect resetting of that hook.
4. As there were no inspection ports in the hook cover plates, it was difficult for the lifeboat's crew to check the relative positions of the locking pieces and hook stoppers.

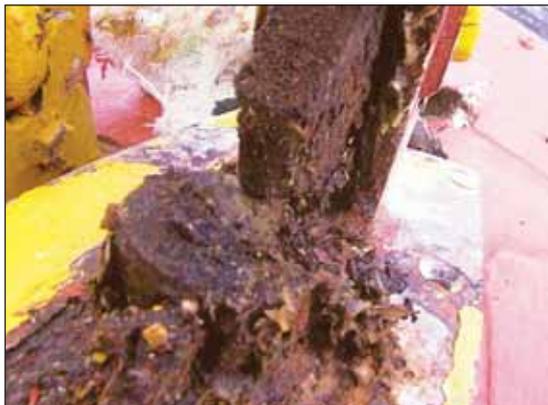
**FIGURE 6:**  
**Locking piece and hook stopper covered in debris**

When the cover plates for the hooks were removed to examine the hook mechanisms, the moving parts under the covers, including the hook stoppers and the tops of the locking pieces, were covered in a large buildup of debris including rust, grease and paint flakes (figure 6). It is likely that, over the previous

11 years of service, debris had filled the tolerance between the hook tails and their mating slots in the hook stoppers. As the debris built up in this space, it would have been progressively more difficult to reset the system with increasing amounts of hook stopper motion lost during the resetting operation.

If the crew had the intention of confirming the reset condition on 10 October 2003, they could see the inside from upside. But it is naturally supposed that, if they did so, it was difficult to confirm clearly the locking condition under the such dirty condition shown in Fig 6 of your report.

1. The on-load release hooks had not been correctly reset after the starboard lifeboat was lowered to the sea on 10 October 2003.
2. There were significant amounts of rust, grease and other debris within the hook mechanisms which resulted in one or both hooks being difficult to reset.

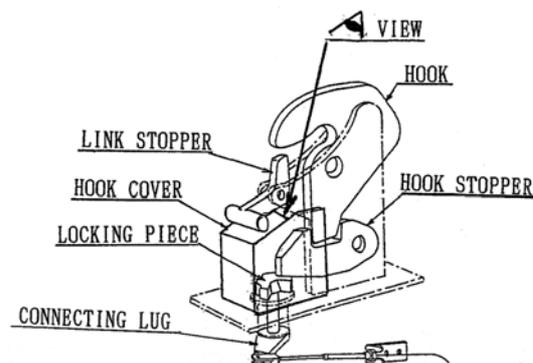
...The report is saying "It was not possible for the ship's crew to verify visually whether or not the hooks were correctly reset. ...this is not true. The condition of the locking piece and the hook stopper can be verified visually from upside as shown in the figure below. The top of the locking piece is visible from upside. We provided the peep hole to the hook cover in order to make the checking work ...more easily.

Despite the manufacturer's assertion that the condition of the locking pieces and the hook stoppers could be verified visually as shown above, there were no instructions on this procedure on board the ship. As well, the amount of debris within the hook assemblies would have made it very difficult to determine with certainty whether or not the hooks were fully reset.

... We have fitted inspection ports in four lifeboats (including those of *Port Arthur*) to enable crew to check visually that the hook is properly reset in the locked position.

.....Installation of an inspection port in this and similar lifeboats will help our crew to check that the locking mechanism is free of debris and that the greasing regime is effective.
