Aviation Safety Incident Report – 200403110

**Engine failure - Melbourne Airport, Victoria  
25-Aug-2004  
Boeing Company 777-312  
9V-SYB**

Engine Failure – Melbourne Airport, 25 August 2004, Boeing Company 777-312, 9V-SYB

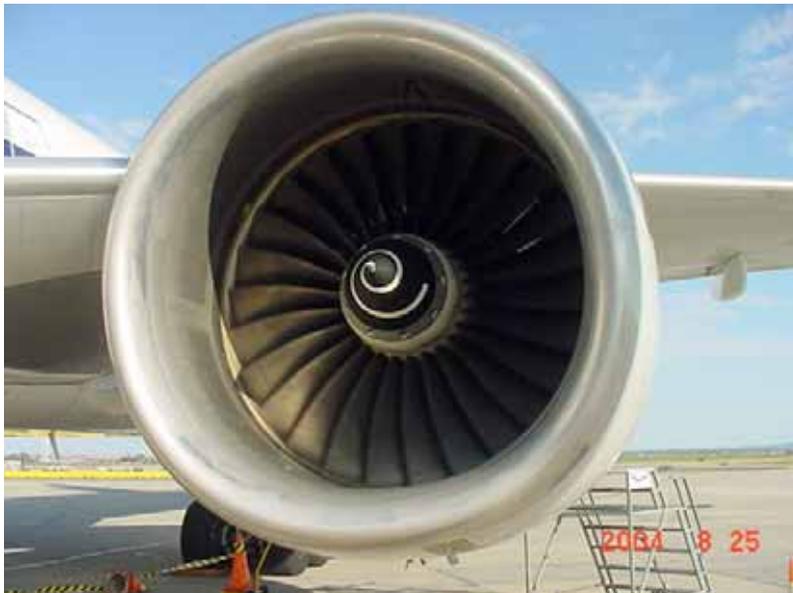
The Australian Transport Safety Bureau (ATSB) dispatched an investigation team to Melbourne to examine the aircraft, where no obvious external damage was evident (Figure 1). The ATSB examination revealed that one of the left engine's composite core panels had broken and separated from the engine during the engine surge (Figure 2). The left engine, a Rolls-Royce Trent 800, Serial number 51067, exhibited only minor damage to a number of components. A borescope inspection of the engine compressor section revealed no significant anomalies with the engine compressor or turbine rotors or stators.

**Figure 1: Trent 800 engine S/No. 51067 fitted to the left position of 9V-SYB**

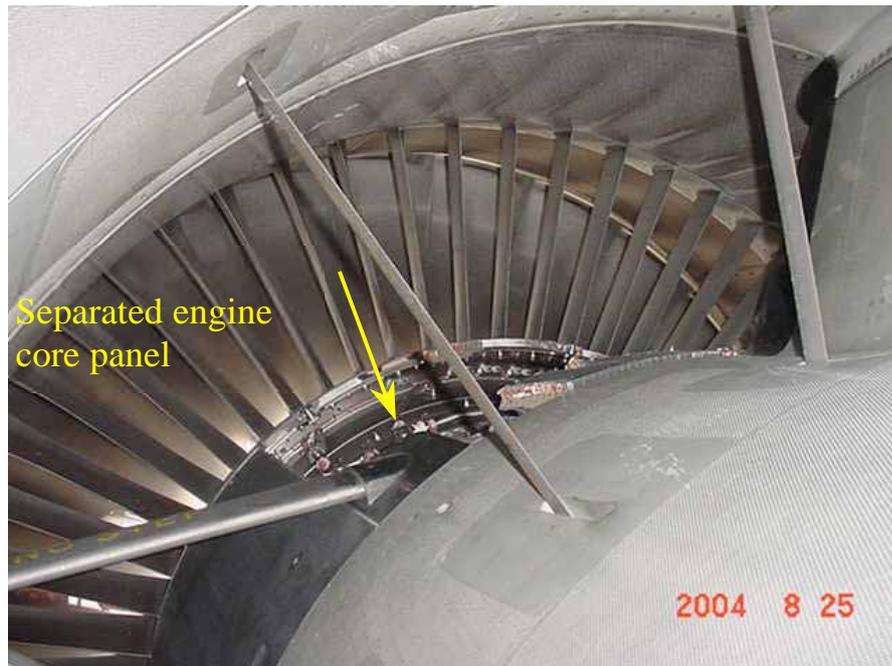
**Figure 2: Separated composite engine core panel in cold stream duct**

The failed engine core composite panel was secondary to the engine surge event and did not contribute to the engine failure.

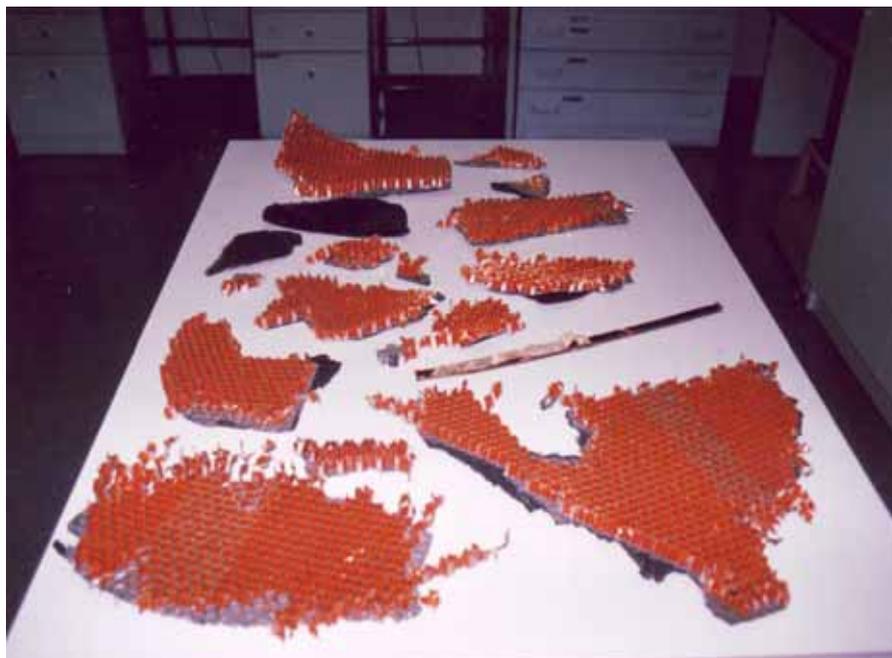
An amount of debris was liberated from the separated left engine core composite panel and was recovered from the departure runway (Figure 3).

**Figure 3: Composite panel remnants recovered from runway**

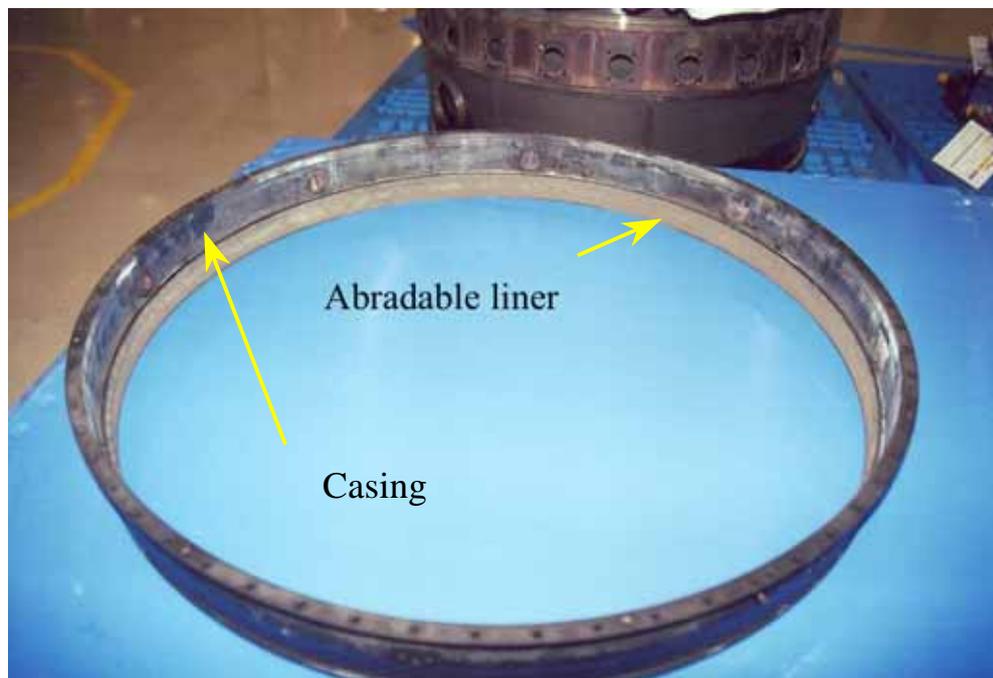
The engine examination revealed that the high pressure compressor (HPC) casing abrasion linings had deteriorated in service. There was a visible loss of abrasion rotor lining on several of the HPC compressor casings (Figures 4 and 5). The engine manufacturer advised that the HPC stage-6 casing-to-rotor clearance was critical to engine airflow control at the take-off thrust setting.

**Figure 4: HPC stage 6 casing and liner assembly**

The engine surge was as a direct result of a breakdown of the airflow within in the engine High Pressure Compressor (HPC). Directly contributing to that condition was a reduction in the HPC efficiency associated with the erosion and loss of HPC casing lining material, particularly at the rear stages of the HPC. The stage-6 lining material loss resulted in increased rotor tip clearances. The stage-6 lining material loss was the most critical stage for airflow control through the HPC during the takeoff.

The ATSB review concluded that the coating quality issues were the most probable factor contributing to the premature degradation of the HPC casing lining leading to the engine surge. While acknowledging the possibility that oxidation may have weakened the coating particle cohesive strength, the significance of this effect had not been quantified in respect of the performance of the lining in service. Other proposed contributors such as Calcia-Magnesia-Alumina-Silica (CMAS) ingestion, extended operation at elevated temperatures and the effects of thermal cycling were not substantiated by evidence. Similar casing liner issues were also apparent in all the other HPC casing liner stages in the engine.

Two engines that were identified as being at risk of surging due to degraded High Pressure Compressor (HPC) efficiency were removed from service.

The Engine Health Monitoring (EHM) procedures have been changed. If an EHM alert is issued and troubleshooting reveals no findings to explain the observed change, the engine manufacturer will review engine parameter data in more detail. This may lead to a recommendation that the engine is removed from service.

The aircraft maintenance manual will be updated to include an inspection check of the condition of the rotor path lining immediately adjacent to the borescope port hole and to contact the engine manufacturer if no evidence of lining loss.

The engine manufacturer has also developed an algorithm to alert changes of HPC efficiency as part of the suite of automatically generated alerts produced for engine health monitoring purposes.

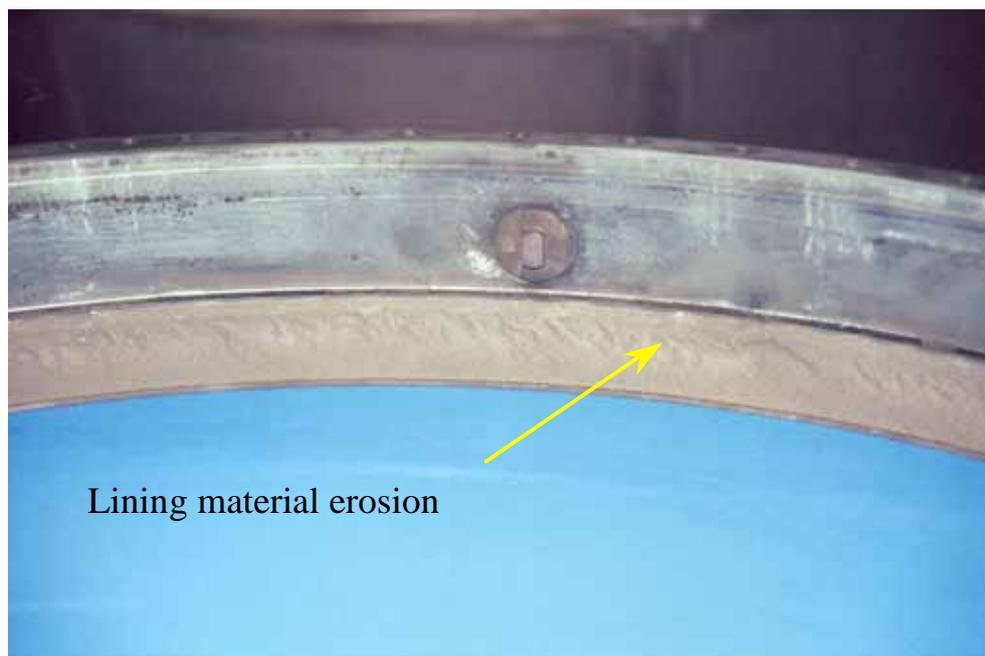
**Figure 5: Detail of HPC stage 6 casing abrasion liner erosion**

- The left engine surged during takeoff.
- The left engine High Pressure Compressor (HPC) casing liners exhibited lining material loss.
- The left engine HPC stage-6 casing lining material was eroded, increasing the rotor tip clearance and reducing the efficiency of the stage at take-off thrust.

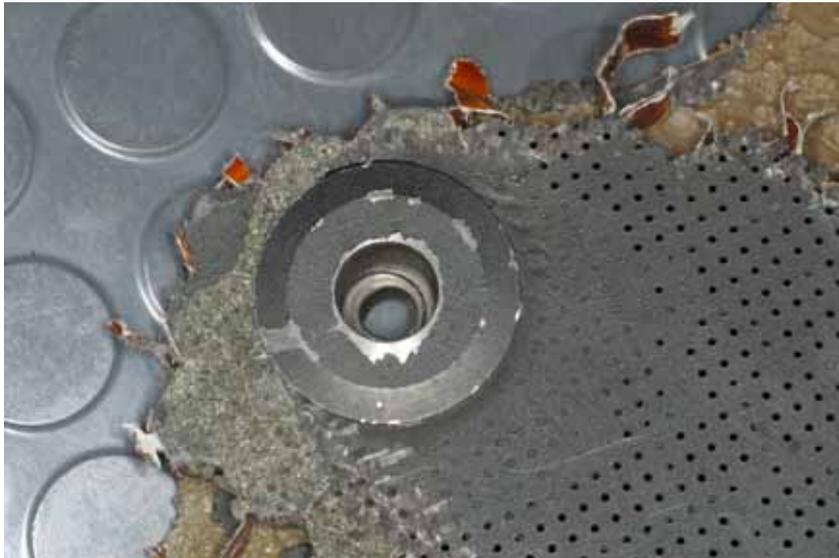
An examination of the separated engine core composite panel indicated that all the panel fasteners were retained in their mounts after the panel failed (Figure 6). One fastener hole showed signs of wear, but there was no direct evidence to suggest that the fitting was loose at the time of the failure (Figure 7). It was apparent from wear in the fastener fitting that it may have been loose previously, and that this looseness may have contributed to some prior weakening of the panel structure, which contributed to the panel failure during the engine surge event.

**Figure 6: Typical composite panel failure around mounting point**

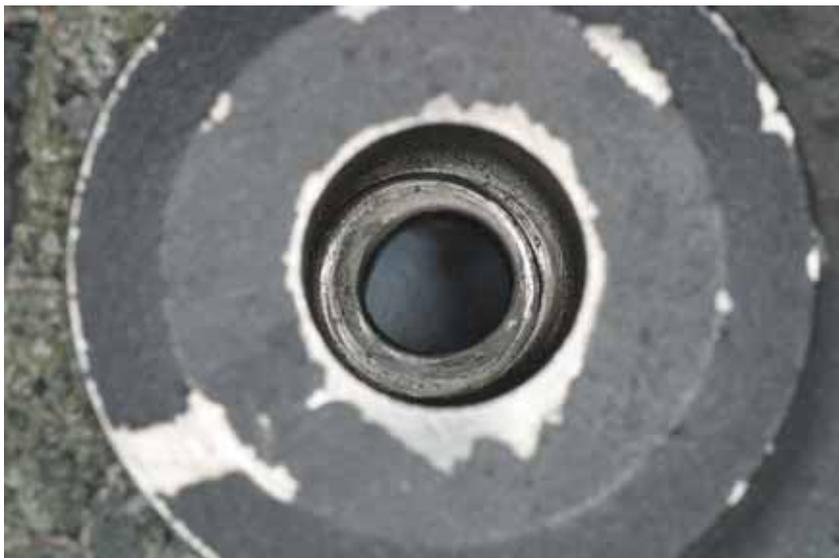
**Figure 7: Elongated fastener hole showing signs of wear**
