ATSB TRANSPORT SAFETY INVESTIGATION REPORT
Marine Occurrence Investigation No. 209
Final

Independent investigation into the man overboard fatality
and subsequent lifeboat accident on board the
French registered Antarctic support vessel

L'Astrolabe
in the Southern Ocean

27 January 2005

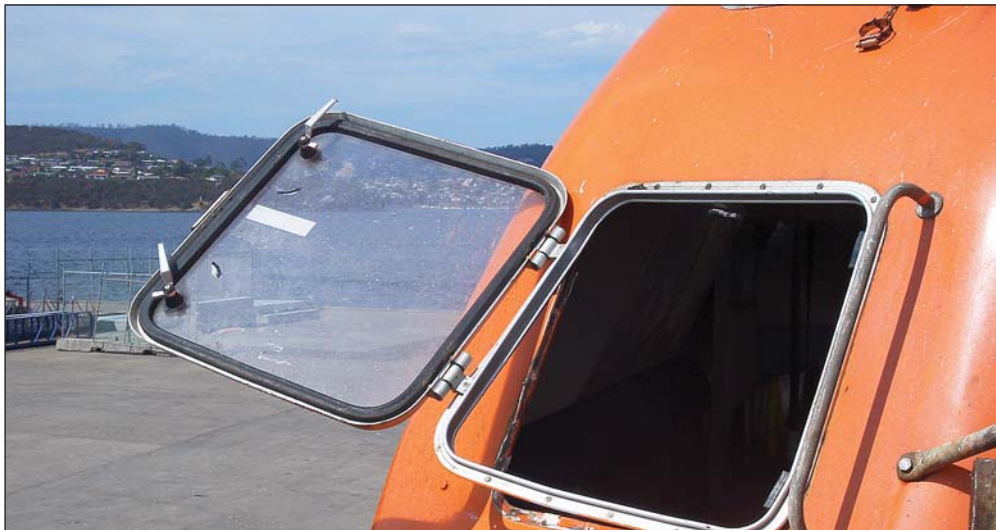
During the recovery operation, the lifeboat suffered a significant amount of damage from both the swinging fall blocks and from contact with the hull of the ship.

This damage included cracks in the lifeboat hull, the forward and after access hatches were partially pulled from the canopy, and the forward handhold adjacent to the access hatch was totally ripped from the canopy (Figures 5–9).

Figure 5: Port lifeboat's rear hatch damage

The damage was repaired in Hobart and *L'Astrolabe* was cleared to continue its operations by its Classification Society and the Australian Maritime Safety Authority (AMSA).

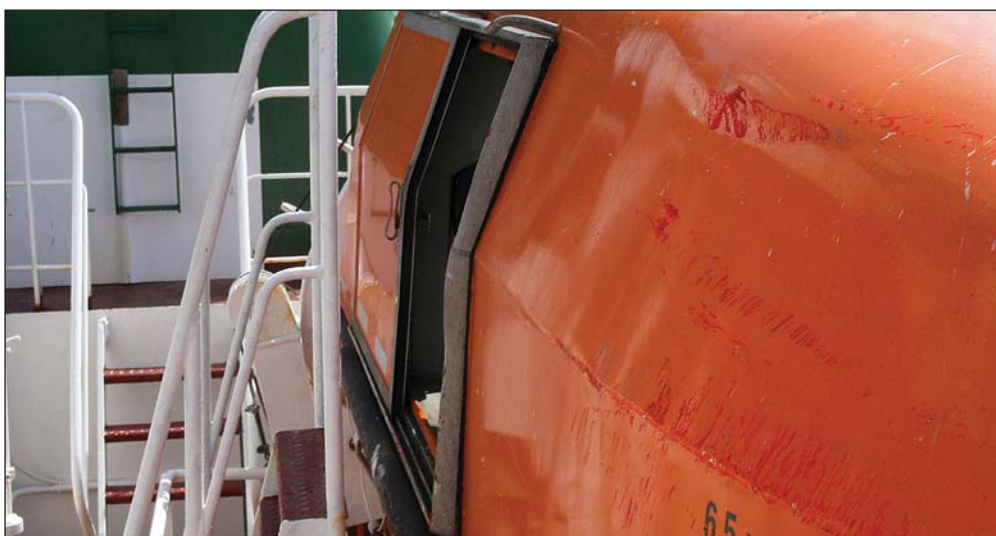
Figure 6: Port lifeboat's contact damage

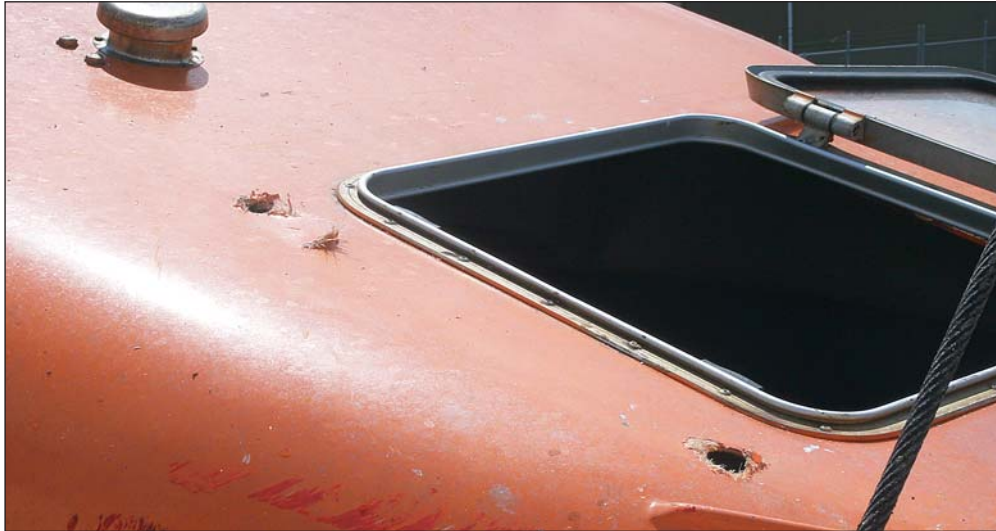
Figure 7: Port lifeboat's forward hatch damage

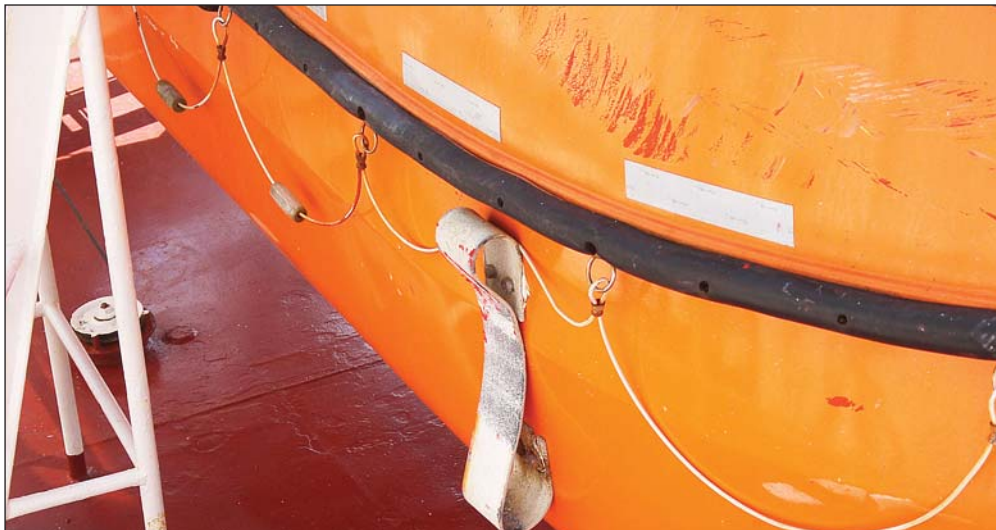
Figure 8: Port lifeboat's contact damage

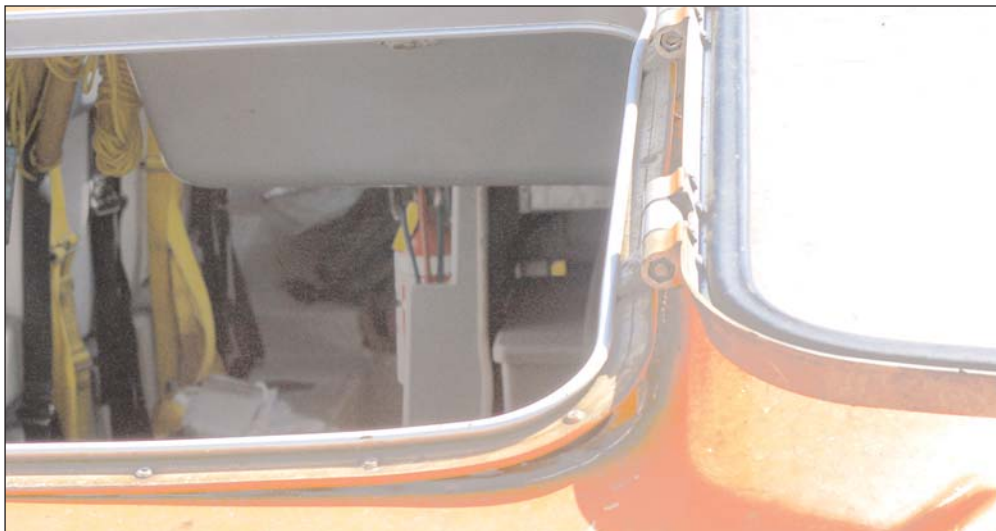
Figure 9: Port lifeboat's forward hatch damage

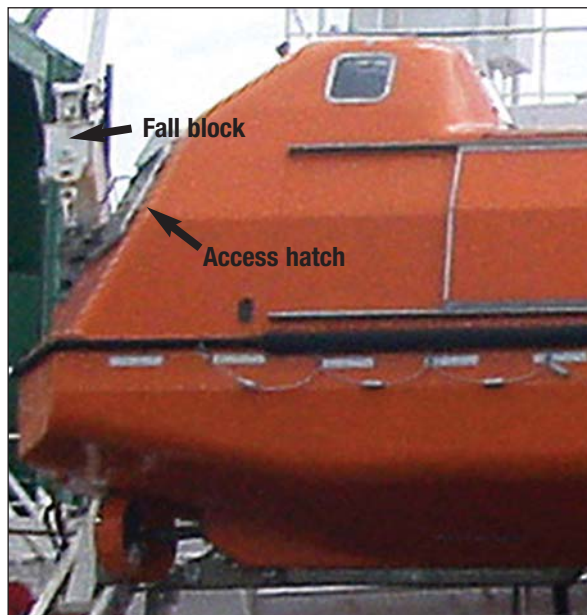
Figure 10: Starboard lifeboat's after access hatch

The after access hatch on *L'Astrolabe*'s lifeboats is located on the outboard side of the boat's canopy and not on the centreline. This location made the task of connecting the suspension ring on the fall blocks to the lifeboat's hook assembly extremely difficult. The crew member was required to position himself in the hatch then lean out (exposing his head and upper body to the dangers of the swinging fall block), while endeavouring to take hold of the swinging fall block or suspension ring and then manoeuvre it into position on the hook.

The off centre location of the hatch meant that he not only had to concentrate on keeping his hands, and head, clear of the swinging fall block, but also on maintaining his balance while leaning out through the hatch.

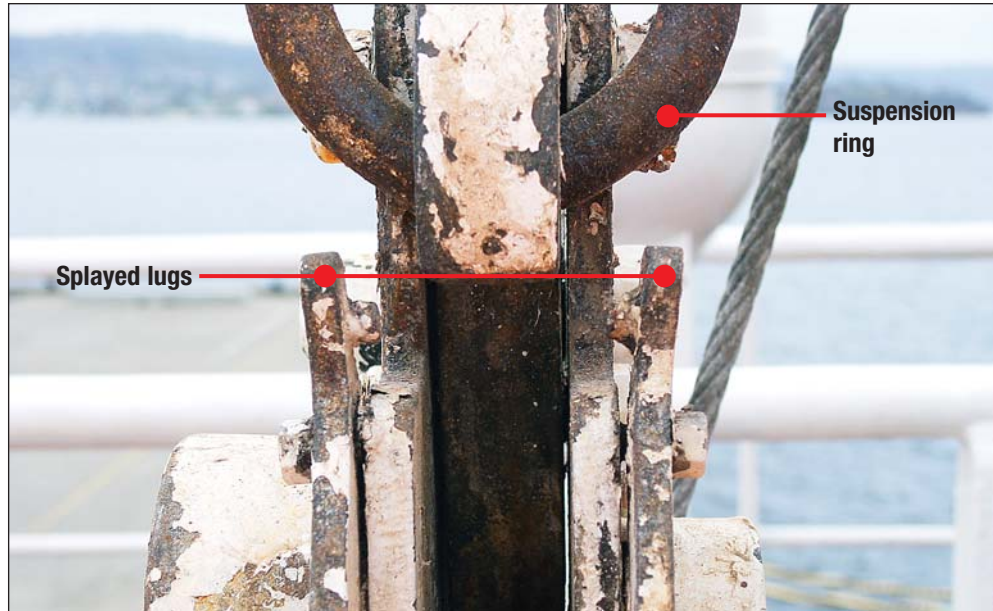
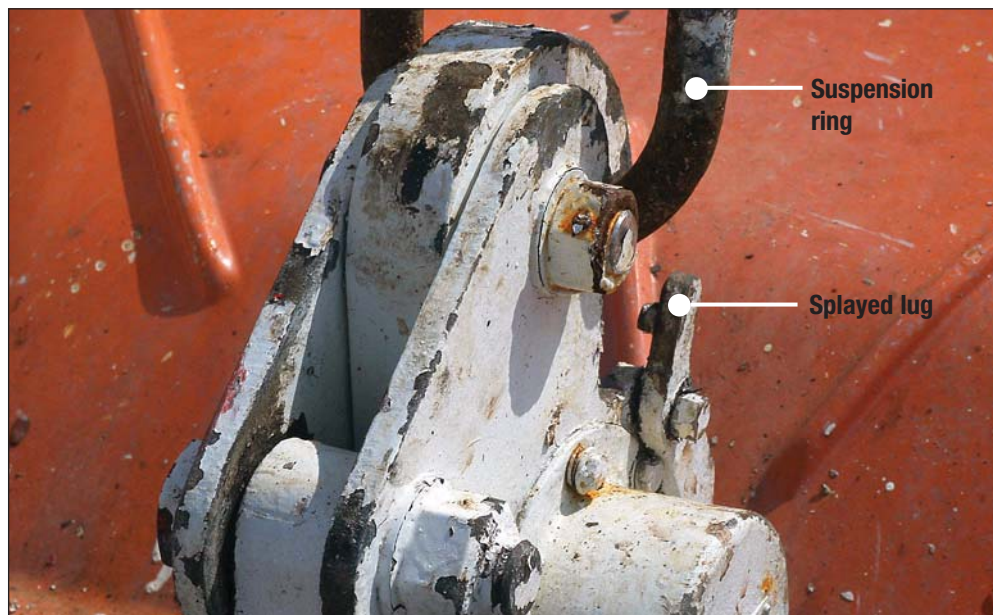
Figures 11: Port lifeboat's forward lifting assembly

Inspection of the port lifeboat's forward hook arrangement (Figures 11 and 12) revealed damage to the latch mechanism. It was not possible to tell whether the damage occurred during the incident on 27 January, or before that date.

The damage consisted of a splaying of the lugs, which had allowed the suspension ring to readily detach from the lifeboat's forward hook during the incident. It is probable that this damage added to the difficulty experienced during the recovery operation, prior to the painters being lowered to the lifeboat.

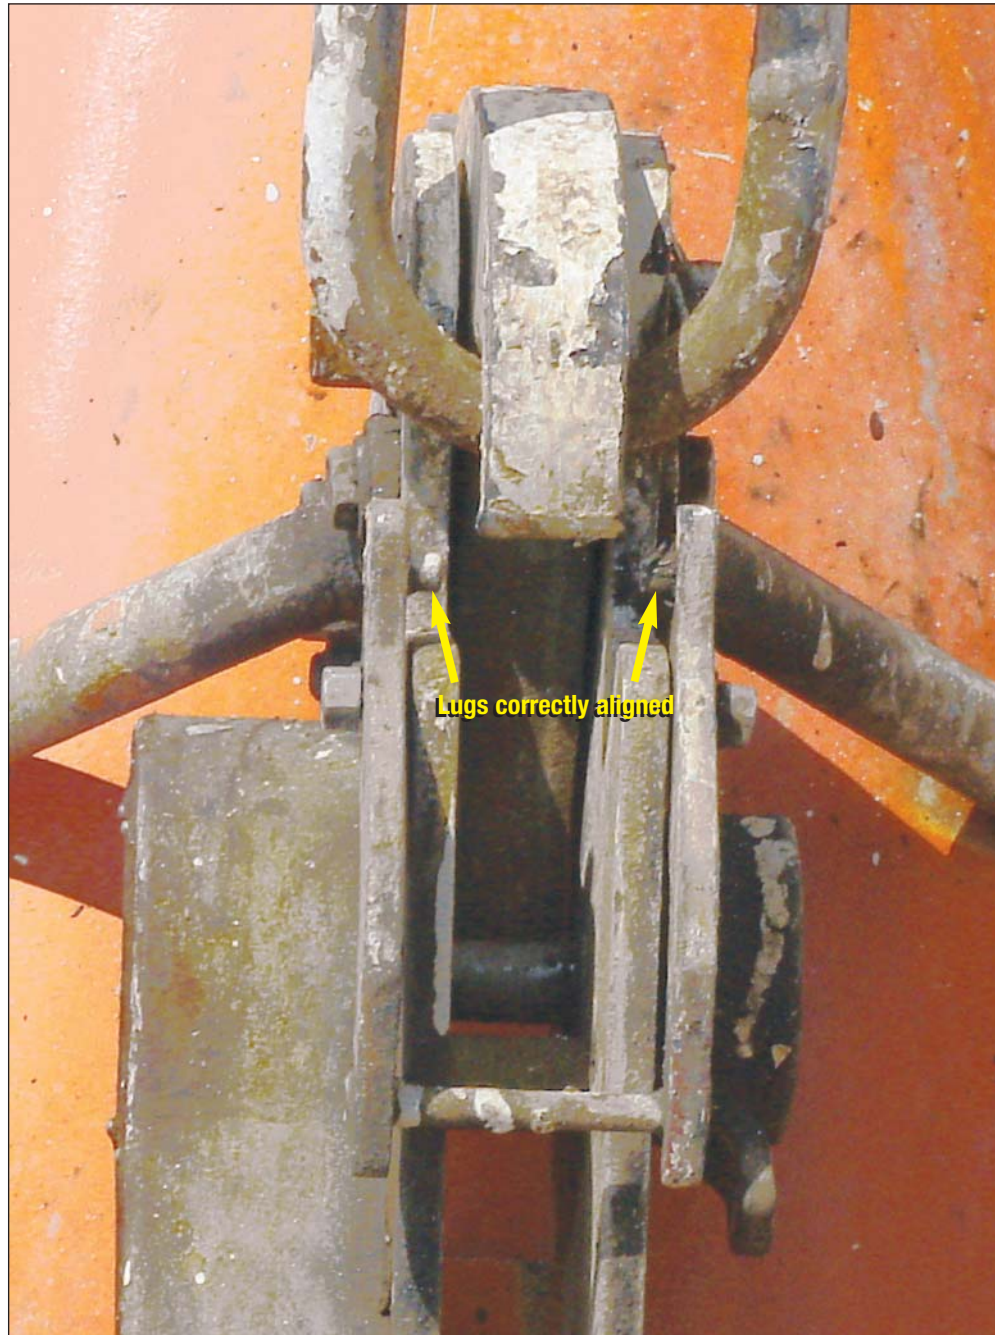
Figures 13: Port lifeboat's after lifting assembly

The aft latch mechanism was not damaged in this way (Figure 13).
