ATSB TRANSPORT SAFETY INVESTIGATION REPORT

Aviation Occurrence Investigation Report – 200601509

Preliminary

**Collision with Terrain
55 km South of Narrandera, NSW
26 March 2006
Cessna 188B, VH-ZIP**

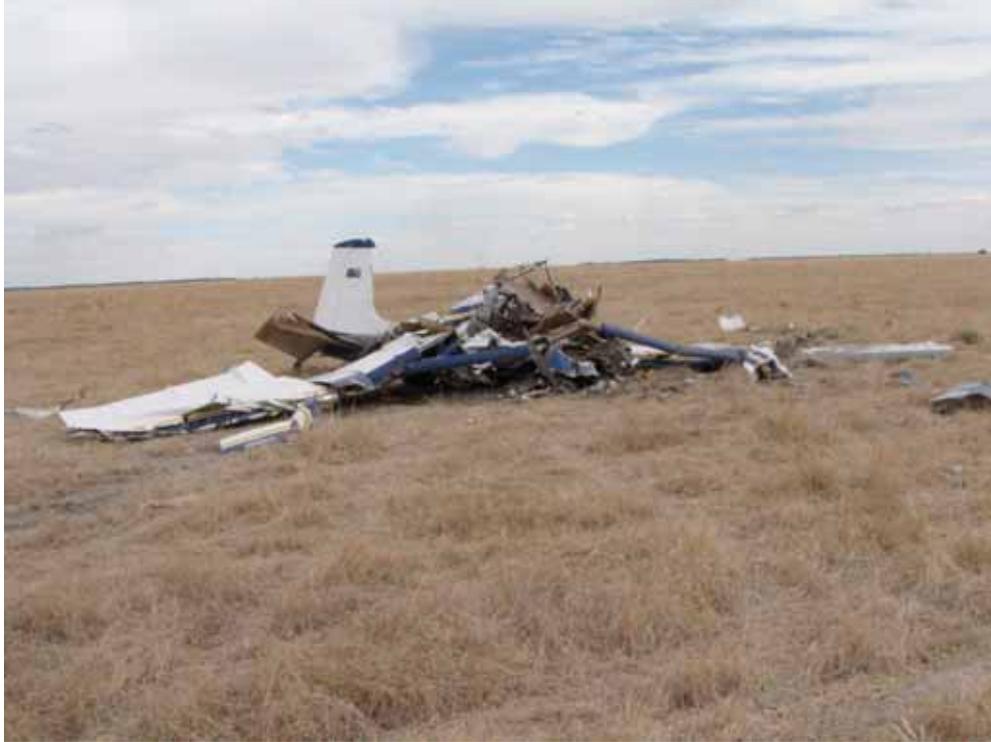
Figure 2: Accident site

Examination of the aircraft wreckage indicated that it had impacted the ground heavily, in a nose-down, right wing-low attitude (Figure 2). All components of the aircraft were accounted for at the accident site and the aircraft was not fitted with an emergency locator transmitter. Weather conditions in the area were reported to be fine with little or no wind.

Due to the rupture of the fuel tanks on impact, the amount of fuel on board could not be established, however an examination of the engine and propeller indicated

that they were producing power at the time of impact. The Australian Transport Safety Bureau has recovered a number of components for further examination.
