Aviation Occurrence Report – 200601688

Engine power loss – Bankstown Airport – 5 April 2006

VH-ZNZ

Amateur-built Lancair 360

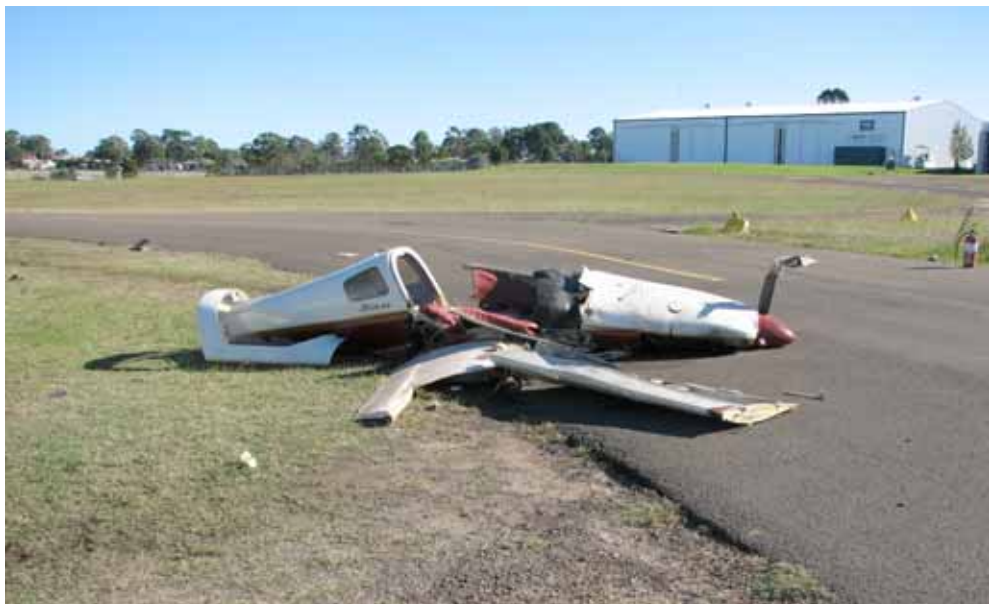
Figure 4: Aircraft wreckage

All of the aircraft parts were located at the accident site and examination of the wreckage showed no pre-impact structural or flight control defects. The outer wings and tail section detached during the accident sequence and the fuselage structure was broken in a number of places (figure 4). The aircraft's fuel tanks were ruptured and there was no fuel able to be recovered from the aircraft.

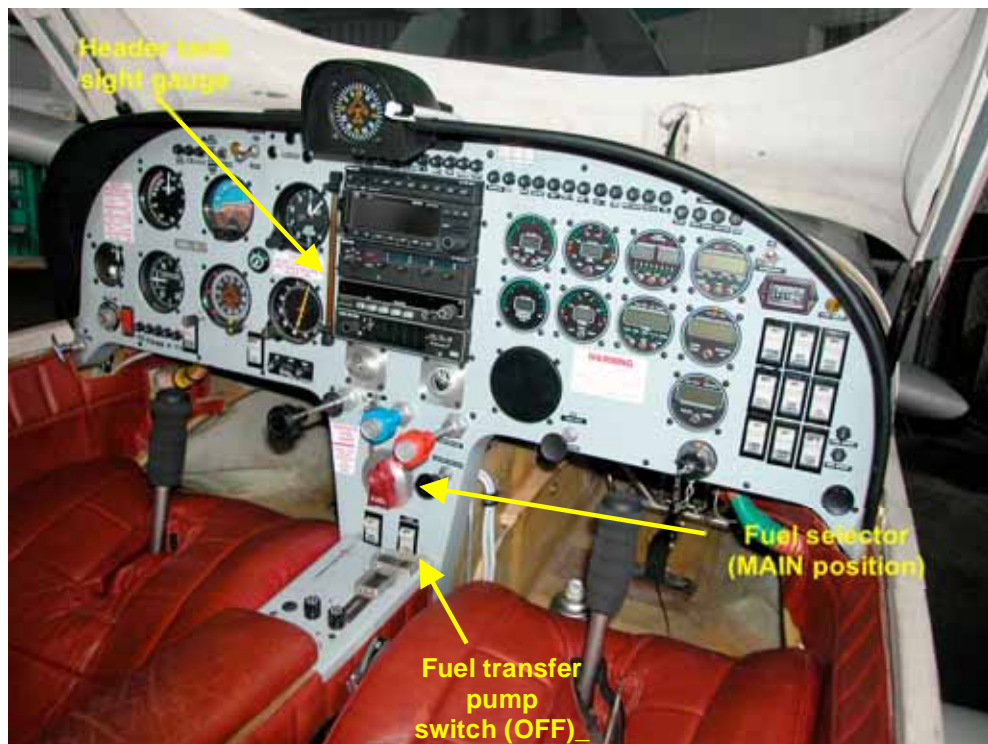
Figure 5: Aircraft cockpit and instrument panel (14 March 2006)

The builder modified the standard fuel system by incorporating a fuel selector (figure 5) and fuel lines that allowed the engine to be supplied directly from the header tank or either wing tank. An electric pump and fuel lines were also fitted to allow transfer of fuel from the left wing tank to the header tank. The header tank had a maximum capacity of 41 L and each wing tank had a maximum capacity of 80 L.

The POH/AFM fuel management information and instrument panel placard did not apply to the system in VH-ZNZ because fuel was not supplied solely from the header tank.

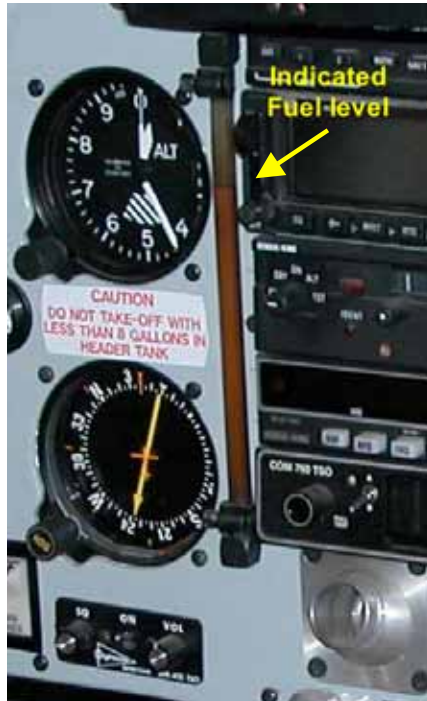
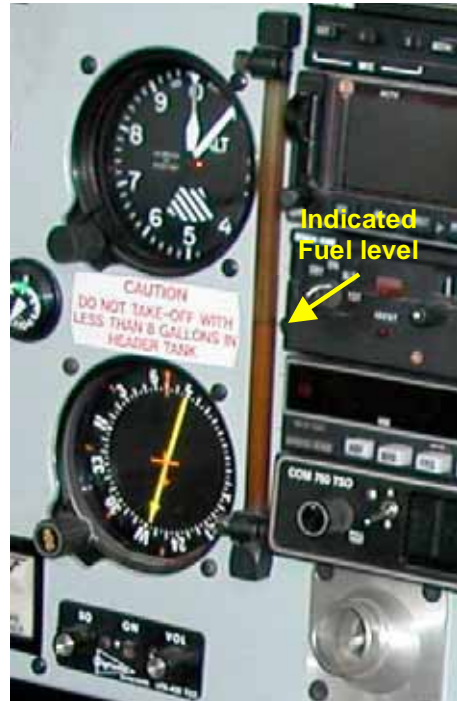
Figure 6: Header tank quantity indications

There was no reliable evidence of tank selection or header tank quantity after 14 March 2006. Although there were reports of engine ground running after that date, the reports were not detailed or consistent. As a result, the investigation was unable to accurately determine the quantity of fuel consumed since 14 March 2006.
