ATSB TRANSPORT SAFETY INVESTIGATION REPORT

Aviation Occurrence Report – 200601688

Engine power loss – Bankstown Airport – 5 April 2006

Amateur-built Lancair 360

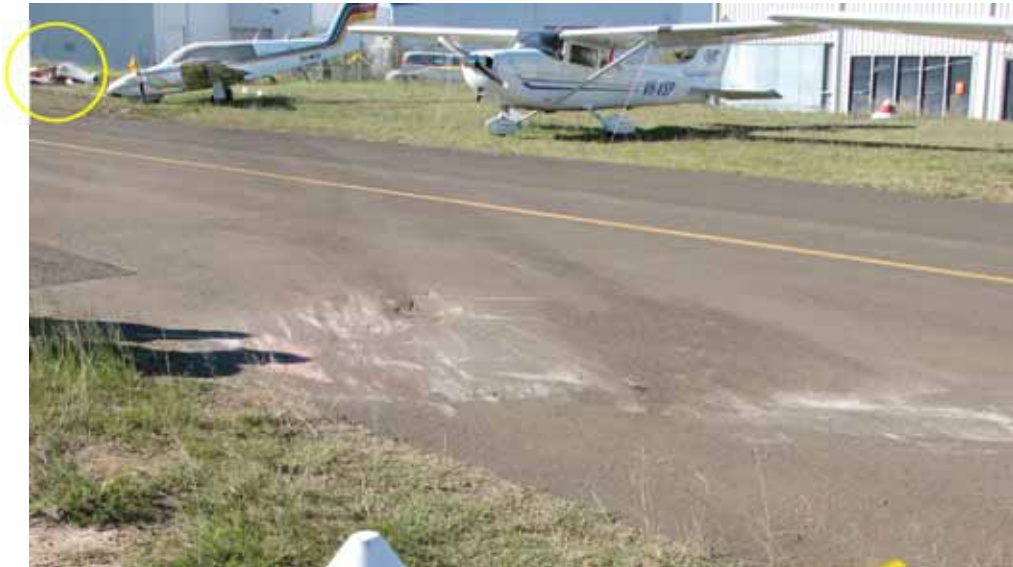
Figure 3: Impact marks on airport taxiway (wreckage circled)

The aircraft impacted the surface of the taxiway upright in a slightly right-wing down, nose-down attitude with indications of right yaw. The aircraft skidded along the taxiway and adjacent grass in the approximate direction of flight, colliding with the nose of a parked twin-engine aircraft before coming to rest 65 metres from the impact point (figure 3).

An oily residue in the accident trail indicated that oil had spilled from the engine crankcase. Discolouration at the initial impact site showed a quantity of fuel had spilled from the right wing tank and little fuel had spilled from the left wing tank. Further along the accident trail there was discolouration on the taxiway consistent with further fuel spillage.
