# Level Crossing Collision – Elizabeth River, NT

## 20 October 2006

At about 1205<sup>1</sup> on 20 October 2006, a double trailer road-train truck drove into the path of a south bound freight train (6DA2) at a level crossing near the Elizabeth River Bridge, NT. The locomotive drivers sustained minor injuries while the truck driver was uninjured.

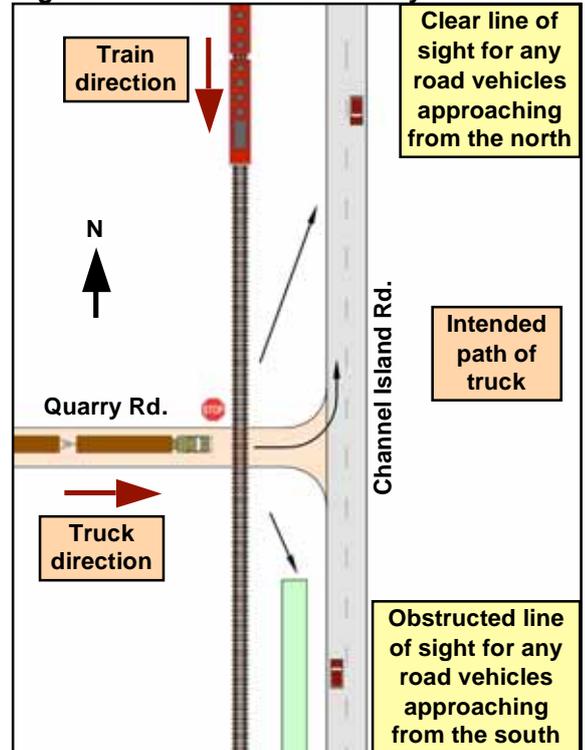
Figure 1: Road-Rail Geometry

The accident occurred at a level crossing located about 520 m south of the Elizabeth River Bridge. The crossing provides road access between Channel Island Road and a quarry located a short distance to the west. The level crossing is categorised as an 'Occupational'<sup>2</sup> crossing, and is commonly referred to as 'Quarry Road' level crossing. At this location, the railway and Channel Island Road run almost parallel with about 20 m separation between them (Refer to Figure 1).

The T-junction between Quarry Road and Channel Island Road is located only 20 m from the level crossing (Figure 1). This allows insufficient space for a road-train truck to fit between the level crossing and the junction. Research has shown, when faced with this configuration, a motorist's attention could be drawn towards the intersection and away from the crossing<sup>12</sup> simply because the motorist is aware of it and the requirement to negotiate the intersection safely.

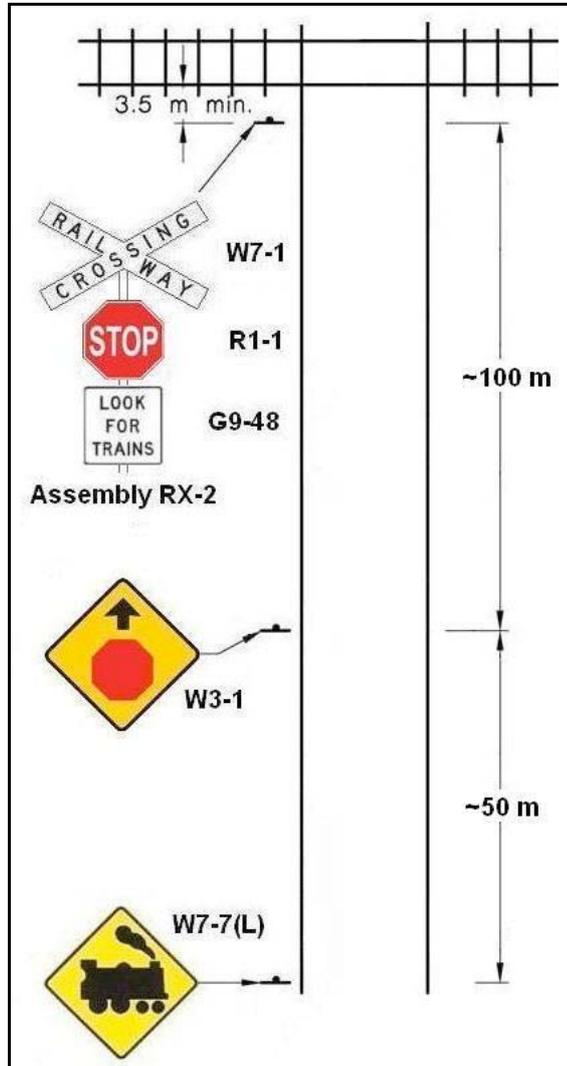
**Figure 3: Signage as installed at Quarry Road on 20 Oct. 2006**

Occupational crossings, that are accessible to the general public, are required to comply with AS1742.7. It was evident that road signage on the western approach to the Quarry Road level crossing (Figure 3) was consistent with the

requirements of AS1742.7-1993, noting that road markings on unsealed roads are not required.

While not a contributing factor in this accident, it was noted that the 'Railway crossing on side road assembly' (RX-4, Illustrated in Figure 3) was missing on both Channel Island Road approaches. All other signage was found to be compliant.

The investigation concluded that there was no deficiency in signage along the western approach to the Quarry Road level crossing that would have contributed to the collision.

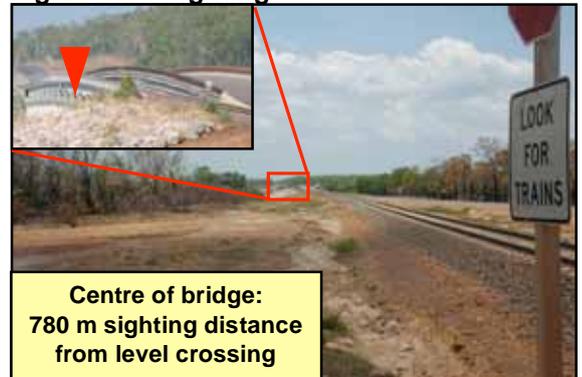
**Figure 4: Sighting distance**

The 'worst case' scenario at Quarry Road level crossing is for a driver of a triple road-train stopped at the 'Stop' sign, attempting to determine if it is safe to cross the tracks before the arrival of an approaching train travelling at 115 km/h. Under these conditions the calculated minimum sighting distance is about 766 m. The sighting distance for a train approaching Quarry Road level crossing from the north was greater than 1000 m with the centre point of the Elizabeth River Bridge being 780 m from the crossing.

The investigation concluded that there was no deficiency in sighting distance at Quarry Road that would have contributed to the collision.

There was a clear unobstructed view of the Elizabeth River Bridge (approximately 780m, Figure 4) for vehicles travelling along Quarry Road from the tree line, about 20m before the level crossing, to the crossing itself. These observations were supported by the truck driver's statement. When approaching the crossing, there was 'good vision' of the bridge (rail and road), firstly through the front windscreen then through the side window as the truck came closer to the crossing.
