ATSB TRANSPORT SAFETY INVESTIGATION REPORT

Aviation Occurrence Report – 200700361

Preliminary

**Engine failure
Cecil Park, NSW
5 February 2007
VH-HYY, Cirrus SR22**

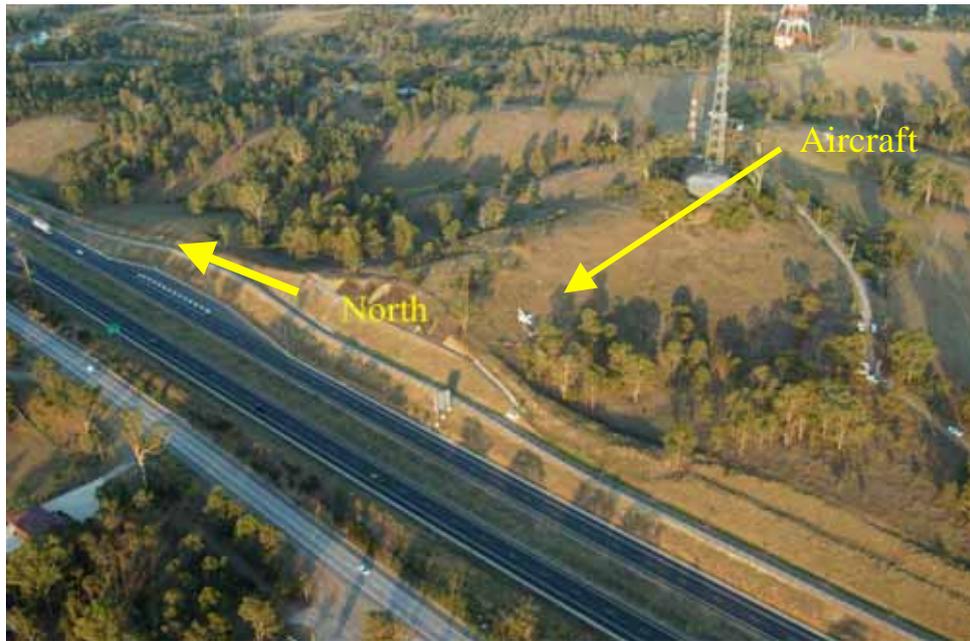
On 5 February 2007, a Cirrus SR22 aircraft, registered VH-HYY, with a pilot and one passenger, was being operated on a private flight from Canberra, ACT to Bankstown NSW. At approximately 1616 ESuT¹, as the aircraft approached the Cecil Park area, the pilot reported to air traffic control (ATC) that the engine had lost power and that he was attempting a forced landing. Soon after, the aircraft impacted terrain close to the M7 freeway in Cecil Park and both occupants sustained serious injuries (figure 1).

Figure 1: Aerial view of accident site showing relationship to M7 freeway²

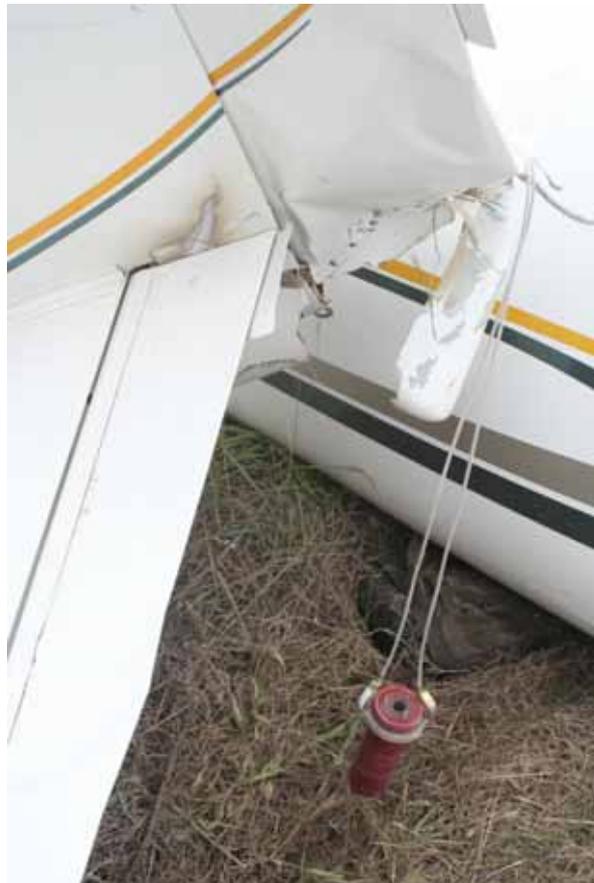
Prior to impact, the CAPS system had been activated by the pilot. However, the parachute system had only partially deployed. The CAPS rocket had fired and exited the aircraft but it became entangled in the rear section of the empennage. As a result, the parachute did not deploy.

Figure 2: CAPS rocket entangled in empennage

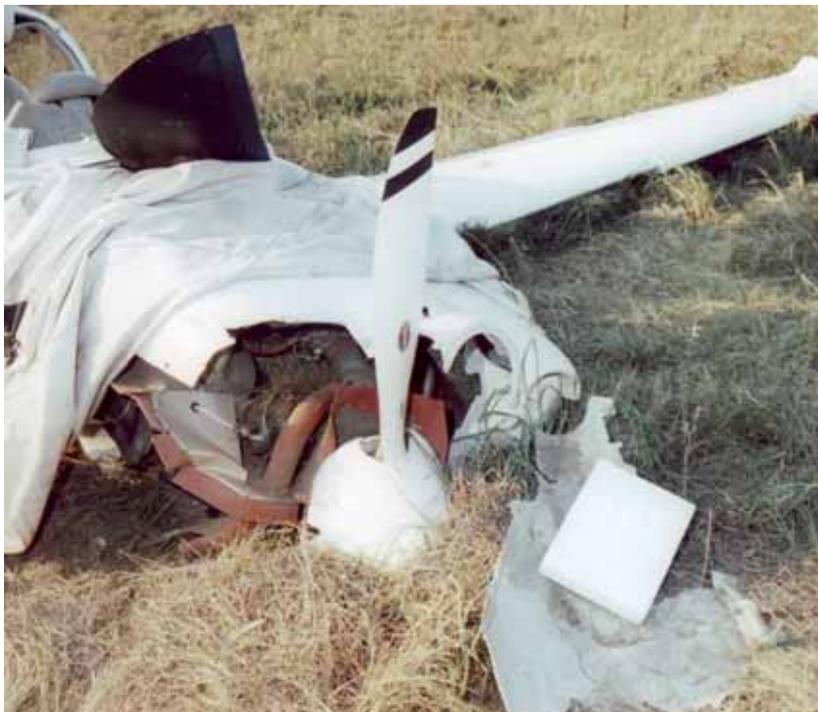
An examination of the propeller damage and ground scars indicated that the propeller was windmilling and was not rotating under power (figure 3).

Figure 3: Propeller as found at accident site

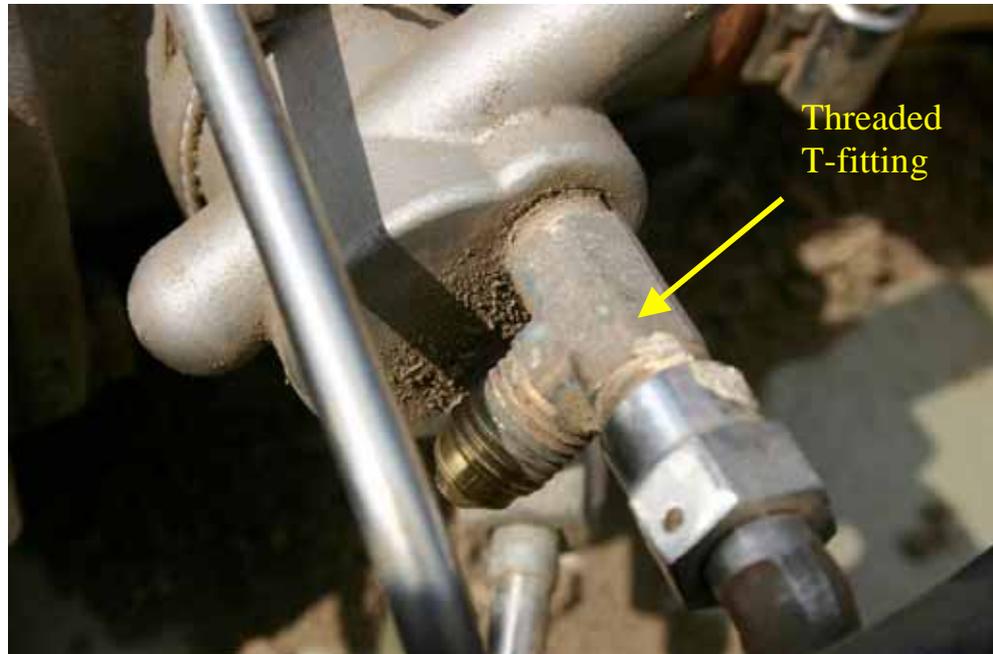
Examination of the aircraft engine at the accident site found that a steel blanking cap from the engine's fuel supply system was missing (figure 4). That cap covered a test port on a threaded 'T- fitting' that led to the engine fuel control unit. The test port allowed for the checking of un-metered³ fuel pressure from the engine driven fuel pump. The cap was normally fastened to the T-fitting and a torque applied to it to ensure that it remained securely fastened. A small, red, plastic, blanking cap, of a

similar size to the missing steel cap, was found beneath the engine at the accident site.

Figure 4: Threaded T-fitting with evidence of blanking cap missing

The engine was removed from the aircraft and taken to an appropriate test facility where it was examined prior to attempting engine runs. The test port on the fuel system threaded T-fitting was connected to a line with a cap secured to the end. The engine was then started and operated normally with the test port line capped. However, each time the cap was removed, the engine stopped within 3 seconds.
