ATSB TRANSPORT SAFETY INVESTIGATION REPORT
Marine Occurrence Investigation No. 238
Final

Independent investigation into the boiler explosions
on board the Panamanian registered bulk carrier

Shirane

2 April 2007

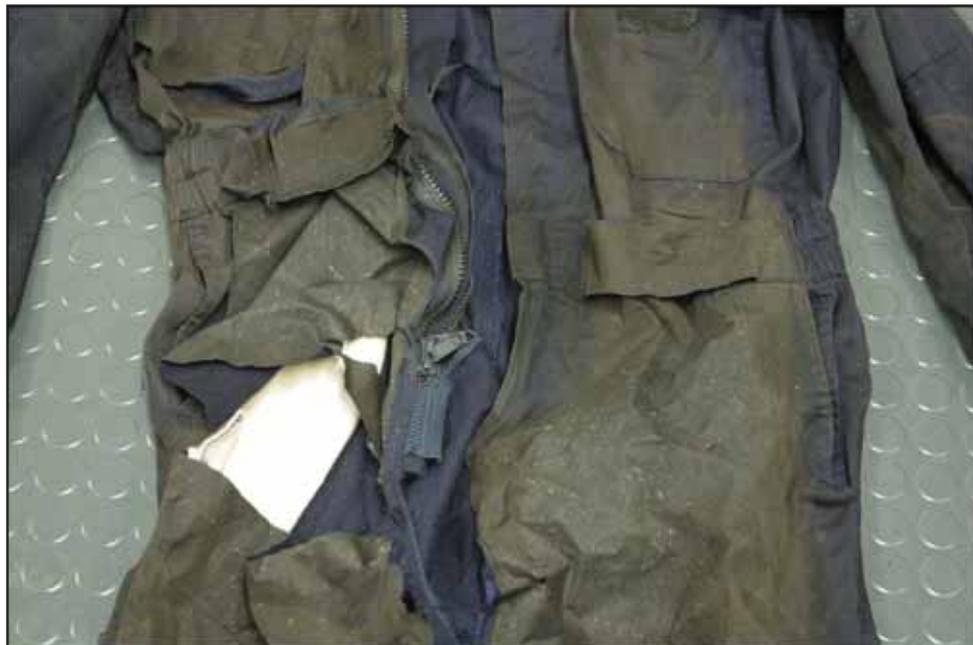
Figure 6: The third engineer's polyester/viscose overalls

When the third engineer's overalls were hit by the flames from the furnace flashback, the central zipper melted and the overall material ignited (Figure 6). The overalls had provided inadequate protection to the third engineer and, as a result, he sustained burn injuries to his stomach.

Neither the synthetic overalls nor the cotton overalls provided the engineers with the protection they needed. Therefore, they were not appropriate for the task.

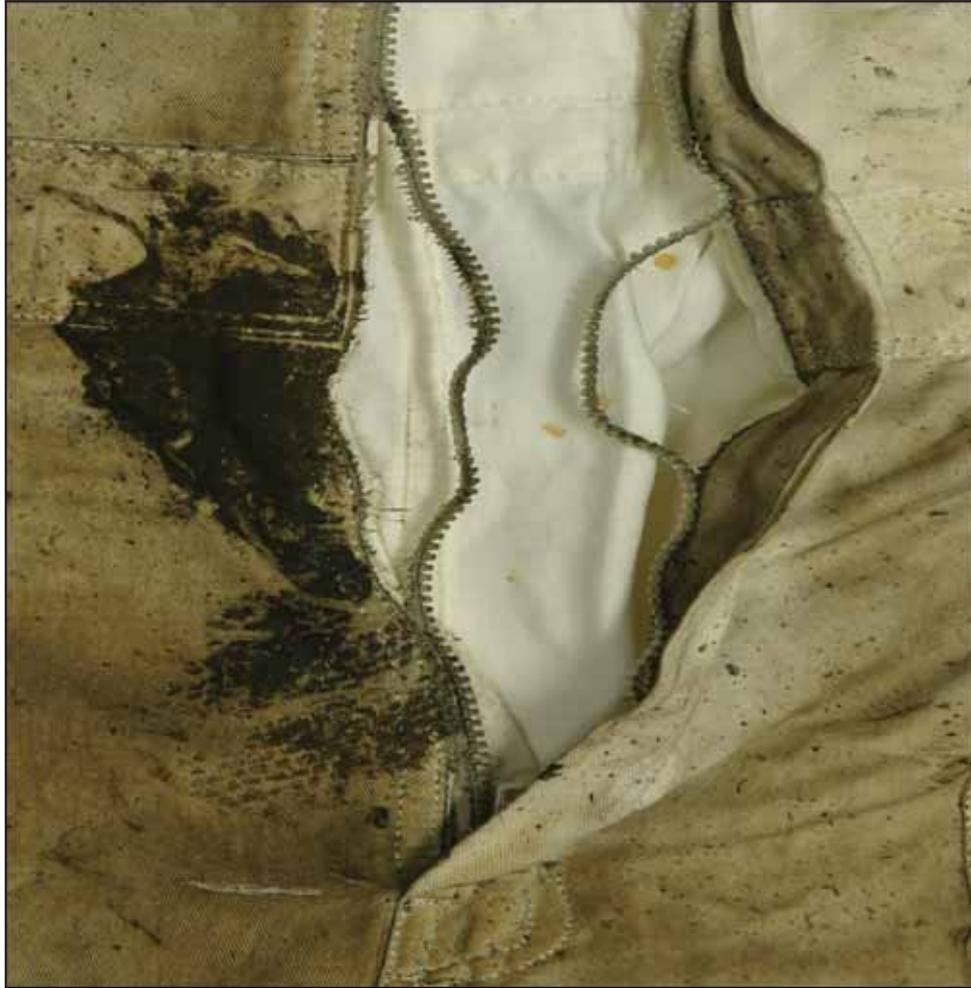
Figure 7: The chief engineer's 100% cotton overalls

On 2 April, the chief engineer and the second engineer were both wearing their issued white cotton overalls. While the second engineer's overalls were not severely damaged by the flashback, the chief engineer's overalls were. It is likely that the chief engineer's overalls were exposed to more flame because of the position he was in at the time of the flashback.

The central zipper in the front of the white cotton overalls was plastic and it was stitched into the overalls using a synthetic thread. When the chief engineer's overalls were exposed to the flashback, the zipper, and the thread holding it in place, melted (Figure 7). This allowed the overalls to fall open and resulted in the chief engineer sustaining burns to his stomach.
