Fuel Starvation – Mt Isa, Qld

17th July 2008

Abstract

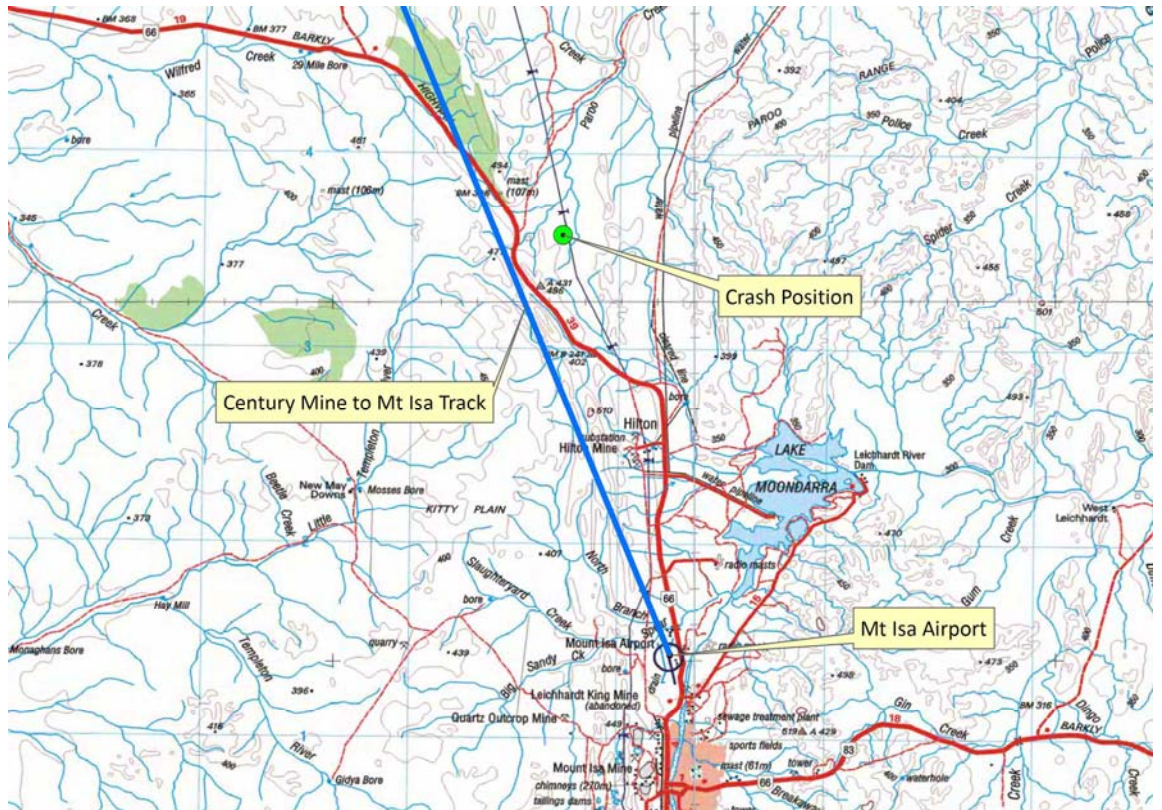
Figure 1: Map of site

On 17 July 2008, at approximately 0915 Eastern Standard Time¹, the pilot of a Piper Navajo PA-31 aircraft, registered VH-IHR, was en route from Century Mine, Qld to Mt Isa, Qld when the left engine lost power. The pilot transmitted an urgency broadcast (PAN) to air traffic control (ATC). A short time later, the right engine also lost power. The pilot then transmitted a distress signal (MAYDAY) to ATC stating his intention to carry out an off-field emergency landing. The aircraft impacted terrain 22 km north of Mt Isa, about 4 km from the Barkly Highway, in relatively flat, sparsely wooded bushland (Figure 1). The pilot, who was the sole occupant, sustained serious injuries.

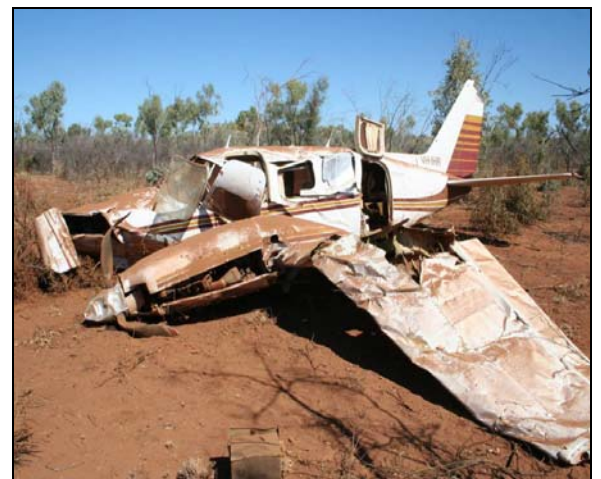
Figure 2: Aircraft wreckage

Examination of the aircraft showed no evidence of pre-impact damage. The damage to the left wing and nose area (Figure 2) of the aircraft indicated that the aircraft impacted the ground at an angle of approximately 30 degrees left-wing down and 30 degrees nose down. The aircraft fuselage showed signs of compression rippling on the under surface and the rudder mass balance weight was bent over to the right at the tip. The distance from the initial impact point to the main wreckage was 17 m. This evidence indicated that the aircraft had a very high rate of decent and low forward airspeed at the time of impact.

The flaps were in the zero (retracted) position as was the cockpit flap indicator and selector. Damage to the landing gear doors indicated that

the landing gear may have been partially extended on impact. The landing gear lever was noted to be in the down position.

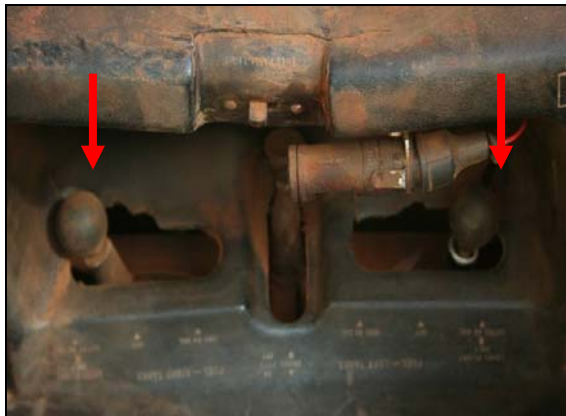
Figure 3: Fuel management panel

Both fuel selector handles were found set to the outboard fuel tank positions indicated by red arrows in Figure 3. The emergency fuel pumps were selected OFF.

Examination of the wreckage clearly indicated that there was sufficient fuel on board the aircraft to complete the flight safely. Had the pilot selected the fuel selectors to the inboard tanks when the engine surged and subsequent power loss occurred, normal operation would have been restored.

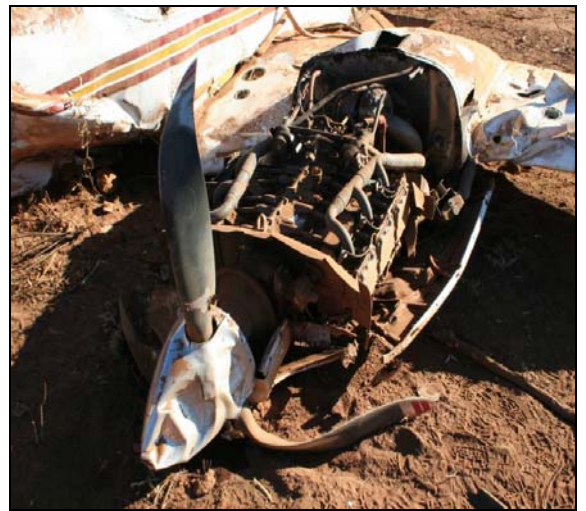
Figure 4: Left engine and propeller

The damage to the propellers indicated that they were not in the feathered position and that the engines were delivering little or no power on impact (Figures 4 and 5).

The engines were inspected externally with no pre-impact defects identified. The engine fuel systems were disconnected at the main fuel inlets and only a small amount of fuel was present.

Having incorrectly diagnosed the situation, the pilot believed that the engines were still producing power. Consequently, he did not feather the propellers which increased the amount of drag on the aircraft. This resulted in a high rate of descent and reduced the glide range and time available to the pilot to prepare for a landing.
