**ATSB TRANSPORT SAFETY REPORT**

Aviation Occurrence Investigation AO-2008-070

Interim Factual

**In-flight upset  
154 km west of Learmonth, WA  
7 October 2008  
VH-QPA  
Airbus A330-303**

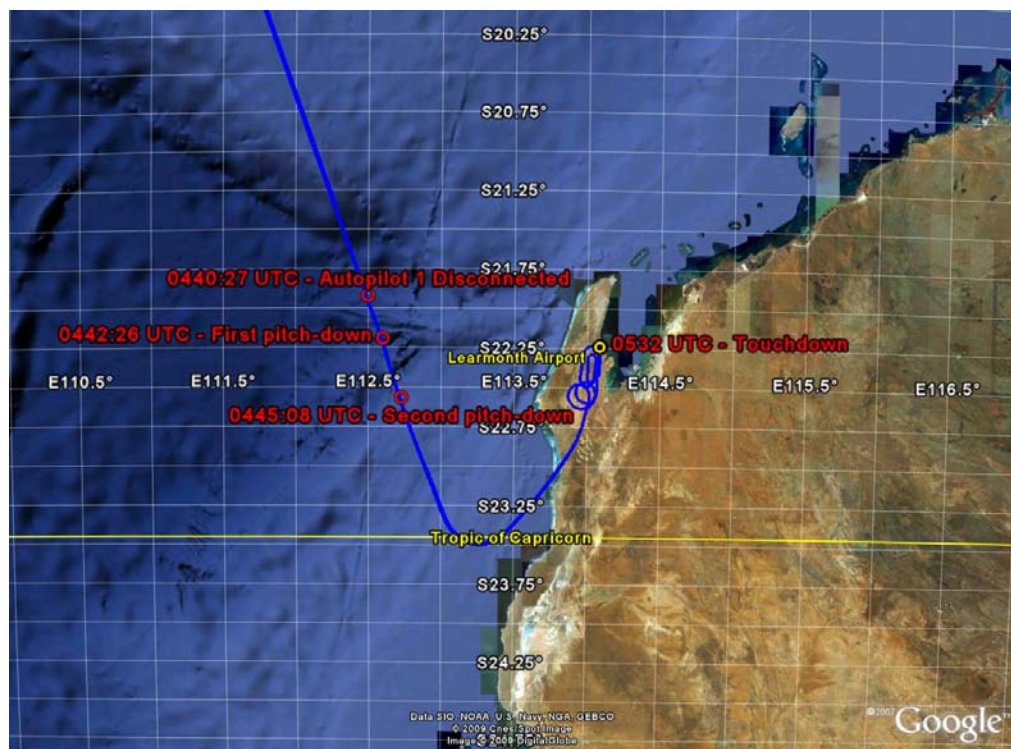
After discussing the situation, the crew decided that they needed to land the aircraft as soon as possible. They were not confident that further pitch-down events would not occur. They were also aware that there had been some injuries in the cabin, but at that stage they were not aware of the extent of the injuries. At 1249, the crew made a PAN<sup>8</sup> emergency broadcast to air traffic control, advising that they had experienced ‘flight control computer problems’ and that some people had been injured. They requested a clearance to divert to and track direct to Learmonth, WA.<sup>9</sup> Clearance to divert and commence descent was received from air traffic control. Figure 1 shows the track of the aircraft and time of key events.

**Figure 1: Aircraft track and key events**

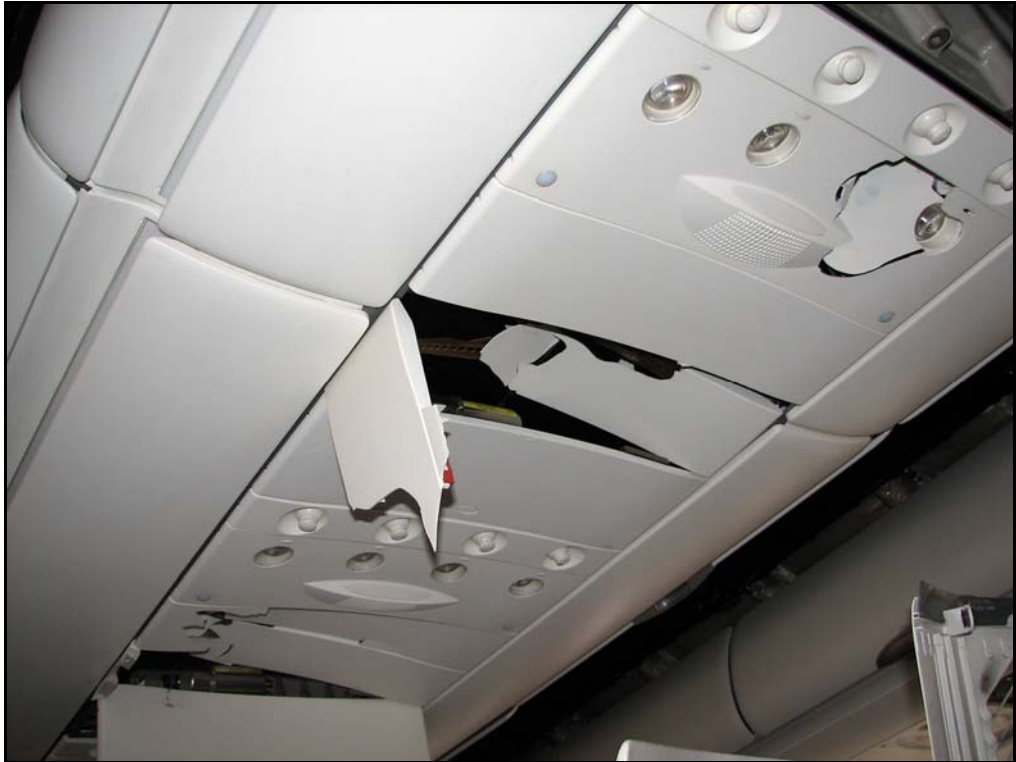
Inspection of the aircraft interior revealed damage mainly in the centre and rear sections of the passenger cabin. The level of damage varied significantly. Much of the damage was in the area of the personal service units (located above each passenger seat) and adjacent panels. The damage was typically consistent with that resulting from an impact by a person or object. There was evidence of damage above approximately 10 per cent of the seats in the centre section of the cabin, and above approximately 20 per cent of the seats in the rear section of the cabin. In addition, some ceiling panels above the cabin aisle-ways had evidence of impact damage, and many had been dislodged from their fixed position.

Oxygen masks had deployed from above nine of the seats where there had been damage to overhead personal service units or adjacent panels. Some of the cabin portable oxygen cylinders and some of the aircraft first aid kits had been deployed.

**Figure 2: Example of damage to ceiling panels above passenger seats**

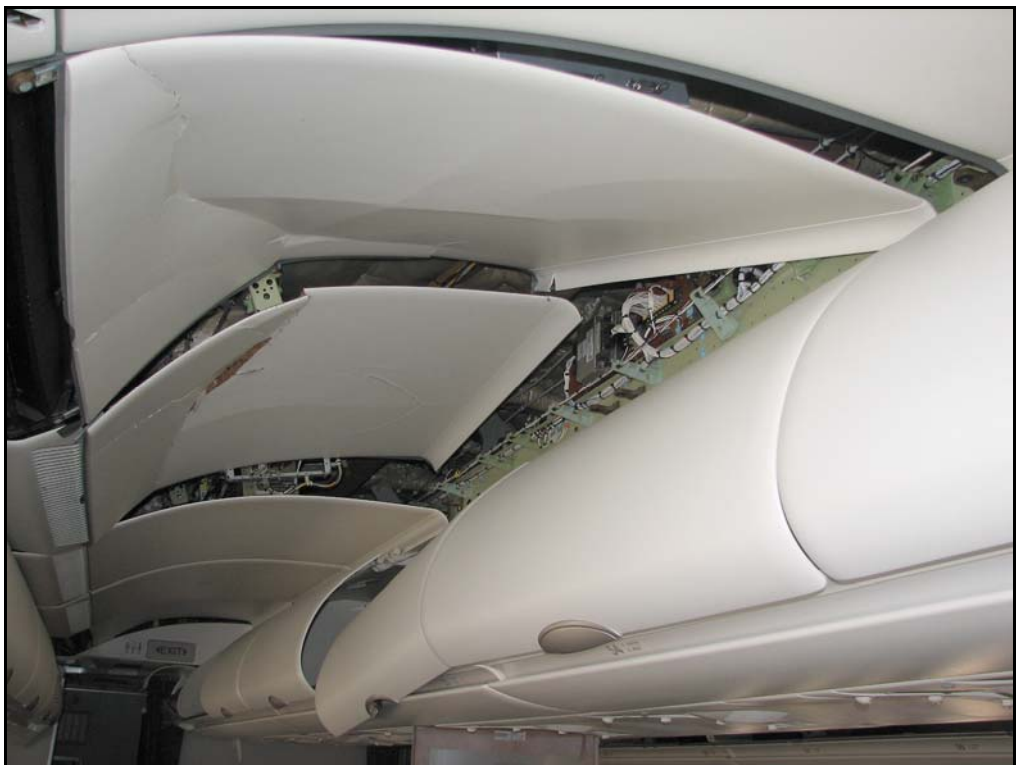
**Figure 3: Example of damage to ceiling panels in aisle**

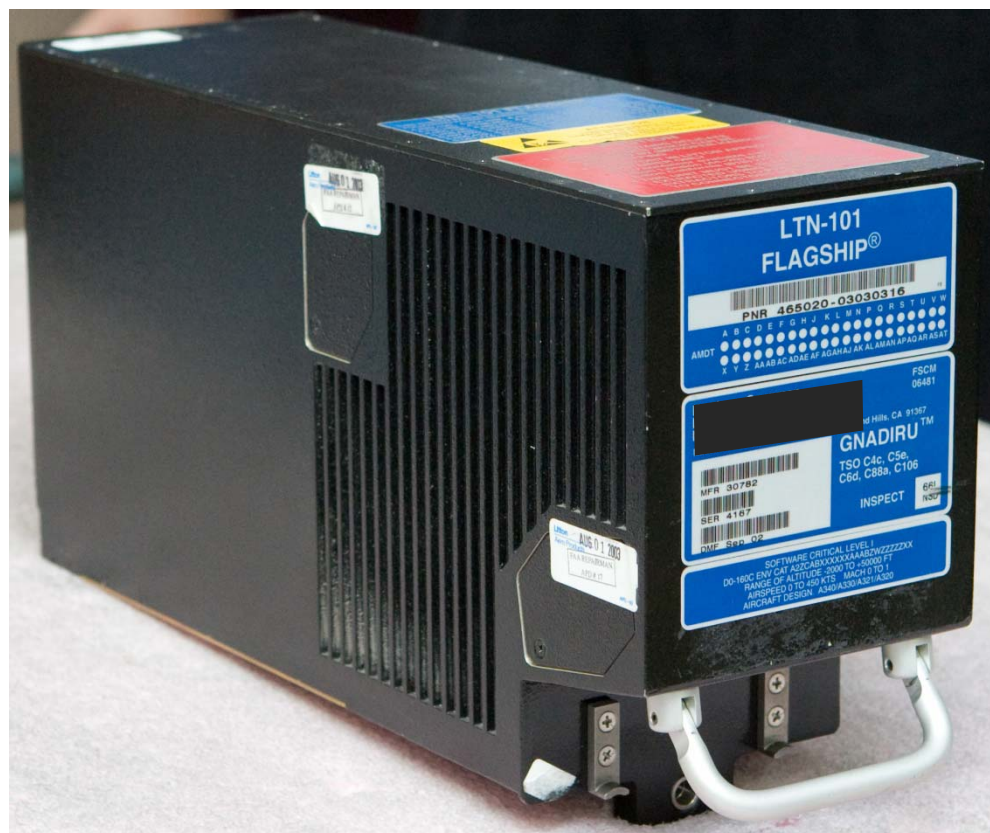
**Figure 6: ADIRU 1 from VH-QPA**

At 0440:28 UTC (1240:28 local time), autopilot 1 disconnected involuntarily<sup>22</sup> and the inertial reference system (IR) function of ADIRU 1 began to indicate 'Fail' (04:40:31). The IR 1 Fail indication continuously indicated 'Fail' until after landing at Learmonth.

The first ADR 1 'Fail' indication began at 0440:41 UTC. This indication lasted for less than 4 seconds. Unlike the IR Fail indication, the ADR Fail indication did not continuously indicate 'Fail'. In total, 20 ADR 1 'Fail' indications were recorded before the aircraft touched down at Learmonth. As the ADR 1 'Fail' parameter was sampled once every 4 seconds, a brief ADR 1 fail indication may not necessarily be sampled and recorded. As a result, the number of actual ADR 1 'Fail' indications may have been larger than the number recorded by the FDR.

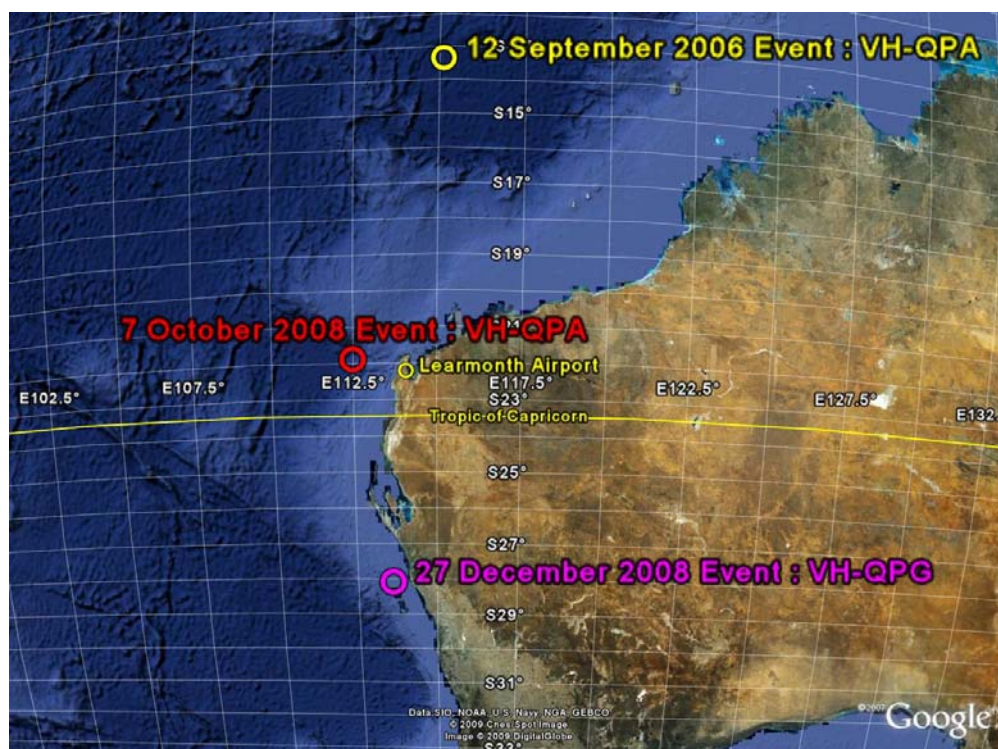
No FDR or QAR data was available for the 12 September 2006 flight. The location of the aircraft at the time of the NAV IR 1 FAULT was estimated using positions reported by ACARS<sup>32</sup> messages transmitted before and after the fault occurred. That technique gave a position 980 km (530 NM) north of Learmonth (Figure 11).

**Figure 11: Locations for each occurrence (the point shown is where the anomalous ADIRU behaviour commenced)**

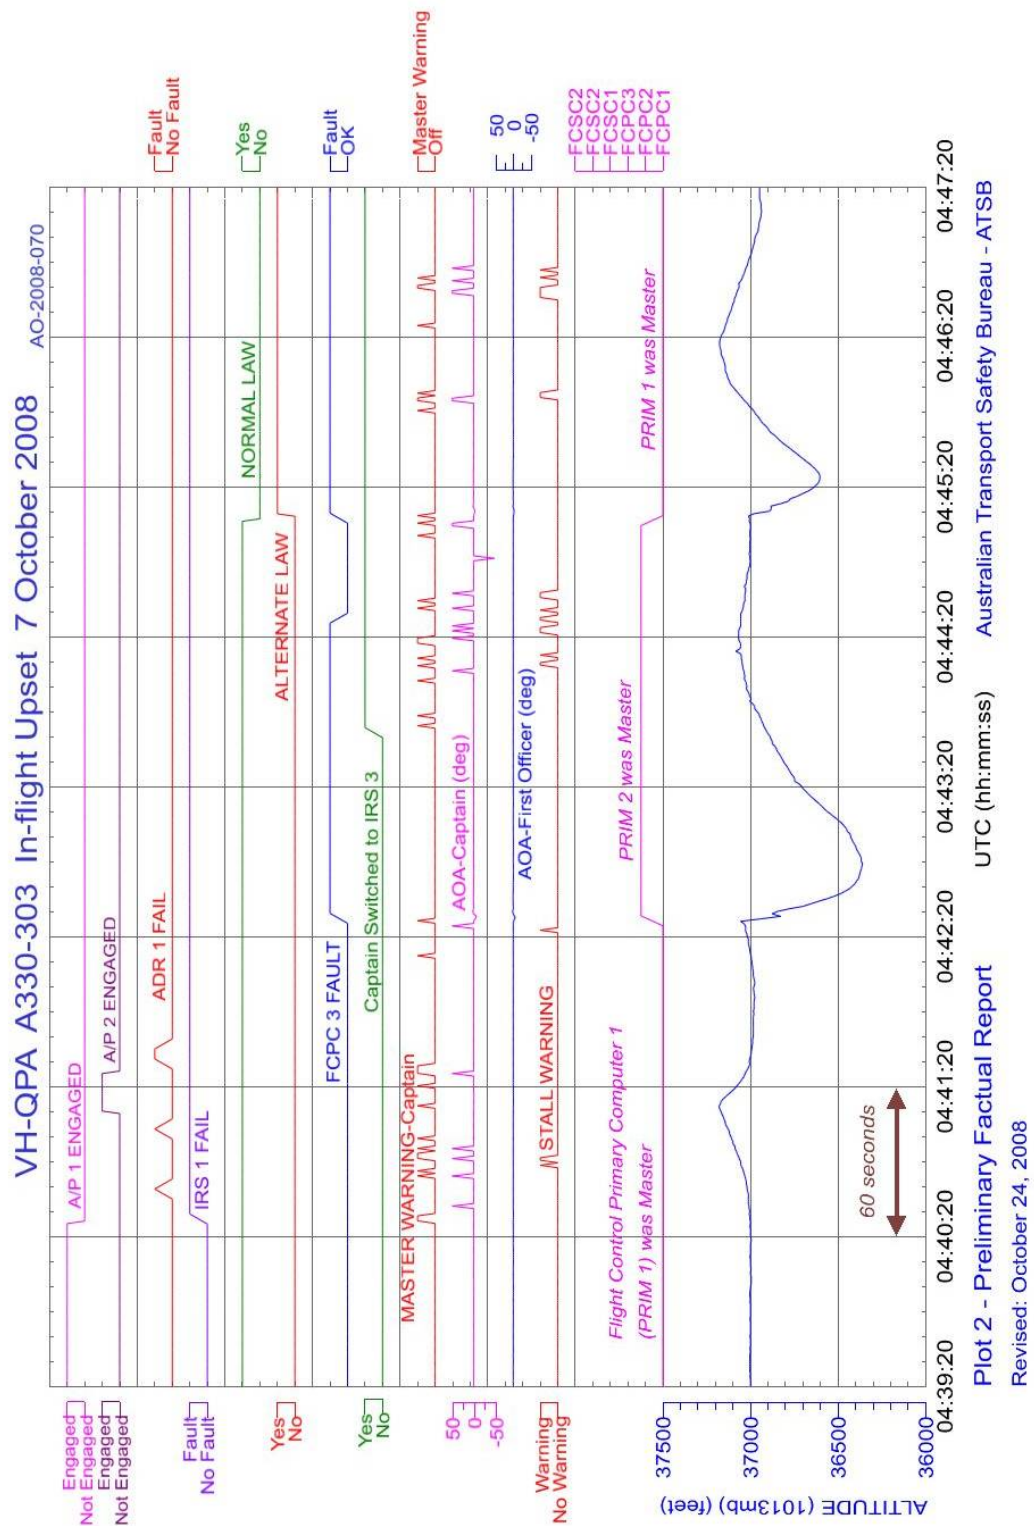
Figure B2: Plot showing selected data during period of both in-flight upset events
