ATSB TRANSPORT SAFETY REPORT
Aviation Occurrence Investigation A0-2008-077
Final

Wake turbulence event Sydney Airport, NSW 3 November 2008

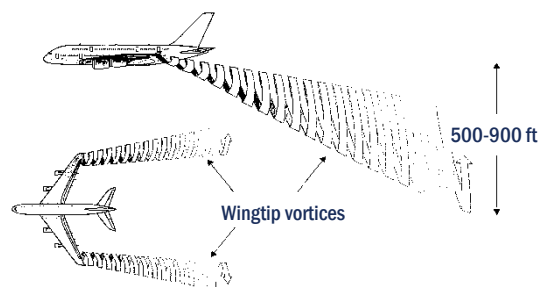
Figure 1: Effects of wake turbulence

Wake turbulence is the result of wingtip vortices that are created when a wing creates lift (Figure 1).² The magnitude and intensity of the vortices is determined by four factors; the amount of lift that is being generated by the wing, the aircraft’s wing span, the air density, and the airspeed of the aircraft that is generating the turbulence.

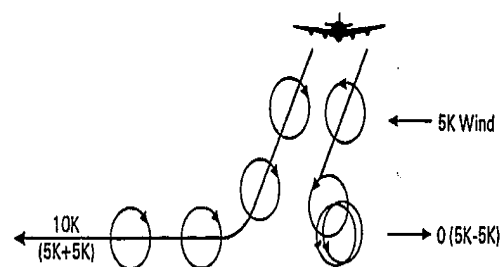
Figure 2: Crosswind effect on wake turbulence

Studies have determined that vortices in still air move outwards at a rate of about 5 kts, and descend at about 300 to 500 ft/min. The studies also showed that a crosswind increased the lateral transportation (drift), or sideways displacement of the vortices (Figure 2).²

Calculations based on the recorded crosswind component of 35 kts at an altitude 2,400 ft, indicated that it would take 72 seconds for the wingtip vortices to cover the combined 1,037 m spacing between the parallel runways and 259 m

that the SAAB was displaced from the centreline (1,296 m total). That was about the elapsed time interval between the A380 passing abeam the upset point, and the SAAB reaching it.
